SERVICE PROCEDURE

25507R1

SUBJECT: SAFETY RECALL

Brake systems on certain 2019 thru 2025 International® CV™ Series trucks built 1/11/2018 thru 9/9/2024, manufactured without a silicone block harness, with feature codes 0004198, 0004240 (Brake system, hydraulic with Hydromax brake booster).

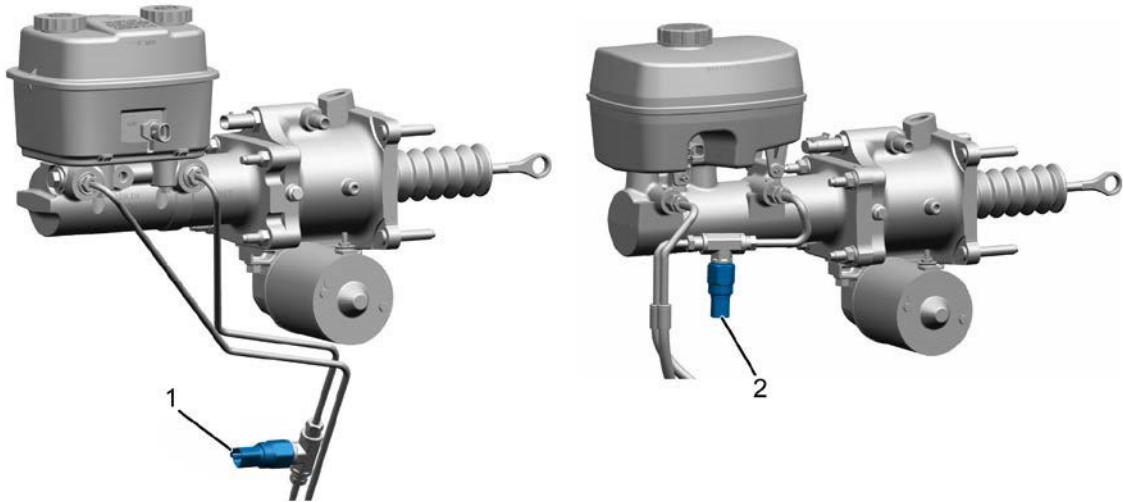
Figure 1. Brake Pressure Switch Placement

NOTE: Placement of the brake pressure switch is different for vehicles built 11/30/2020 and prior and vehicles built 12/01/2020 and after (Figure 1, Items 1 and 2).

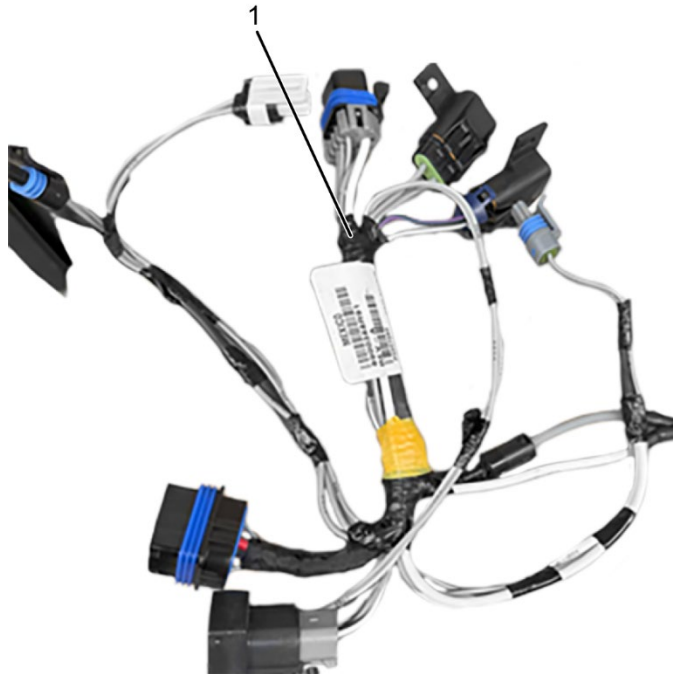
Figure 2. Harness Not Fully Taped

NOTE: Harness part number 8900388R91 will require the harness to have electrical harness tape installed, if it is not already fully taped. The tape is to prevent abrasion to the harness from other components.

7. Verify that the replacement harness is fully taped.
 - a. If the harness is not fully taped (Figure 2), proceed to Step 8.
 - b. If the harness is fully taped, proceed to Step 11.

8. When wrapping the harness start with three wraps around the harness and finish up with three wraps. The electrical tape should overlap the previous wrap and be half the width of the tape.

9. When taping the junction areas of the harness, the electrical tape should be wrapped around all wires going to the junction area and should overlap half the width of the previously installed wrap.

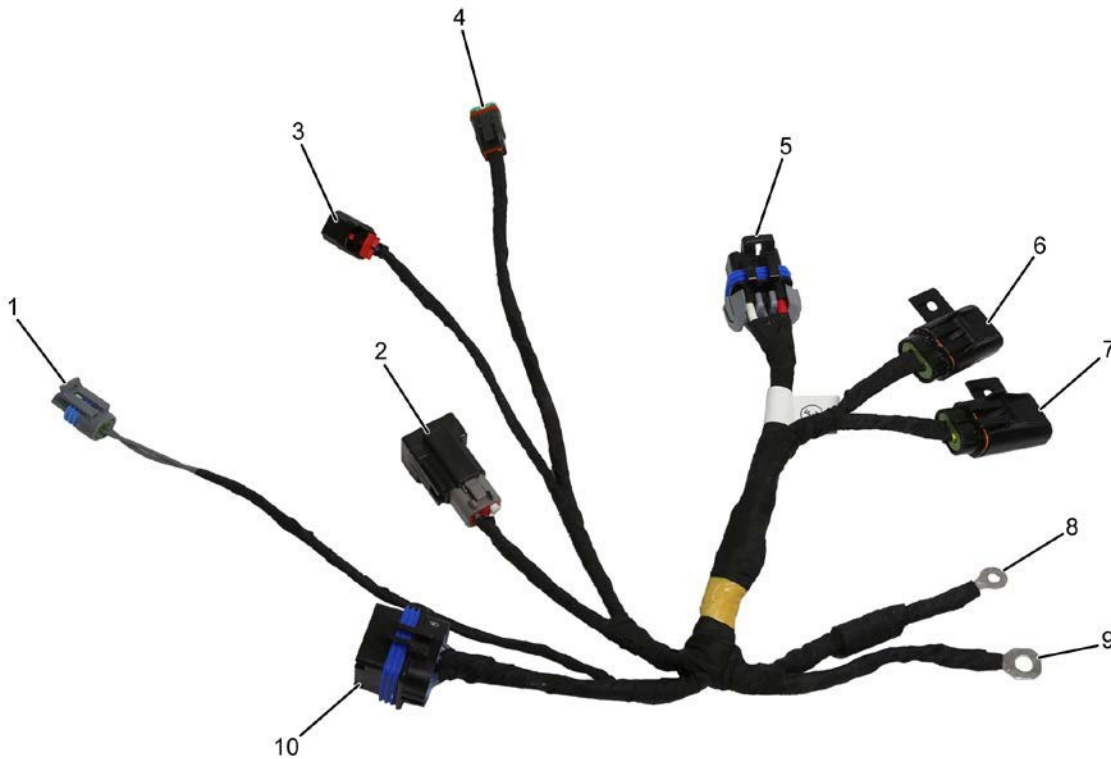
Figure 8. Brake Jumper Harness for 12/01/2020 and later

These vehicles may have been built with a brake pressure switch assembly that allows brake fluid to leak beyond the diaphragm seal into the pressure switch. The brake fluid may seep into the electrical components and short the brake pressure switch.

If brake fluid shorts the brake pressure switch and the associated fuse, the circuit can generate excessive heat that can result in a fire increasing the risk of property damage or personal injury to the operator.
