GROUP	MODEL
	Safety Recall Campaign	2020-2022MY Niro EV (DE EV) w/AVN 5.0 Wide
	NUMBER	DATE
	SC342	November 2025

SAFETY RECALL CAMPAIGN

SUBJECT: REARVIEW CAMERA ASSEMBLY REPLACEMENT (SC342)

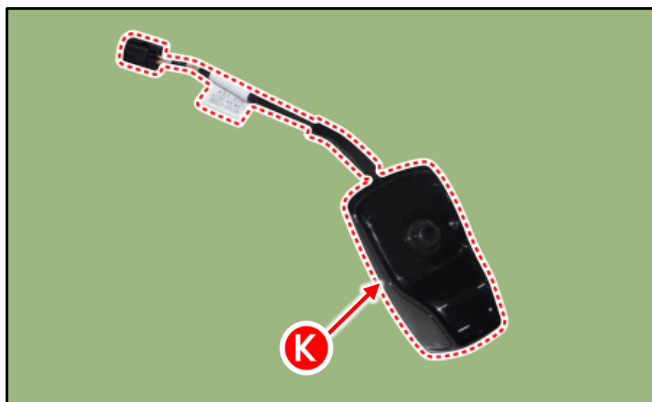
This bulletin provides information to replace the rearview camera assembly on certain 2020-2022MY Niro EV (DE EV) vehicles produced from January 15, 2020 through March 29, 2022 equipped with an AVN 5.0 Wide Navigation 10.25-inch touchscreen display. Due to damage from voltage surges in the rearview camera power circuit, the rearview camera in the subject vehicles may become inoperative and fail to display a rearview image while in reverse. As a result, the subject vehicle fails to comply with the rear visibility requirements of Federal Motor Vehicle Safety Standard (FMVSS) No. 111 "Rear Visibility", thereby increasing the risk of a crash. Follow the procedure outlined in this publication to replace the rearview camera assembly with an improved part with increased voltage surge protection on the applicable vehicle. Before conducting the procedure, verify that the vehicle is included in the list of affected VINs.

11. Replace the rearview camera assembly (K) with the new part in the reverse order of removal.

Take care not to damage the tailgate glass when removing the camera.
