SAFETY RECALL

Date	Number	Release	Page
08.2025	SC0481	02	1(21)

MMD Electric MVSS 124 Return to Idle MD6 BE, MD7 BE

Revision: Updated Repair Instructions

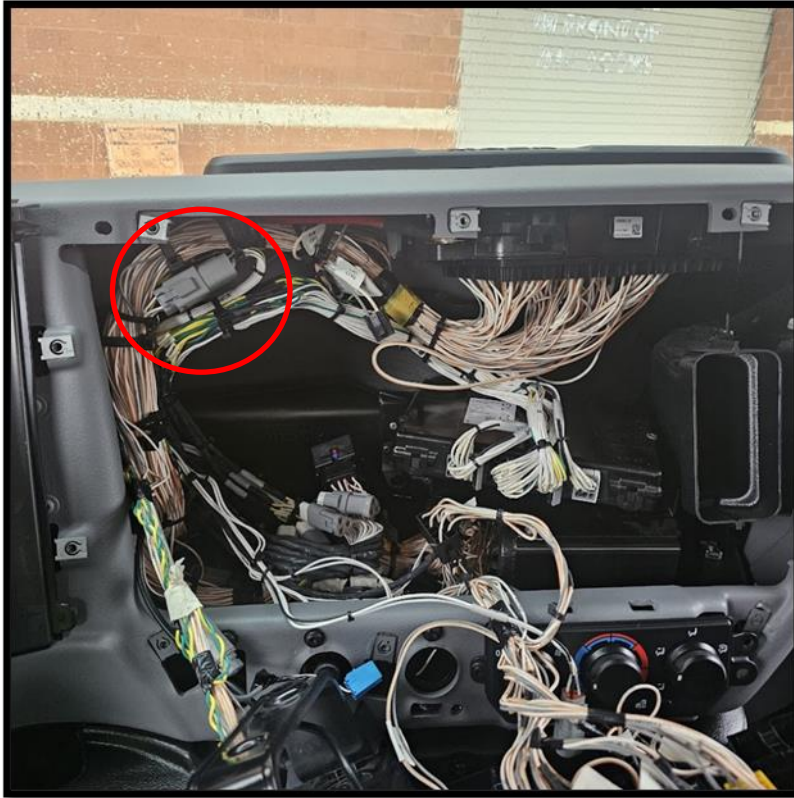
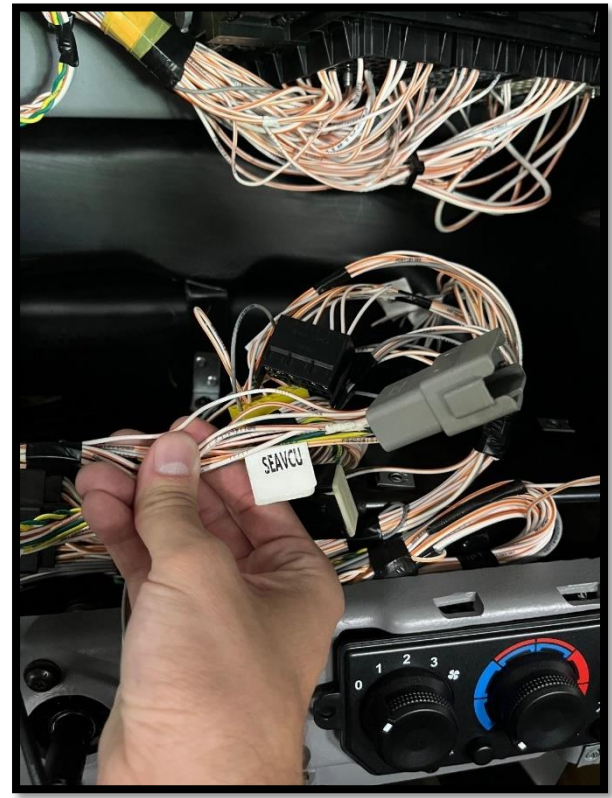
11. Locate the EXRO interface connector. It is a 12-pin gray connector labeled SEAVCU.

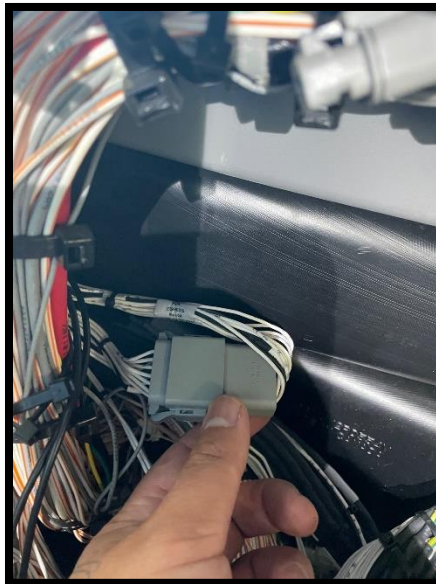
If you find the connector and it is not labeled SEAVCU and the wires are not labeled (picture below), no re-pin is needed. Please proceed to step 18.

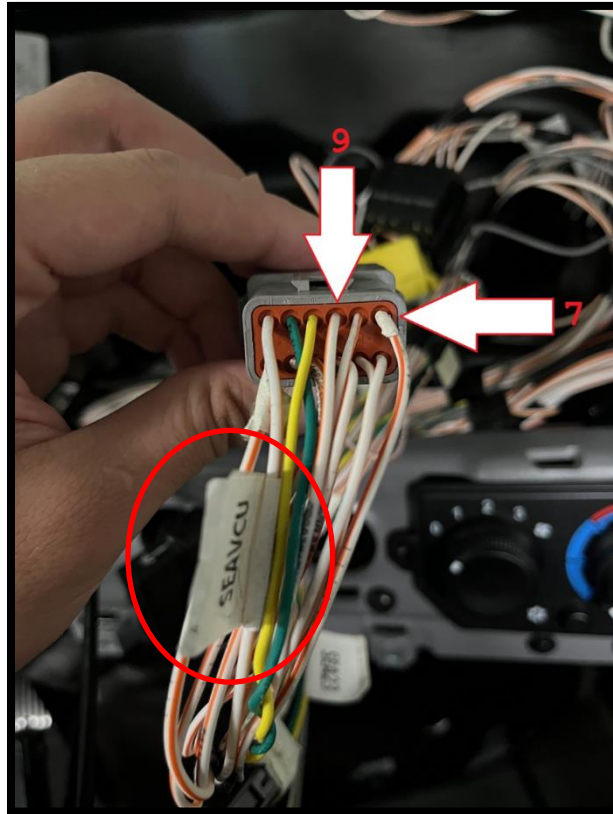
12. Remove zip ties and disconnect the connector for better access.
13. Locate cavities 7 and 9 of the connector. Ensure that you are locating the cavities at the connector that has the SEAVCU label.

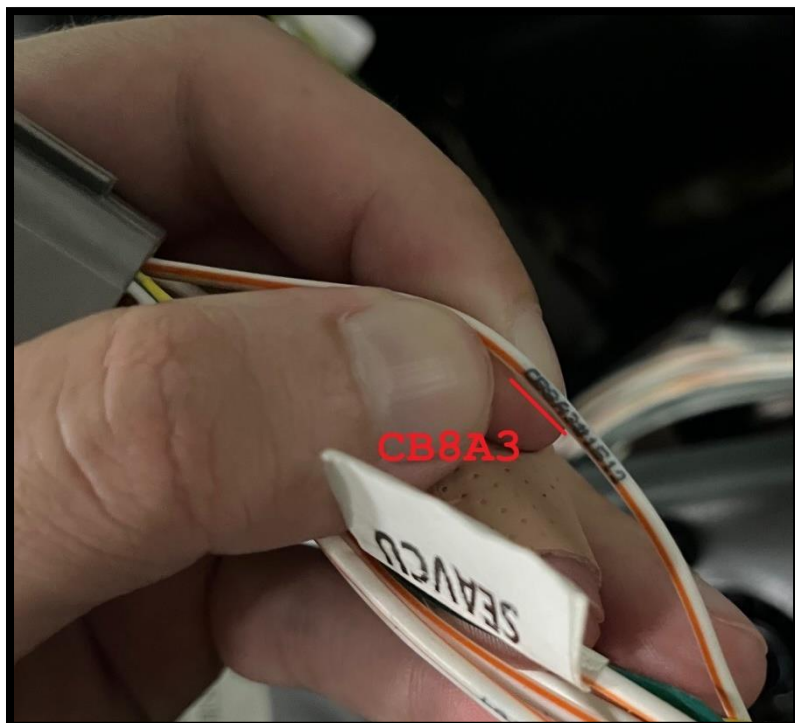
14. Check the wire ID printed on the wires in cavity 7 and 9.

- Cavity 7 should have ID CA3A3,
- Cavity 9 should have ID CB8A3.

16. If incorrect, relocate the wires by following the steps below.
