SAFETY RECALL

Date	Number	Release	Page
08.2025	SC0481	01	1(21)

MMD Electric FMVSS 124 Return to Idle MD6 BE, MD7 BE

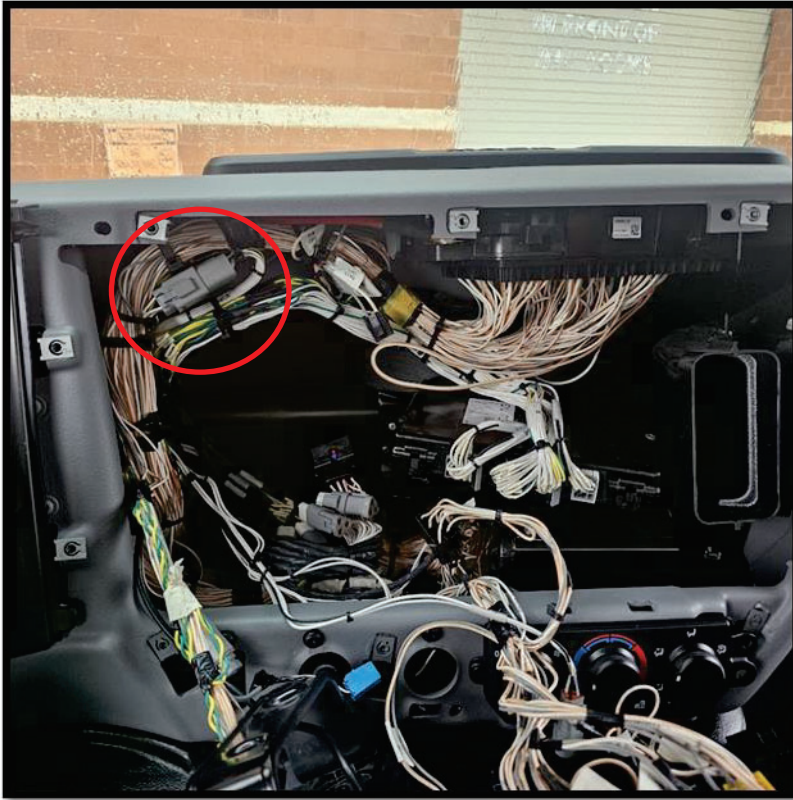
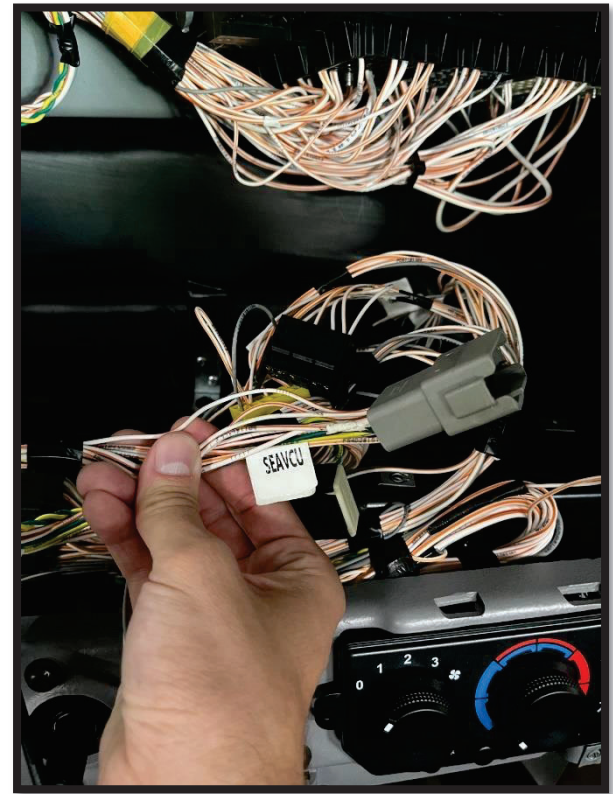
11. Locate the EXRO interface connector. It is a 12-pin gray connector labeled SEAVCU.

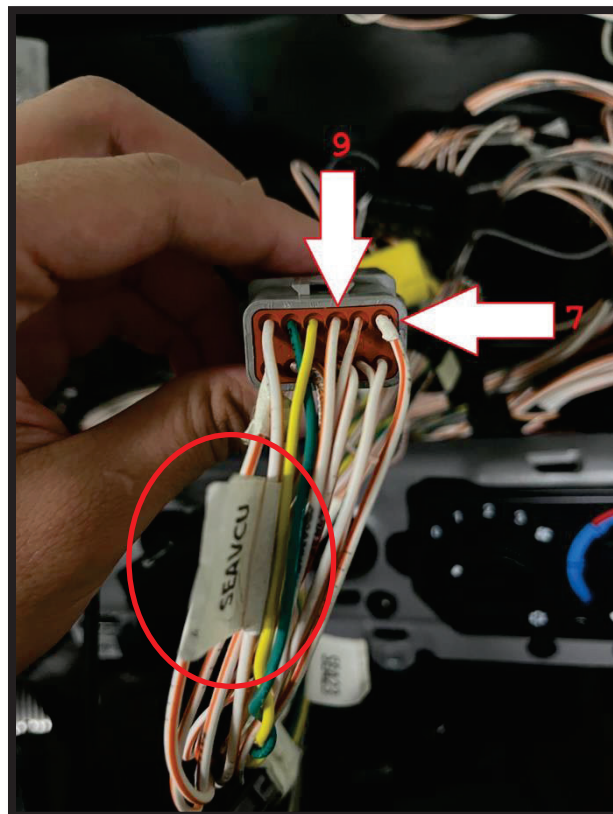
13. Locate cavities 7 and 9 of the connector. Ensure that you are locating the cavities at the connector that has the SEAVCU label.

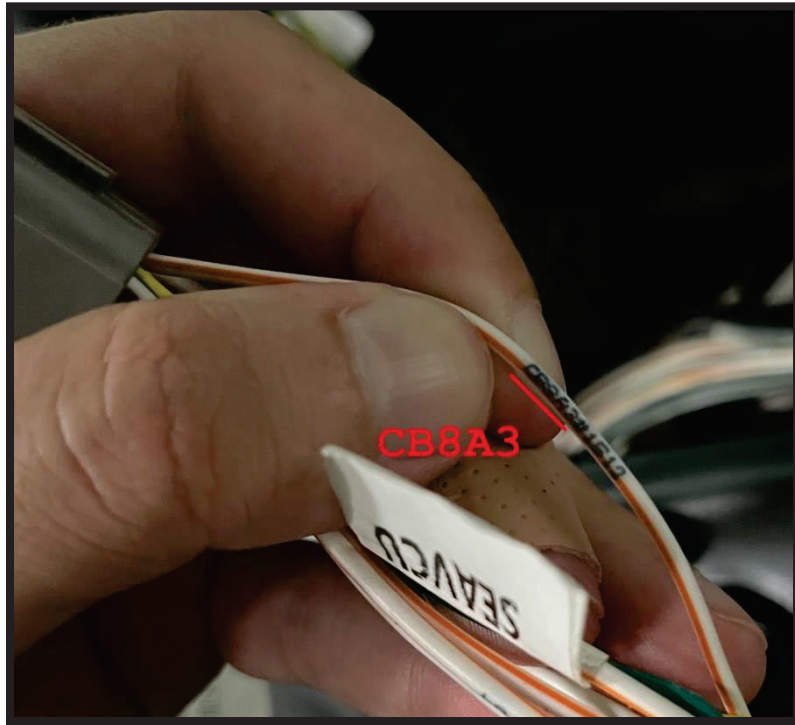
14. Check the wire ID printed on the wires in cavity 7 and 9.

- Cavity 7 should have ID CA3A3,
- Cavity 9 should have ID CB8A3.

16. If incorrect, relocate the wires by following the steps below.
