# Safety Recall

## N252513060 Roof Rail Airbag Inflator May Rupture

Release Date: June 2025

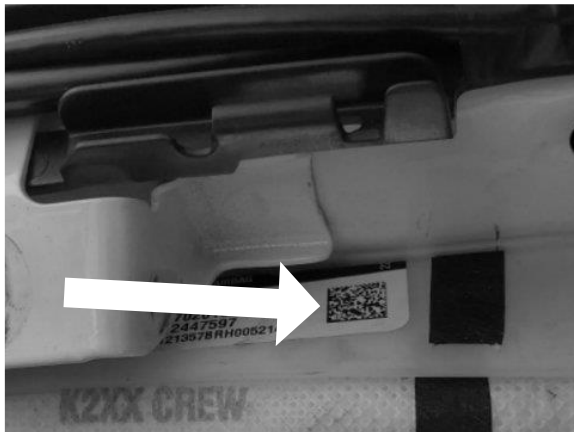
6058834

**Record the serial number on each of the white airbag labels.**

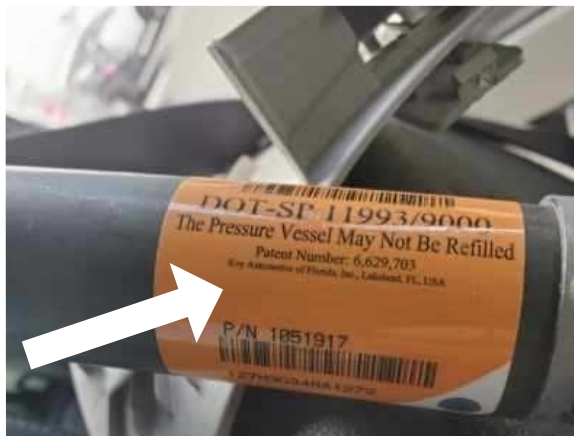
6058836

**DO NOT record the serial number (orange label) on the inflator.**
