## SV-RCL-025-002 FST Adventure Brake Line Inspection Recall

### NHTSA Campaign Number: 23E-074 (Recall: 25V-459)

MY24 FST Adventure Platform Motorcycles

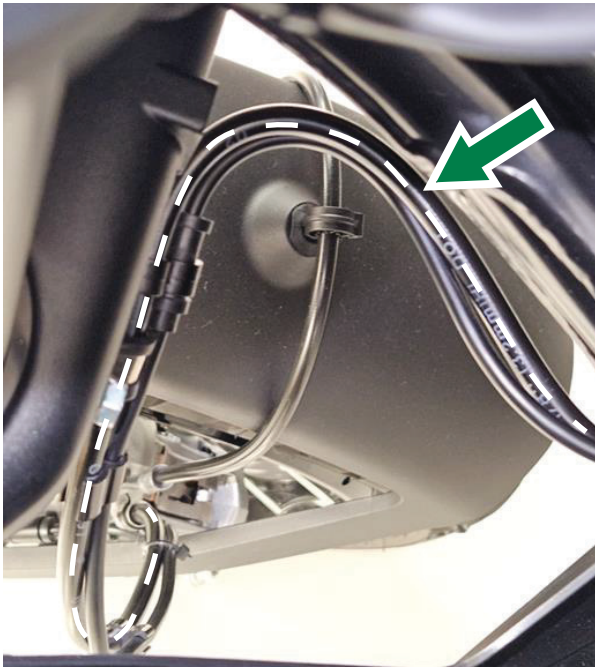
Top View Normal

1. Inspect the brake line from the top of the motorcycle.
  - **Normal:** The brake line has enough slack and is positioned below the frame with slack between the p-clamp and the caliper.
  - **Twisted:** The brake line is tight with little slack causing the line to be positioned next to the frame. There is little to no slack between the p-clamp and the caliper.

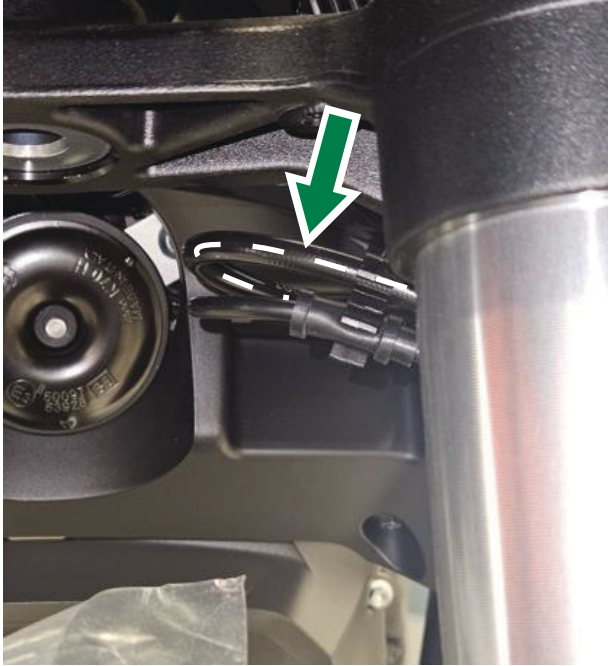
Front View Normal

- **Normal:** The brake line will be in line with the p-clamp. The bend is pointed towards the horn and is nearly horizontal.
- **Twisted:** The brake line is more vertical and out of alignment with the p-clamp. The bend will not be visible as it is above the fork triple clamp next to the frame.

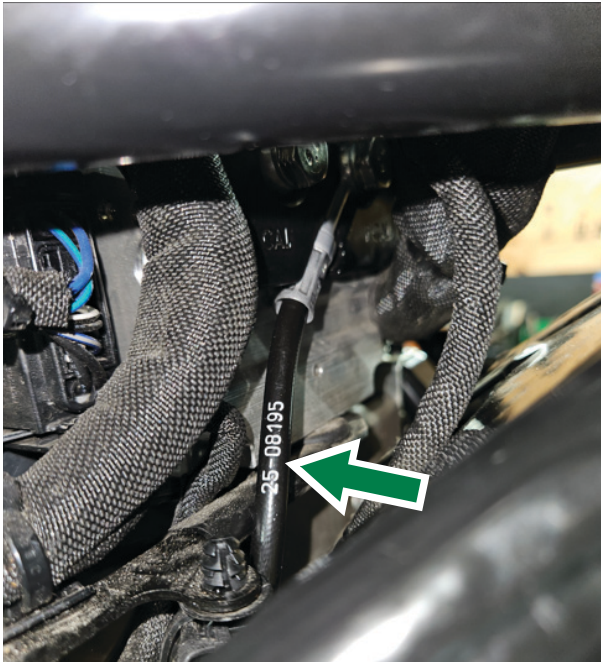
Part Number Outward

3. Inspect the brake line at the HCU.
  - **Normal:** The part number of the brake line will be facing outward.
  - **Twisted:** The part number of the brake line will be facing inward.
4. If the brake line is twisted, proceed to ["Brake Line Replacement" on page 5](#) to replace the line. If not twisted, the motorcycle can be returned to service.
