To: Mercedes-Benz Dealer Principals, General Managers, Sales Managers, Service Managers, Parts Managers	From: Anthony Washington, Senior Manager, Regulations and Certifications
Re: Recall Campaign Launch Notification Model: Metris Model Year: 2020-2023 Rework Infotainment Harness	Date: October 2025

IMPORTANT RECALL CAMPAIGN INFORMATION

Campaign No.:	Campaign Codeword:	NHTSA ID:	Rework Infotainment Harness
2025090006	VS2GARPIN	25V463	
<p>This is to notify you of a Recall Campaign to rework the infotainment harness on approximately 43,432 MY 2020-2023 Metris Vans. The recall campaign will be visible on the www.NHTSA.gov website and may generate questions from customers. All affected VINs will be flagged as "OPEN" in VMI</p>			
Background			
Issue	<p>Mercedes-Benz AG, the manufacturer of Mercedes-Benz Metris vehicles, has determined that on certain Metris (447 platform) vehicles, the electrical connection to the infotainment system might not meet current specifications. In this case, power may be sporadically interrupted to the infotainment system. As a consequence, the rearview camera image might be temporarily unavailable and impair rearward visibility while the vehicle is in reve

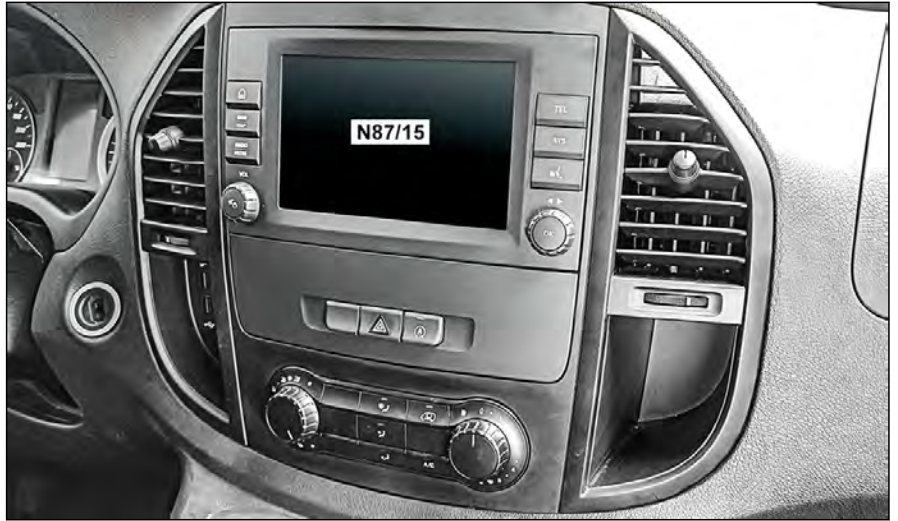
S82.60-A060-75

N87/15 Radio/radio navigation

Notice	Information on preventing damage to electronic components due to electrostatic discharge		AH54.00-P-0001-01A
Notice	Notes on carrying out repair work in the vehicle interior		AH68.00-D-0001-01KOS
	Check		
1	Check if vehicle is affected by measure.		
	Remove		
2	Remove radio (radio/radio navigation (N87/15)).	Model 447.6/7 The contact sockets on the electrical connectors (electrical connector (A)) of the radio (radio/radio navigation (N87/15)) must be replaced.	AR82.60-S-7502E

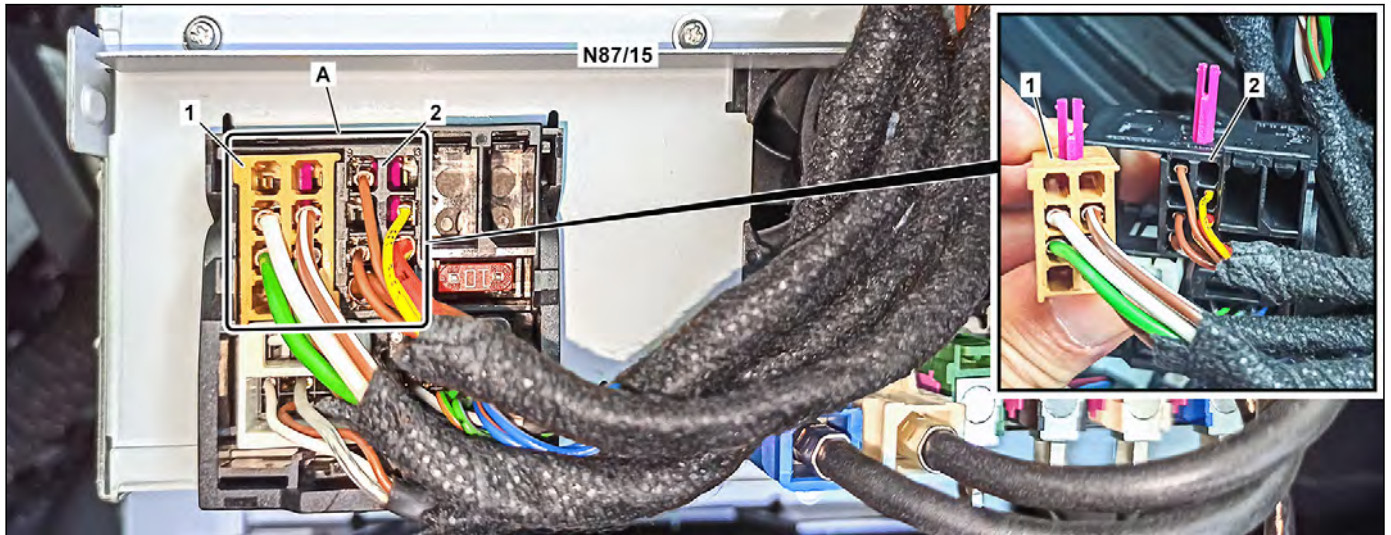
S82.60-A059-78

N87/15 Radio/radio navigation
1 Ocher yellow housing

2 Black housing
A Electrical connector

Replace		
3	<p>Replace all contact sockets of ocher yellow housing (1) of electrical connector (A).</p> <p>

Always remove electrical connectors individually from ocher yellow housing (1), replace contact sockets and reinstall into ocher yellow housing (1).</p> <p>

For all slots on the ocher yellow housing (1), use the contact sockets with replacement part number A 006 982 19 26.</p> <p>

Always remove the electrical connectors individually from the black housing (2), replace the contact sockets and install again into the black housing (2).</p> <p>

It is essential to have two new contact sockets at slots 9 and 11 with replacement part number A 006 982 17 26, two new contact sockets at slots 12 and 15 with replacement part number A 006 982 19 26, and use a new contact socket on slot 14 with replacement part number A 006 982 15 26.</p>	<p>AR00.19-S-0100E</p> <p>AR00.19-S-0120E</p> <p>PE82.60-S-2000VVB</p>
