# SAFETY RECALL

## 2nd Row Headrest

Reference: 20C / NHTSA 25V-472

2023-2024 (WL) Jeep Grand  
Cherokee/Grand Cherokee L

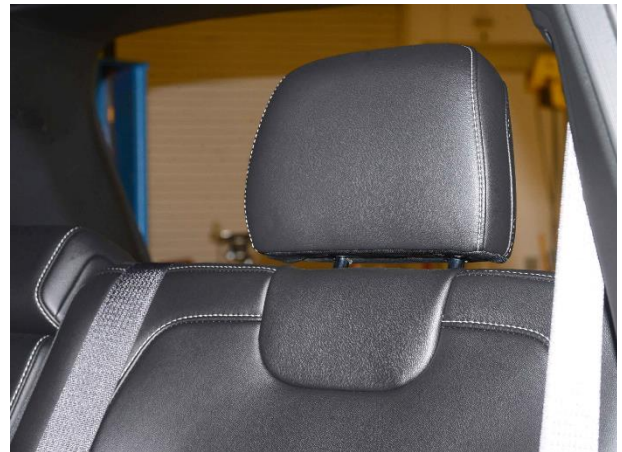
**Figure 1 – Headrest In Locked Position**

1. Move the front seats forward.
2. Make sure that the headrest is in the locked position (Figure 1).

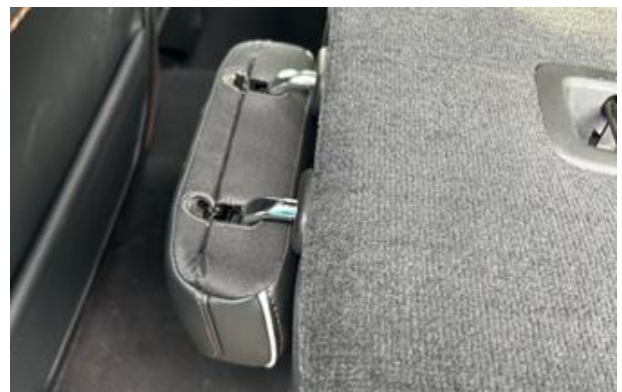
**Figure 2 – Second Row Seat Folded Flat**

3. Fold the second row seat to the fully flat position (Figure 2).

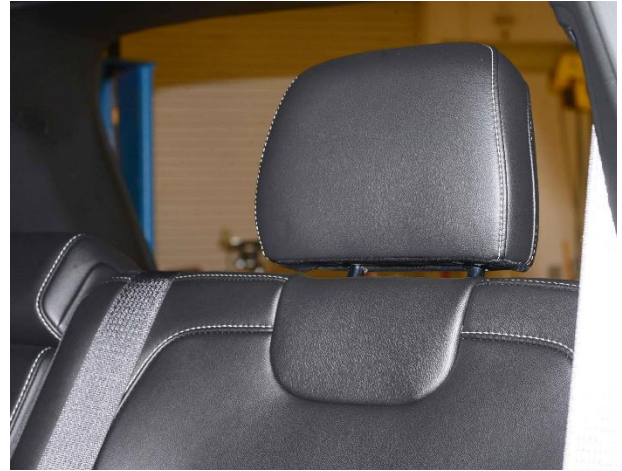
**Figure 3 – Second Row Seat Fully Upright**

4. Return the second row seat to the fully upright position (Figure 3).
5. Return the headrest to the locked position (Figure 1).

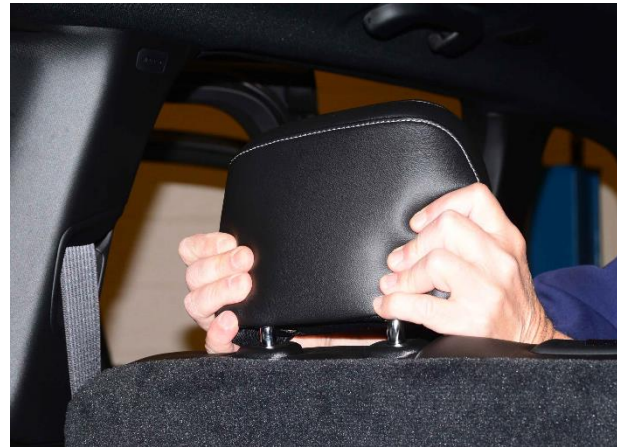
**Figure 4 – Testing Headrest – Side to Side Motion**

6. Kneeling in the seat, facing the headrest, with moderate effort, rock the headrest from side to side using both hands (Figure 4).

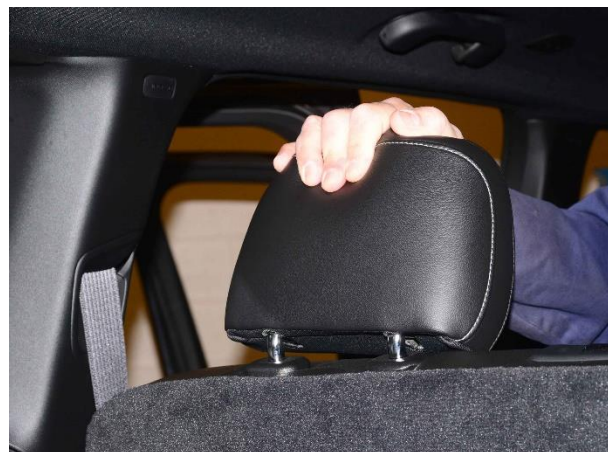
**Figure 5 – Testing Headrest – Fore / Aft Motion**

7. Pull the headrest toward you with moderate effort (Figure 5).

8. Did the headrest release from the locked position?

**NOTE:** If the headrest fails to remain locked in the upright position during any of the ten tests, it must be replaced.

- **Yes:** replace the headrest. Proceed to **B. Headrest Replacement.**
- **No:** Repeat Steps 2-7 nine more times. If the headrest remains locked each time, it has passed inspection.
