L74X-
R.01.25

To: After Sales Official Network
Subject: Door gas spring fixing pin
Date: 22/07/2025
Pages: 4

Door gas spring fixing pin

Revuelto

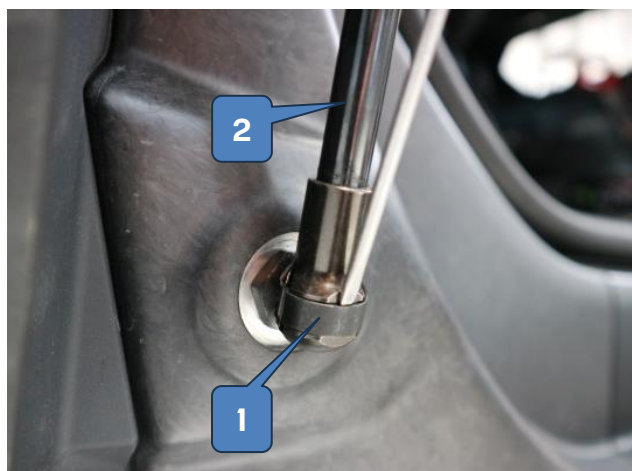
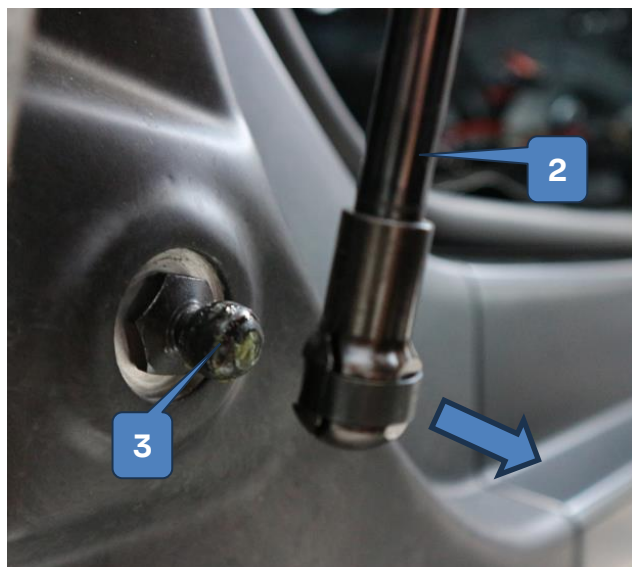
During ongoing product monitoring, Automobili Lamborghini S.p.A. identified a potential issue on some vehicles and has released a new mandatory update for the potentially affected cars for the verification of the correct tightening torque of the door gas spring spherical pin.

2. In the lower area, open the safety catch (1) of the gas spring (2) using a screwdriver and move it slightly backwards.
3. Release the gas spring (2) from the fixing pin (3).
4. Check the tightening of the fastening pin (3), (tightening torque $24\text{Nm} \pm 10\%$ - 5.39lbft). If it is not tightened correctly, tighten it to the prescribed tightening torque of $24\text{Nm} \pm 10\%$ (5.39lbft).
5. Once the tightening has been checked, reposition the gas spring (2) on the fixing pin (3) and then close the safety catch (1).
6. Carry out the same procedure on the other door.
