IMPORTANT SAFETY RECALL

NHTSA Safety Recall 25V-478

SUBJECT: Campaign # 199 – Under Seat Wire Routing

Under Seat Wire Routing / Airbag May Fail to Deploy

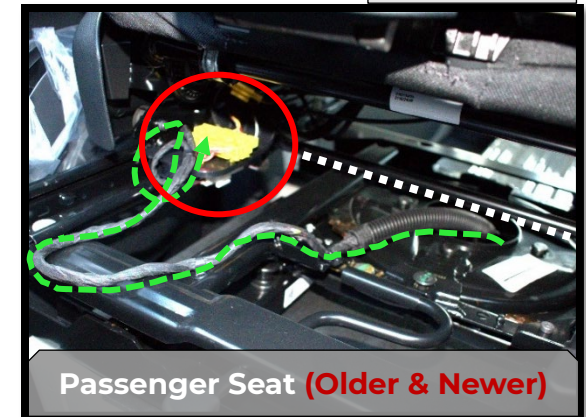
- For Older affected chassis, the Yellow Plug will be the end of the wire route for both Driver and Passenger seats. (See Figure 6 & 7)
 - For Newer affected chassis, the wire routed under the Passenger's Seat will end up being connected to the Yellow Plug (See Figure 6) and the wire routed under the Driver's Seat will end up splitting ways to the Yellow & White Plug (See Figure 8).

- A. Review the wire routing to confirm that the OEM wire path from Mercedes is being followed. Ensure the wires route from the seat base, through the center circular cutout, in the seat swivel, then go **under** the seat sliding bar (White dashes) and connect to the correct plug.

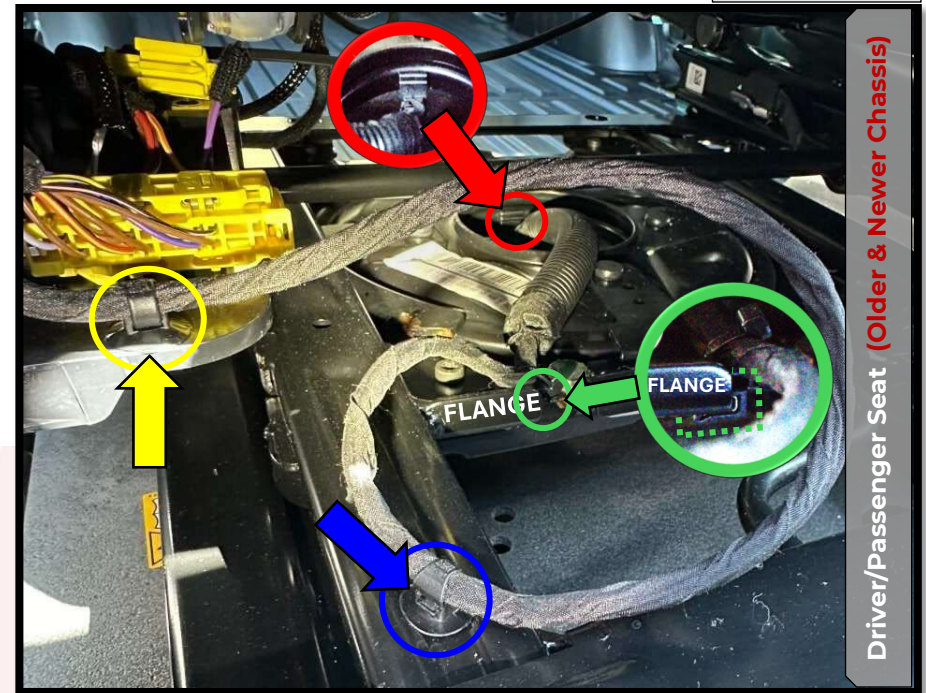
Figure 10

A. Locate all OEM retention points on the harness for Chassis with manually adjustable Passenger Seats (Older and Newer Chassis). There are 4 retention points:

- One Push Mount At the Yellow Plug Base (Yellow Arrow)
- One Push Mount At the Seat Slide Track (Blue Arrow)
- One Clip Mount At the Seat Base Flange (Green Arrow)
- One Clip Mount At Circular Cutout Hole (Red Arrow)

C. Ensure all wire tie mounts are installed in their proper location. (See the list above for the correct location points)

D. Inspect the wire tie mounts for any damage.

Note: If damaged, install replacement right next to existing mount on OEM harness. Cut the tail from Wire Tie after installation and leave the OEM mount in place.

- Clip Mount - firmly tug on the mount clips to see if it will disengage from the metal flange and the seat swivel hole.
- Push Mount - firmly tug on the push mount clip(s) to see if it will disengage from the mounting hole location on the seat slide-trac and, if applicable, at the Yellow plug base.

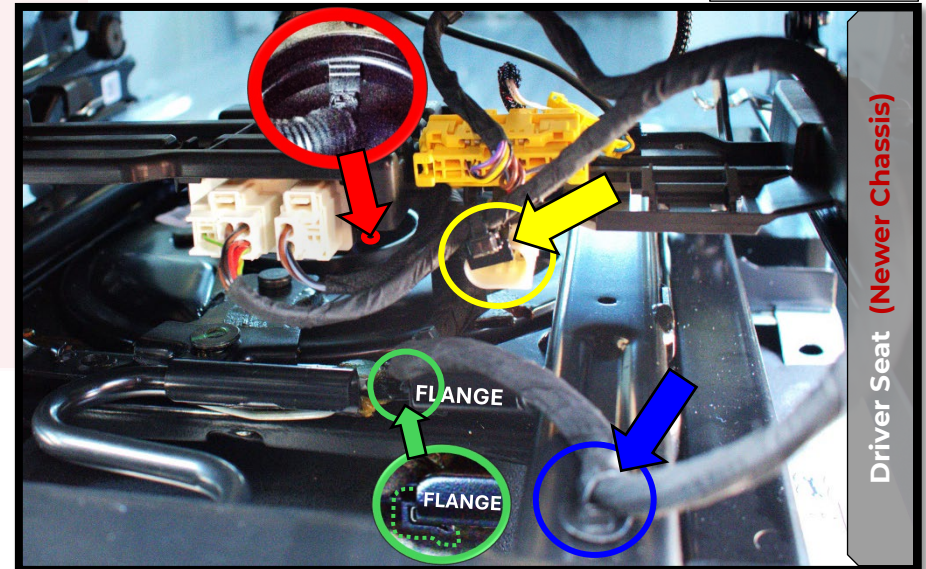
Figure 11

B. Locate all OEM retention points on the harness for Chassis with manually adjustable Driver Seats (Newer Chassis). There are 4 retention points:

- One Clip Mount At the White Tunnel Plug (Yellow Arrow)
- One Push Mount At the Seat Slide Track (Blue Arrow)
- One Clip Mount At the Seat Base Flange (Green Arrow)
- One Clip Mount At Circular cutout (Red Arrow)

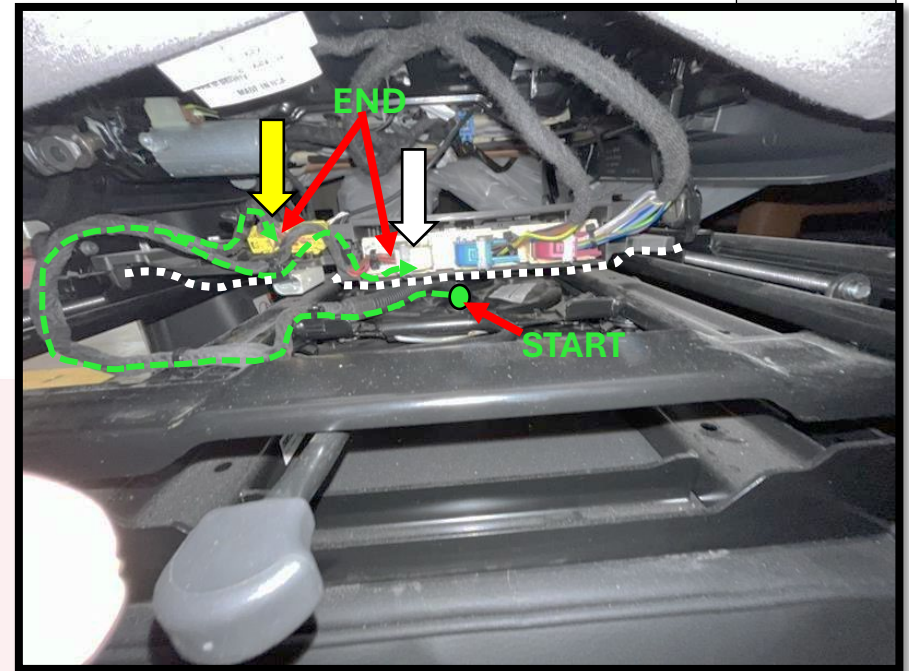
- For electronic seats (Passenger & Driver)(See Figure 2):
 - The wire should route from the seat base, up through the center circular cutout in the seat swivel, then between the plugs and the plug carrier (White dashes), and then to the yellow and white plugs mounted to the underside of the seat. See Figure 2 for the correct routing.

- C. Inspect the OEM wire harness from the yellow and white plugs to the center circular cutout in the seat swivel for any damage, such as chafing or cuts (See Figure 2 Green Arrow for the wire route).

- If the wiring appears damaged, document with photos and contact Winnebago Technical Service.
 - D. Ensure that the proper length of the OEM wire harness is accessible by assuring the Clip Wire Tie Mount is correctly installed to the center circular cutout in the seat swivel. (See Figure 3)

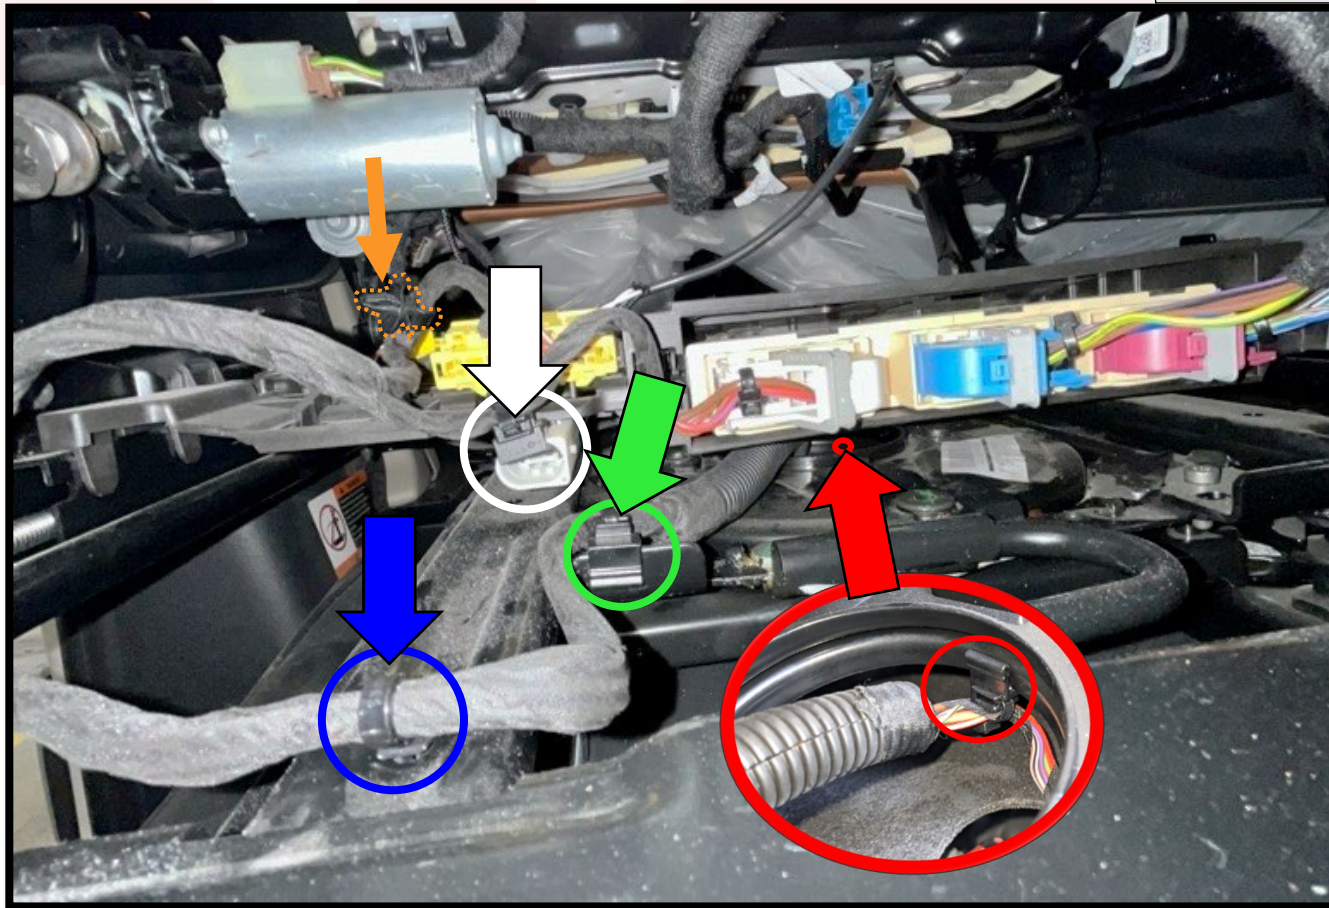
Figure 7

A. Locate all OEM retention points on the harness. (See Figure 8)

For Chassis with electronically adjustable seats there are 4 connection points:

- One Tie Mount at the White Plug (White Arrow)
- One Push Mount at the Seat Rail (Blue Arrow)
- One Clip Mount at the Seat Swivel Base Flange (Green Arrow)
- One Clip Mount at the Circular Cutout Swivel Hole (Red Arrow)

Note: The Fir Tree push mount near the yellow plug is not used and will not be reinstalled. (Orange Arrow)
