Recall Repair Instructions

NHTSA Recall # 25V-481

Tiffin Motorhomes Recall # TIF-145

Models involved: 2025 GH2 Motorhomes

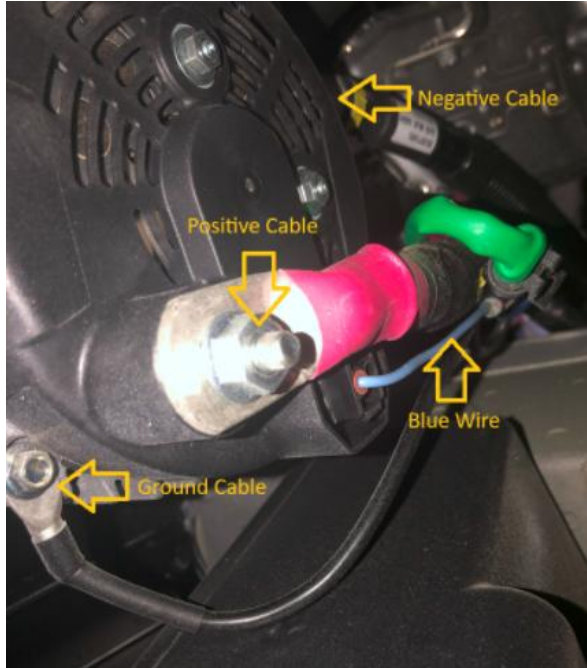
2. Remove existing secondary alternator from mount. Remove positive cable and wrap cable end with electrical tape to prevent any contact. Remove negative cable and then use wire cutters to remove blue wire. Remove ground cable. See Figure 2 for existing secondary alternator diagram.

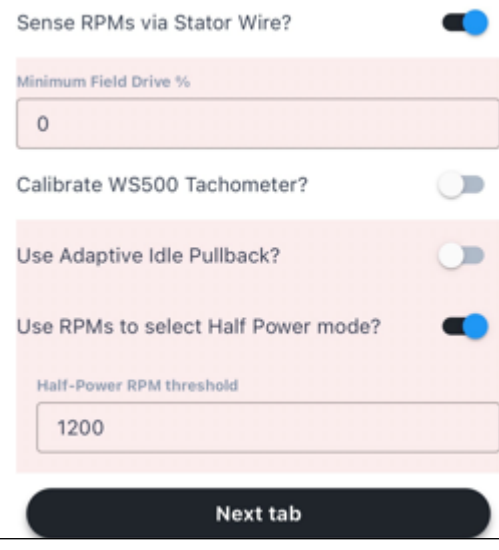
Figure 11D - Toggle ON “Sense RPMs via Stator Wire”
 Leave ON “Use RPMs to select Half Power Mode”
 Ensure threshold remains at 1200 RPMs

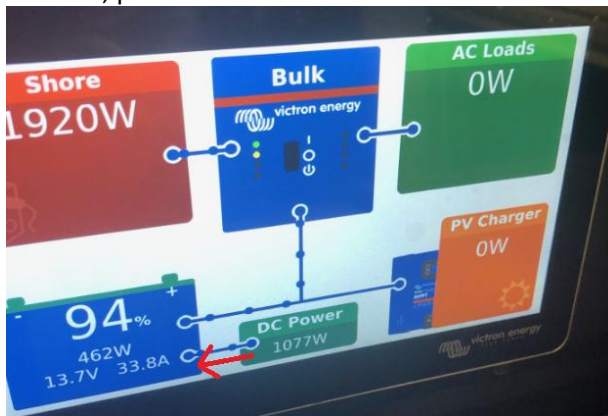
16. Hold the accelerator pedal to where RPMs are at 1200 or a little higher and check display screen. After a few seconds, power flow should move from DC Power to the battery. Figure 13
