SAFETY RELATED RECALL

Global Recall Action
Number: N759v5

| Subject: Range Rover (L405) Front Suspension Knuckle Crack | Publication No.: N759v5 |
| | Model Year: 2014 - 2016 |

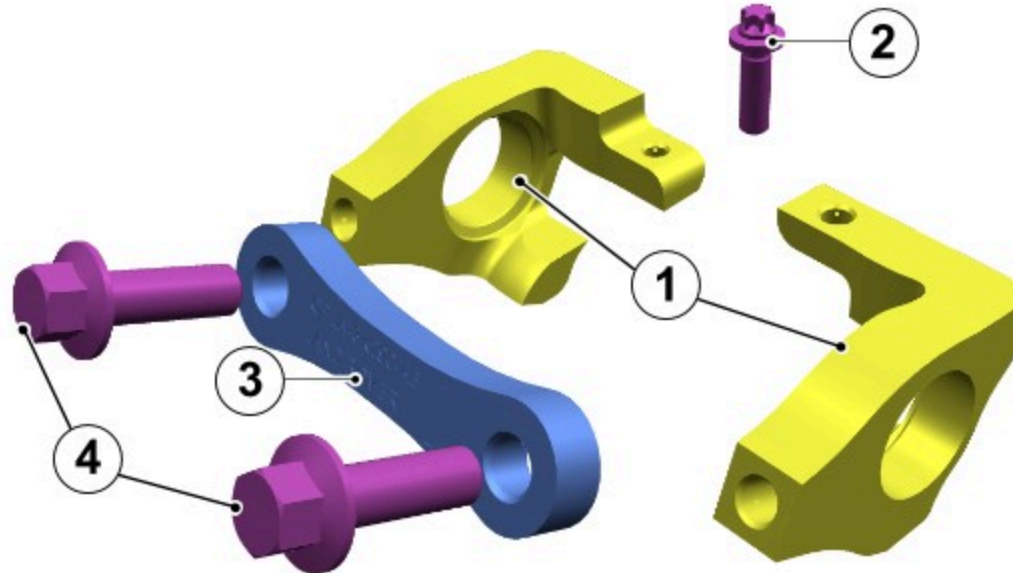
E377524

1. The illustration shows the front knuckle bracket components.

1. Front knuckle bracket side hooks.
2. Front knuckle bracket side hooks bolt.
3. Front knuckle bracket rear plate.
4. Front knuckle bracket rear plate bolts.

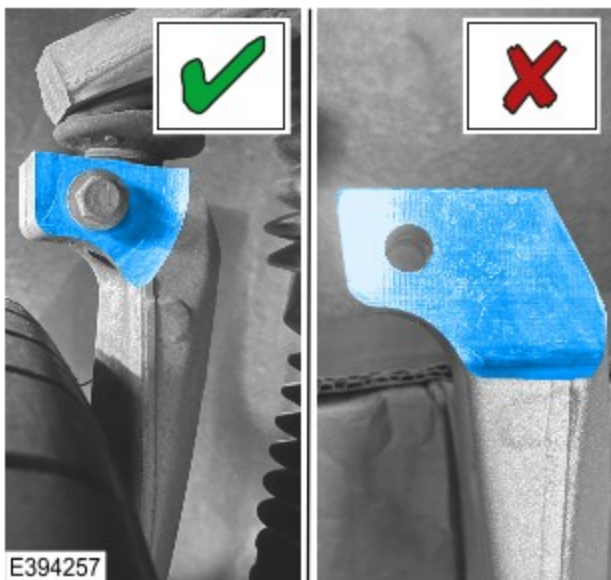
- The vehicle may have either type of front wheel knuckle installed, both types of front wheel knuckles could be installed on the vehicle.
- Both front wheel knuckles must be inspected. The vehicle may have a different type of front wheel knuckle installed on the left side to the right side.

Inspect the front right wheel knuckle.

- If the front right wheel knuckle is the type shown in the illustration with the **GREEN ✓**, it has **PASSED** service inspection 1. No further action is required for the front right wheel knuckle, **continue to the next step**.
- If the front right wheel knuckle is the type shown in the illustration with the **RED X**, it has **FAILED** service inspection 1. **Continue to the next step**.

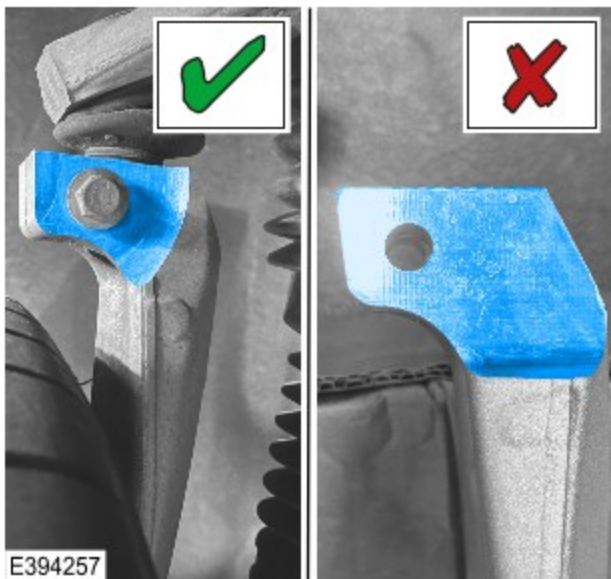
- The vehicle may have either type of front wheel knuckle installed, both types of front wheel knuckles could be installed on the vehicle.
- Both front wheel knuckles must be inspected. The vehicle may have a different type of front wheel knuckle installed on the left side to the right side.

Inspect the front left wheel knuckle.

- If the front left wheel knuckle is the type shown in the illustration with the **GREEN ✓**, it has **PASSED** service inspection 1. No further action is required for the front left wheel knuckle, **continue to the next step**.
- If the front left wheel knuckle is the type shown in the illustration with the **RED X**, it has **FAILED** service inspection 1. **Continue to the next step**.

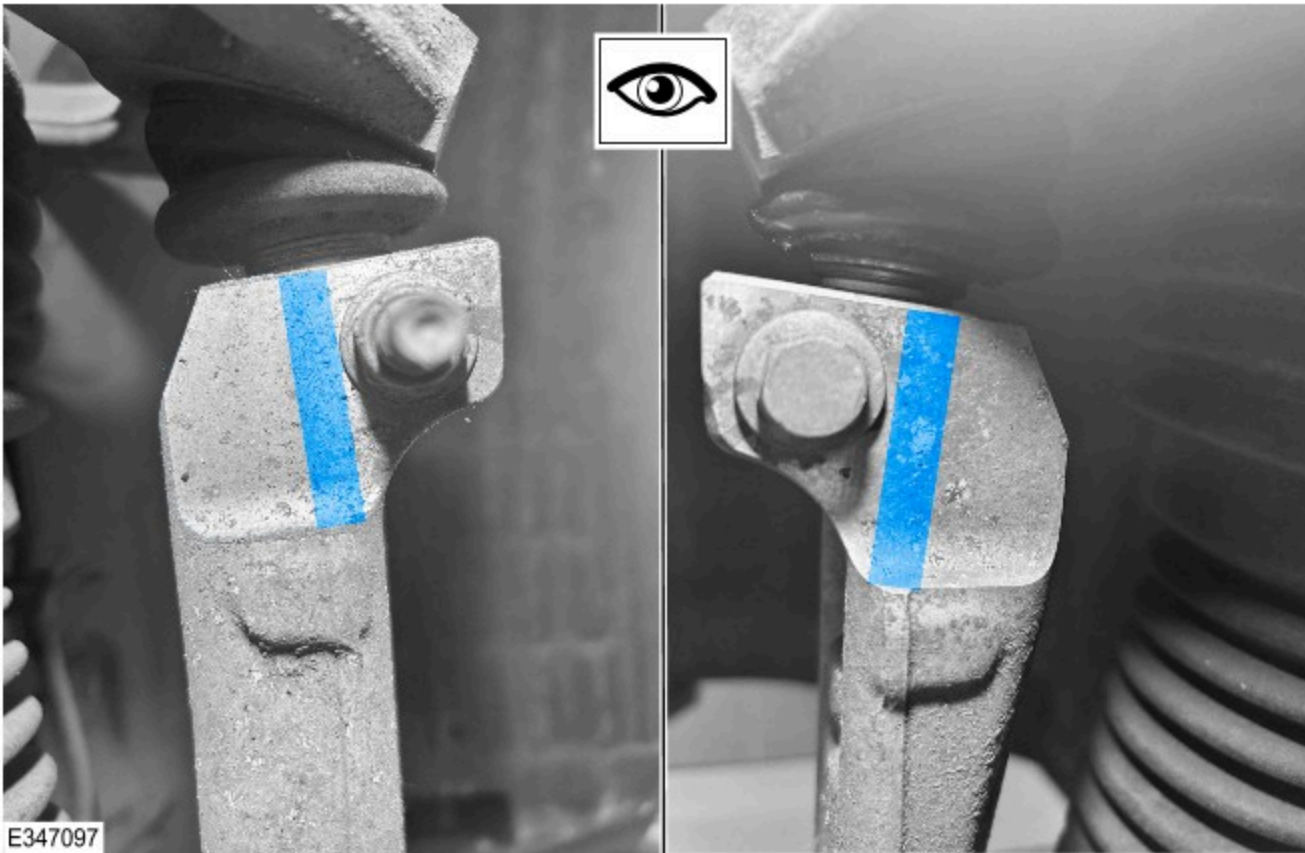
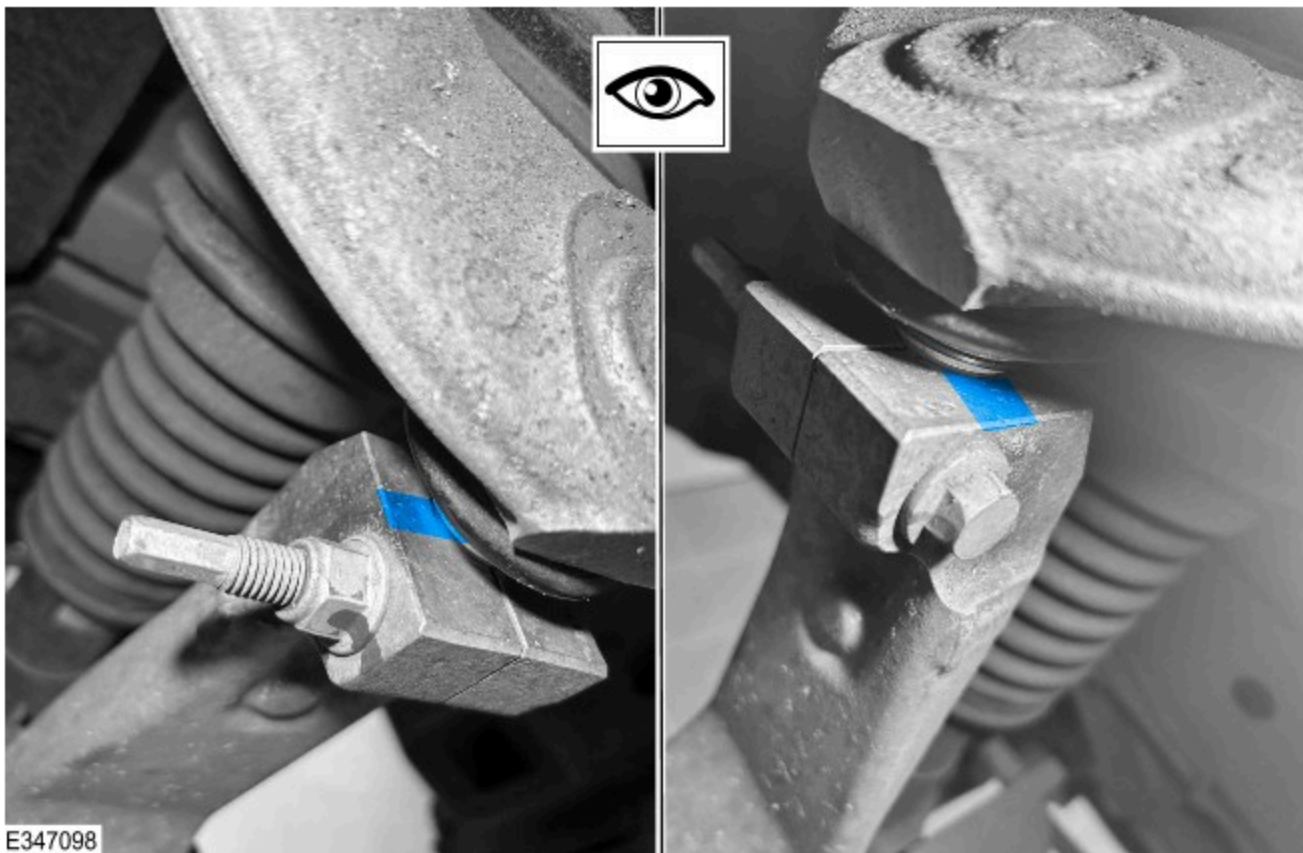
3. Carefully inspect the front knuckle for visible cracks. Examples of cracks are shown in the next step.

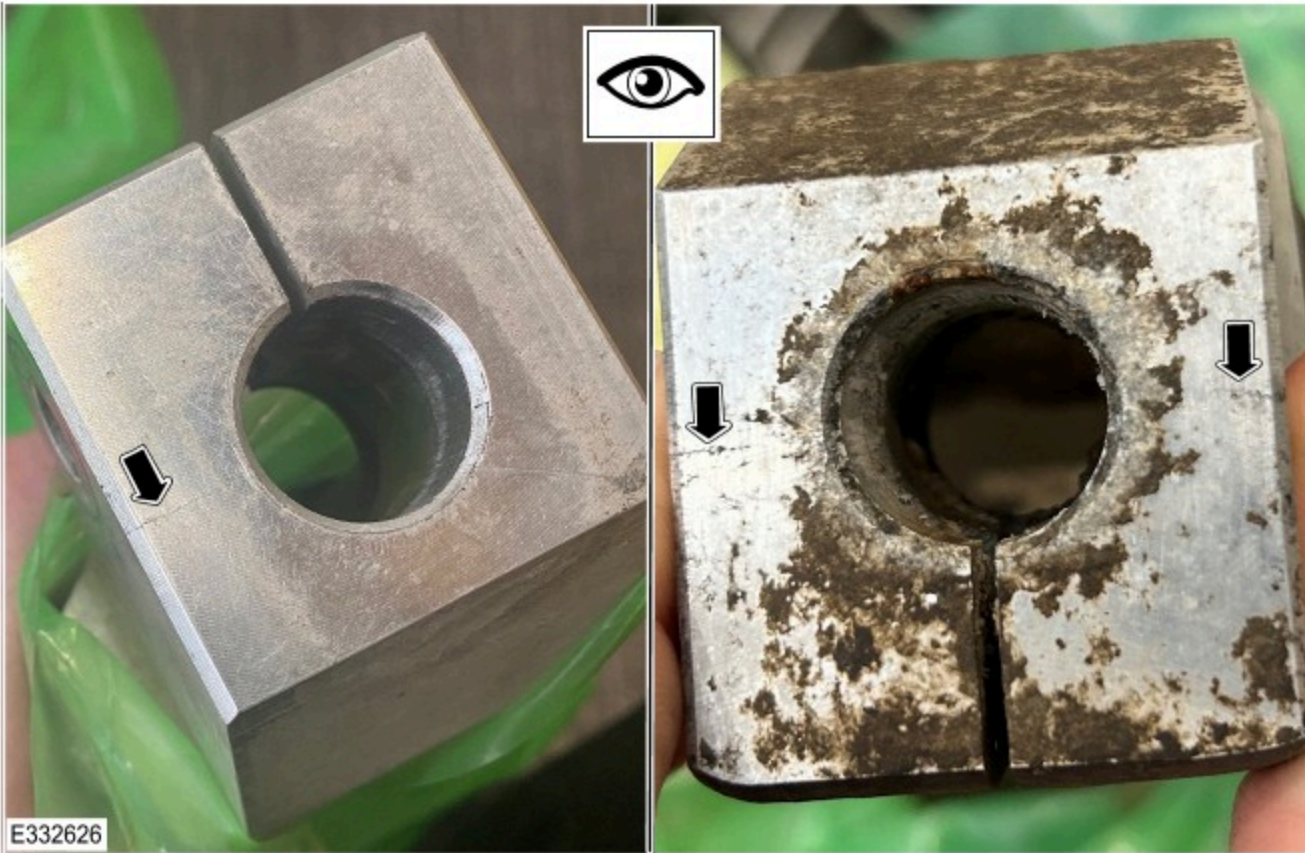
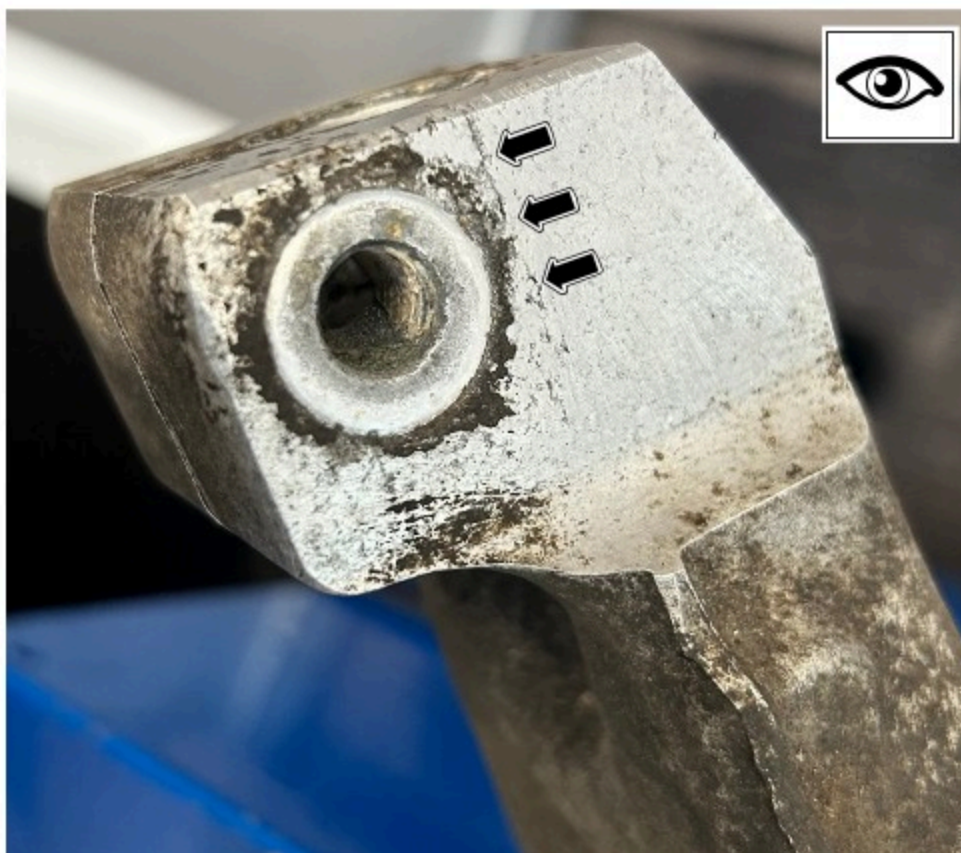
E332627

- The example illustrations are applicable to both left and right front knuckles.
- Use a suitable flashlight and / or a mirror to assist with the visual inspection.

Examples of front knuckle cracks are shown in the illustrations.

- If cracks **ARE** visible on the front knuckle, the front knuckle has **FAILED** service inspection 2. Replace the front knuckle that has **FAILED** service inspection 2 (see TOPIx Workshop Manual section 204-01: Front Suspension - Removal and Installation - Wheel Knuckle).
- If cracks **ARE NOT** visible on the front knuckle, the knuckle has **PASSED** service inspection 2. **Continue to the FRONT KNUCKLE BRACKET INSTALLATION PROCEDURE.**
