Safety Recall

Code: 42E7

Subject Rear Tie Rod Bolt

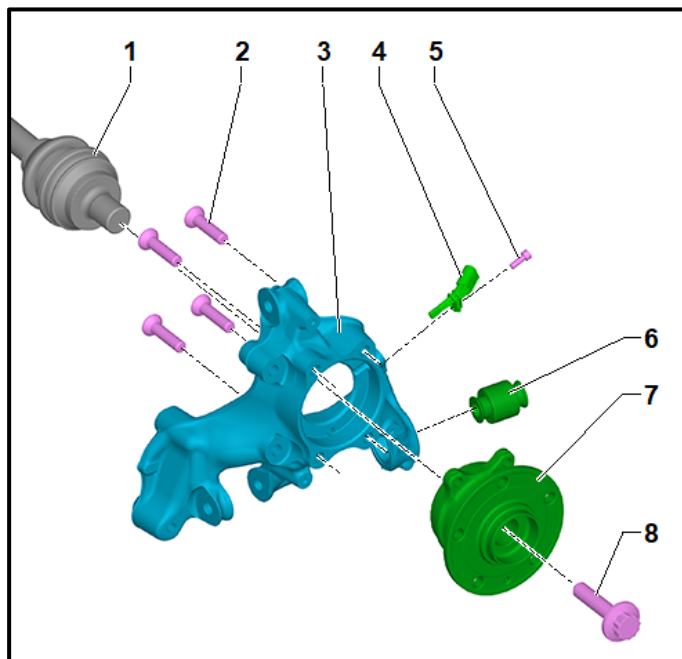
Section C – Replace Rear Suspension Components

The repair in this section is only to be performed on vehicles where the rear tie rod bolt was found to be damaged during the inspection.

- Replace the wheel bearing housing <3> per the ELSA repair manual:
 - *Repair manual > Chassis > Suspension, Wheels, Steering > 42 Rear Suspension > Wheel Bearing and Trailing Arm, Multi-Link Suspension.*
- When replacing the wheel bearing housing, also replace the following components per the ELSA repair manual:
 - Wheel bearing / hub assembly <7>.
 - Wheel speed sensor <4>.
 - Brake dust shield / backing plate (not pictured).
 - All associated nuts and bolts.
