# SAFETY RECALL

## Tire Pressure Monitoring System

Reference: 56C / NHTSA 25V-527

2024 - 2025 (JL) Jeep Wrangler

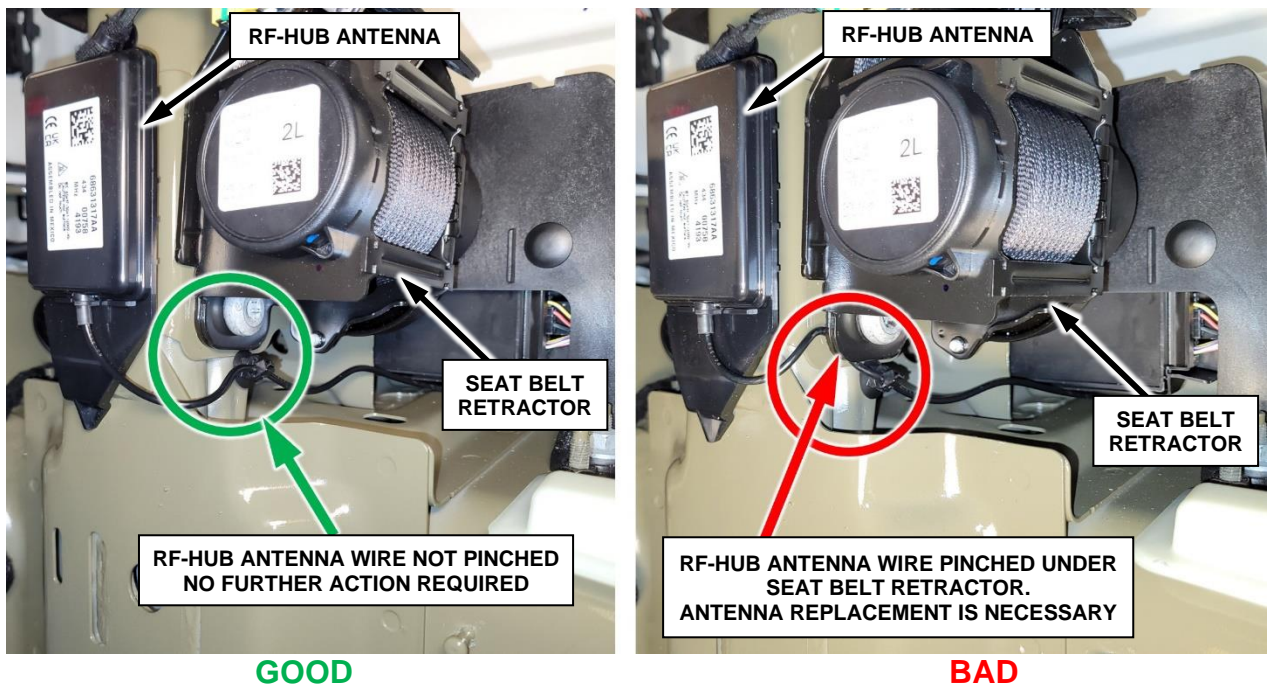
**Figure 11 – Inspect for RF-HUB Antenna Wire Trapped Under Seat Belt Retractor.**

The remote start antenna cable on about 78,989 of the above vehicles may have been built with a remote start antenna cable pinched under the left rear seat belt retractor bracket, which may result in the Tire Pressure Monitoring System (TPMS) unable to detect low tire pressure. A TPMS that is unable to warn a driver of tire pressures outside of recommended limits can cause a vehicle crash without prior warning.

15. Inspect the Radio Frequency Hub (RF-HUB) antenna wire (Figure 11).
16. Is the RF-HUB antenna wire trapped under the seat belt retractor? Refer to (Figure 11).
- **NO:** RF-HUB antenna wire is **NOT** trapped under the seat belt retractor. Claim the inspection LOP.
    - a) Reinstall the quarter trim panel and rear scuff plate in reverse order of disassembly verifying all clips are fully secured.
    - b) If equipped with hard top: Reconnect the electrical connector and washer hose to the hard top and install the trim cover if equipped.
    - c) Position the rear seat where customer had it then close the rear window and swing gate.
  - **YES:** RF-HUB antenna wire **IS** trapped under the seat belt retractor. Proceed to: **Radio Frequency Hub (RF-HUB) Antenna Replacement.**

Inspect for a pinched Radio Frequency Hub (RF-HUB) antenna wire and if pinched, replace the RF-HUB antenna.
