Recall Repair Instructions

NHTSA Recall # 25V-554

Tiffin Motorhomes Recall # TIF-146

Models involved: 2025 GT1 Motorhomes

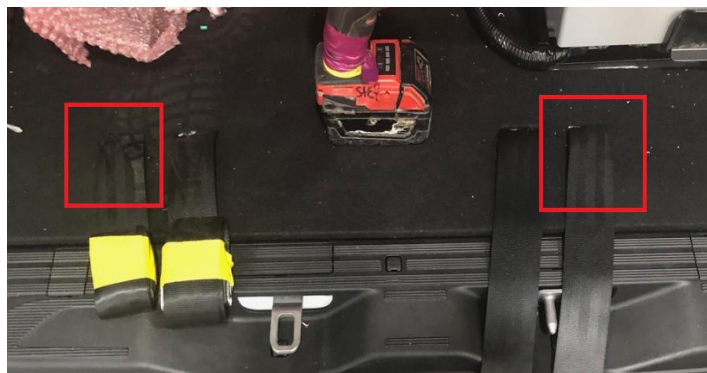
Figure 2B

1. Open the rear doors of the van and measure the buckle portion of the driver's and passenger's three-point seat belts, shown in figure 2B. The correct buckle is 34 inches, at least 32 inches should be visible above the carpet. The incorrect buckle is approximately 26 inches. If the correct length of buckle is installed on both the driver's and passenger's side, please file a warranty claim for inspection so the recall will be cleared from the motorhome.

3. Cut out a 3"x2" section of the floor to the rear of the belts to expose the mounting bolts for the buckle portion of the rear seatbelts, see figure 2A. Ensure the 2 belts toward the outside are the ones cutout, see figure 2B. The inside belts are for the middle lap belt and do not need to be modified.
