# SAFETY RECALL

## Side Curtain Airbag

Reference: 82C / NHTSA 25V-573

2025 (RU) Chrysler Pacifica  
2025 (RU) Chrysler Voyager

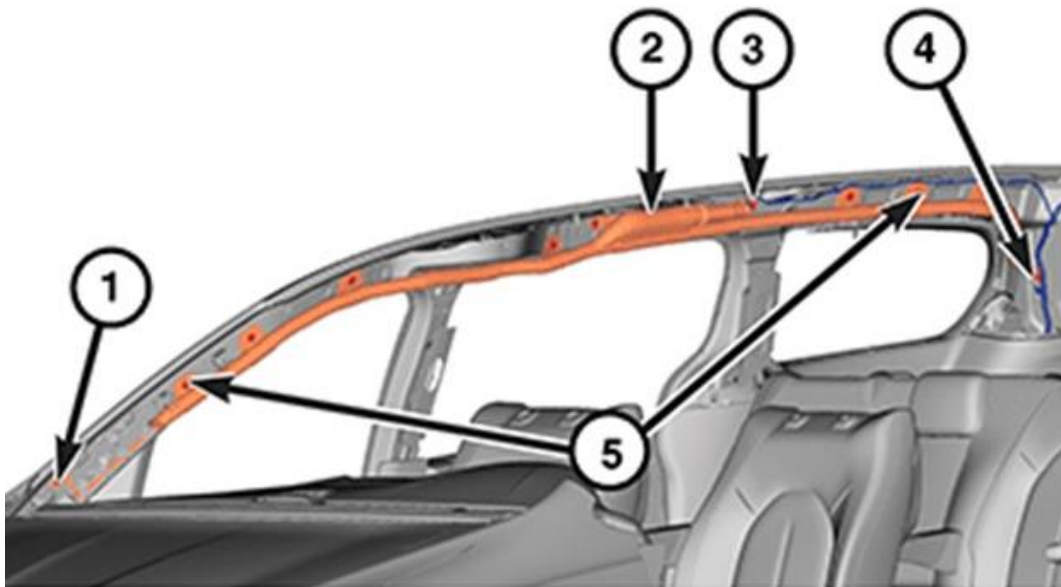
**Figure 25 – Side Curtain Airbag (CAB)**

- 1 - Fastener
- 2 - SABIC
- 3 - Body Wire Harness Connector
- 4 - Fastener
- 5 - Fasteners

55. Disconnect the body wire harness connector for the CAB from the connector receptacle of the inflator above the front door opening (Figure 25).
56. Remove the fastener that secures the airbag front tether to the A-pillar (Figure 25).
57. Remove the fastener that secures the airbag rear tether to the D-pillar (Figure 25).
58. Remove the fasteners that secure the CAB to the inner roof rail (Figure 25).
59. Remove the CAB from the vehicle as a unit and **DISPOSE** of in a proper manner (Figure 25).

60. Obtain the **NEW** CABs for each side of the vehicle.
61. Clean the CAB mounting studs with mineral spirits, toluene, or equivalent (Figure 25).
62. Apply blue threadlocking compound Mopar Part Number 04318031AB (MS-90061) or equivalent to the CAB mounting studs (Figure 25).
63. Install the **NEW** CAB to the vehicle as a unit (Figure 25).
64. Engage the CAB to the weld studs of the inner roof side rail. Be certain that the CAB is not twisted.
65. Working from front to rear, install the fasteners that secure the CAB and the inflator bracket to the inner roof rail and tighten to 6 N·m (53 in. lbs.) (Figure 25).

66. Install the fastener that secures the airbag front tether to the A-pillar and tighten to 6 N·m (53 in. lbs.) (Figure 25).
67. Install the fastener that secures the airbag rear tether to the D-pillar and tighten to 6 N·m (53 in. lbs.) (Figure 25).
68. Connect the body wire harness connector for the SABIC to the connector receptacle of the inflator above the sliding door opening (Figure 25).

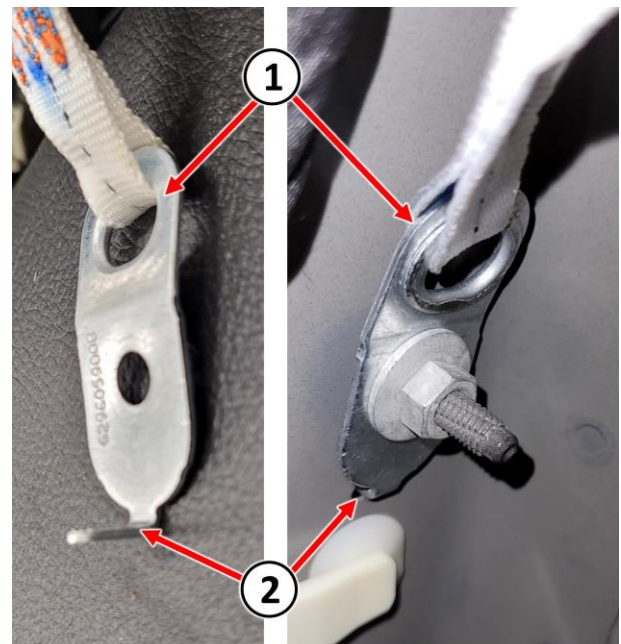
**Figure 26 – CAB Tether**

- 1 - Tether  
2 - Tether Tab

**NOTE: The CAB tether tab must be properly positioned in the corresponding hole. Failure to insert the tab in the corresponding hole could allow the tether end to rotate out of proper position while tightening the fastener (Figure 26).**
