# SAFETY RECALL

## Side Curtain Airbag

Reference: 82C / NHTSA 25V-573

2025 (RU) Chrysler Pacifica  
2025 (RU) Chrysler Voyager

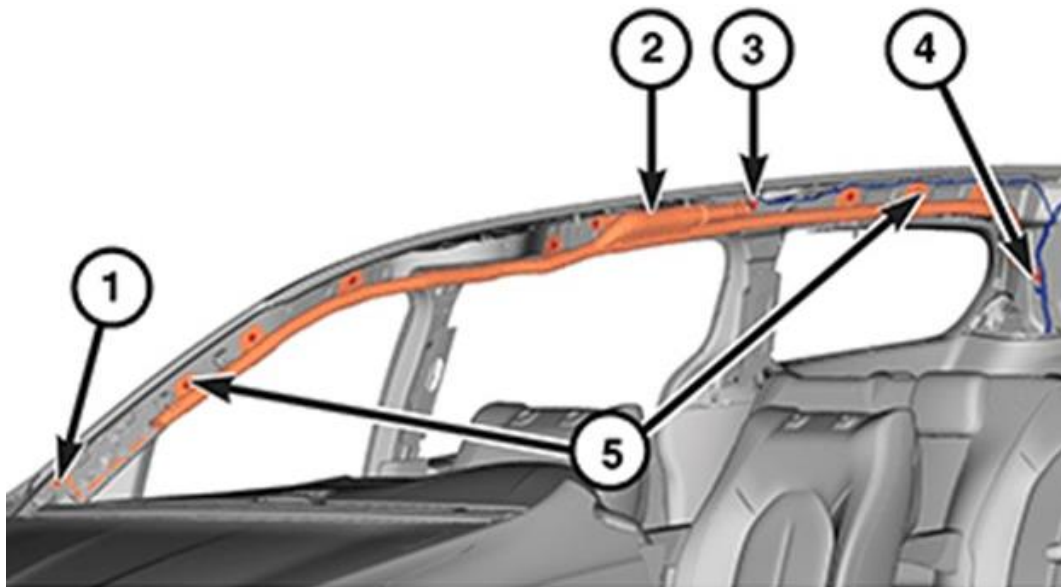
**Figure 25 – Side Curtain Airbag (CAB)**

- 1 - Fastener
- 2 - SABIC
- 3 - Body Wire Harness Connector
- 4 - Fastener
- 5 - Fasteners

55. Disconnect the body wire harness connector for the CAB from the connector receptacle of the inflator above the front door opening (Figure 25).
56. Remove the fastener that secures the airbag front tether to the A-pillar (Figure 25).
57. Remove the fastener that secures the airbag rear tether to the D-pillar (Figure 25).
58. Remove the fasteners that secure the CAB to the inner roof rail (Figure 25).
59. Remove the CAB from the vehicle as a unit and **DISPOSE** of in a proper manner (Figure 25).

60. Obtain the **NEW** CABs for each side of the vehicle.
61. Clean the CAB mounting studs with mineral spirits, toluene, or equivalent (Figure 25).
62. Apply blue threadlocking compound Mopar Part Number 04318031AB (MS-90061) or equivalent to the CAB mounting studs (Figure 25).
63. Install the **NEW** CAB to the vehicle as a unit (Figure 25).
64. Engage the CAB to the weld studs of the inner roof side rail. Be certain that the CAB is not twisted.
65. Working from front to rear, install the fasteners that secure the CAB and the inflator bracket to the inner roof rail and tighten to 6 N·m (53 in. lbs.) (Figure 25).

66. Install the fastener that secures the airbag front tether to the A-pillar and tighten to 6 N·m (53 in. lbs.) (Figure 25).
67. Install the fastener that secures the airbag rear tether to the D-pillar and tighten to 6 N·m (53 in. lbs.) (Figure 25).
68. Connect the body wire harness connector for the SABIC to the connector receptacle of the inflator above the sliding door opening (Figure 25).
