SAFETY RECALL

Instrument Panel Cross Car Beam

Reference: 71C / NHTSA 25V-575

Remedy available for
2025 (KM) Jeep Wagoneer S

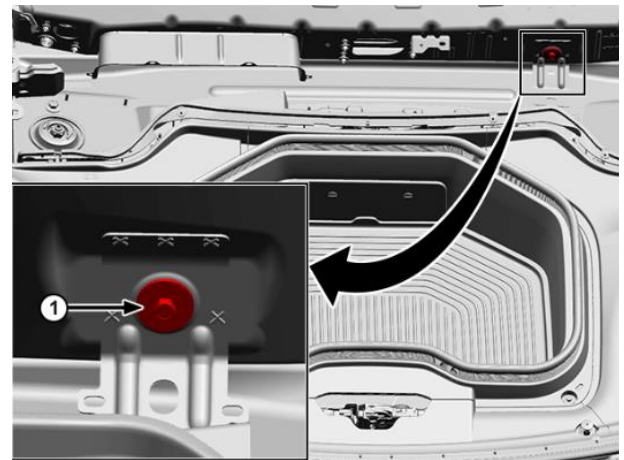
Figure 1 – CCB to Dash Panel Bolt

2. Remove the cowl panel cover. Refer to the detailed service procedures available in DealerCONNECT/ Service Library under: Service Info> 23 - Body/Exterior/COVER, Cowl Panel/Removal and Installation.
3. Remove the wiper linkage to gain access to the CCB bolt. Refer to the detailed service procedures available in DealerCONNECT/ Service Library under: Service Info> 23 - 08 - Electrical / 8R - Wipers/Washers / LINKAGE, Wiper Arm / Removal and Installation.
4. Remove the cross car beam (CCB) to instrument panel bolt (1) (Figure 1).

36. Install the cross beam to instrument panel bolt and tighten to 25 N·m (18 ft. lbs.).
37. Install the cowl panel cover. Refer to the detailed service procedures available in DealerCONNECT/ Service Library under: Service Info> 23 - Body/Exterior/COVER, Cowl Panel/Removal and Installation.

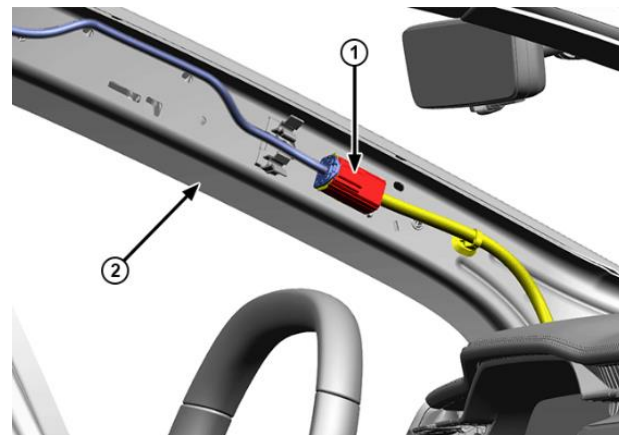
Figure 2 – Wire Harness Connector and A-Pillar (Left side shown, right side similar)

7. Release the wire harness fastener and disconnect the wire harness connector (1) at the left A-pillar (2) (Figure 2).
8. Remove the left cowl trim panel. Refer to the detailed service procedures available in DealerCONNECT/ Service Library under: Service Info> 23 - Body/Interior/PANELS/Removal and Installation.

22. Engage the wire harness fastener and connect the wire harness connector at the right A-pillar (Figure 2).
23. Install the right A-Pillar trim panel. Refer to the detailed service procedures available in DealerCONNECT/ Service Library under: Service Info> 23 - Body/Interior/PANELS/Removal and Installation.

33. Engage the wire harness fastener and connect the wire harness connector at the left A-pillar (Figure 2).
34. Install the left A-Pillar trim panel. Refer to the detailed service procedures available in DealerCONNECT/ Service Library under: Service Info> 23 - Body/Interior/PANELS/Removal and Installation.

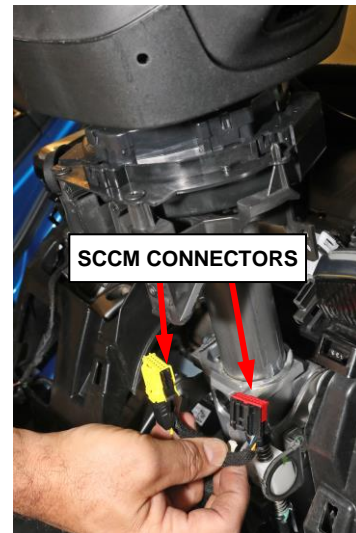
Figure 3 – SCCM Connectors

NOTE: SCCM removal is not necessary for column removal. After removing the upper and lower steering column shrouds, disconnect the SCCM electrical connectors from the back side of the SCCM, then the harness retainer clips (Figure 3).

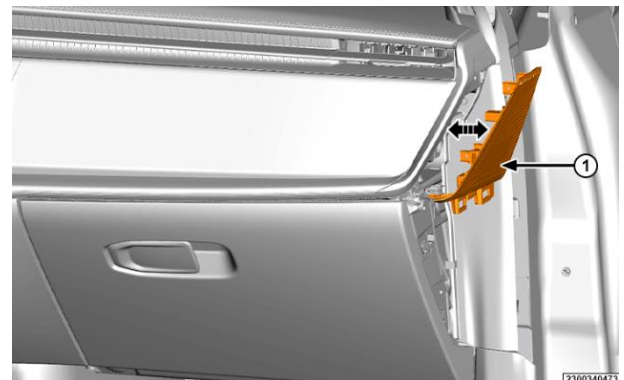
Figure 4 – Upper End Cap (Right side shown, left side similar)

10. Remove the steering column. Refer to the detailed service procedures available in DealerCONNECT/ Service Library under: Service Info> 19 - Steering/COLUMN/Removal and Installation.
11. Using a trim stick or equivalent, remove the left upper end cap (1) from the instrument panel (Figure 4).

28. Install the left A-pillar extended trim panel (Figure 5).
29. Install the left upper end cap from the instrument panel (Figure 4).
30. Install the steering column. Refer to the detailed service procedures available in DealerCONNECT/ Service Library under: Service Info> 19 - Steering/COLUMN/Removal and Installation.

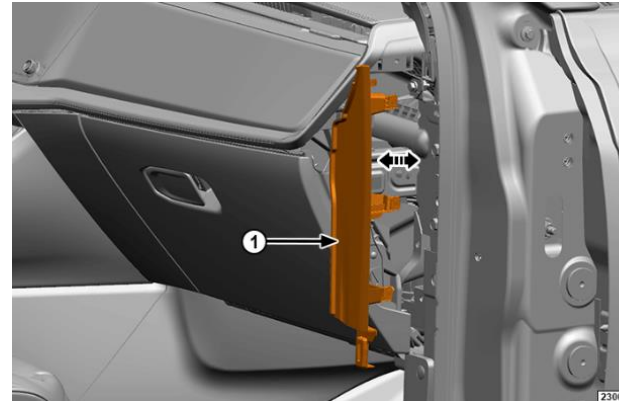
Figure 5 – A-Pillar Extended Trim Panel (Right side shown, left side similar)

- Using a trim stick or equivalent, remove the left A-pillar extended trim panel (1) (Figure 5).

20. Install the right A-pillar extended trim panel (Figure 5).
21. Remove the right cowl trim panel. Refer to the detailed service procedures available in DealerCONNECT/ Service Library under: Service Info> 23 - Body/Interior/PANELS/Removal and Installation.

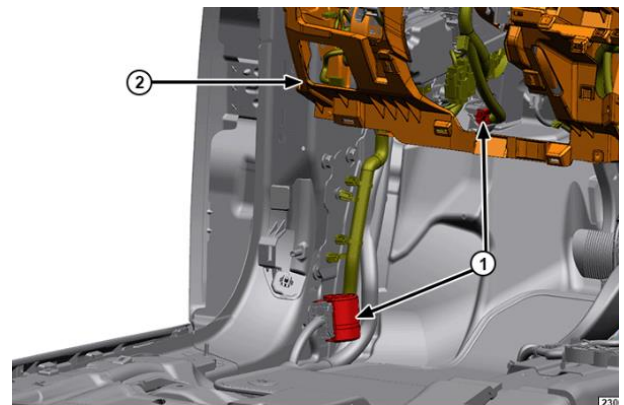
Figure 6 – Wire Harness Connectors

- Position the carpet aside on the driver side and disconnect the wire harness connectors (1) (Figure 6).

26. Install the CCB to right side cowl bolts and tighten to 23 N·m (17 ft. lbs.), and the side fastener to 8 N·m (71 in. lbs.) (Figure 7).
27. Position the carpet aside on the driver side and connect the wire harness connectors (Figure 6).

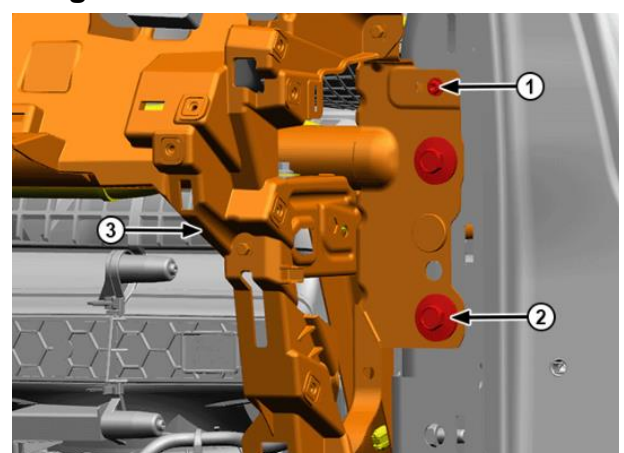
Figure 7 – CCB to Cowl Side Bolts and Fastener (Right side shown, left side similar.)

- Remove the left bolts (2) and side fastener (1) (Figure 7).

15. Working in the glove box opening, install the nut on the stud and tighten to 8 N·m (71 in. lbs.) (Figure 12).
16. Install the CCB to right side cowl bolts and tighten to 23 N·m (17 ft. lbs.), and the side fastener to 8 N·m (71 in. lbs.) (Figure 7).

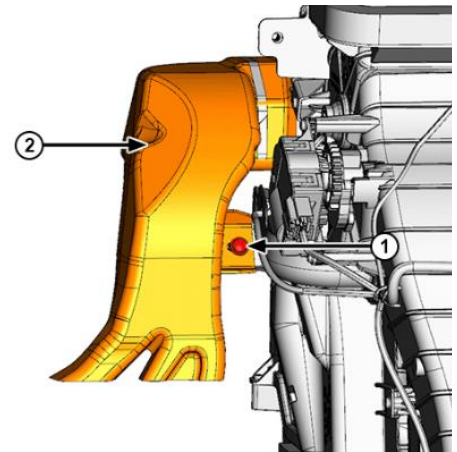
Figure 8 – Air Duct and Fastener

15. To aid in removal of the HVAC nut, remove the fastener (1) securing the front left floor air duct (2) and remove the front left floor air duct from the vehicle (Figure 8).

24. Working in the steering column opening, install nut on the stud and tighten to 8 N·m (71 in. lbs.) (Figure 9).
25. Install and securely tighten the fastener securing the front left floor air duct and install the front left floor air duct to the vehicle (Figure 8).

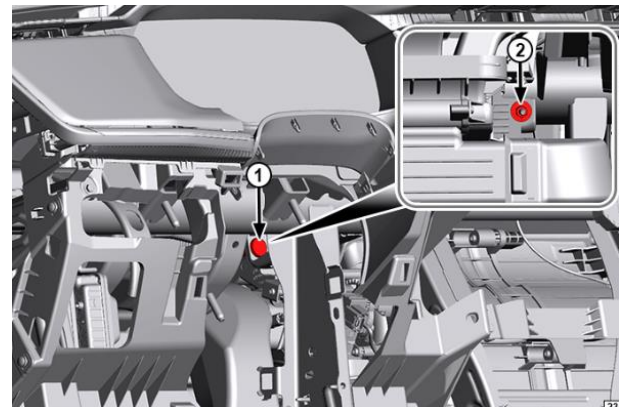
Figure 9 – HVAC to I/P Stud and Nut

16. Working in the steering column opening, remove the nut (2) from the stud (1) (Figure 9).
17. Remove the right A-Pillar trim panel. Refer to the detailed service procedures available in DealerCONNECT/ Service Library under: Service Info> 23 - Body/Interior/PANELS/Removal and Installation.

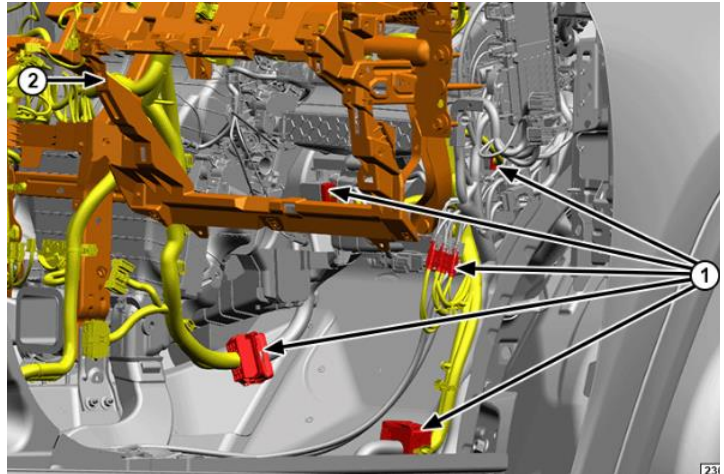
Figure 10 – Wire Harness Connectors

24. Position the carpet aside on the passenger side and disconnect the wire harness connectors (1) (Figure 10).

17. Install the instrument panel to HVAC bolt through the glove box opening and tighten to 8 N·m (71 in. lbs.) (Figure 11).
18. Position the carpet aside on the passenger side and connect the wire harness connectors (Figure 10).

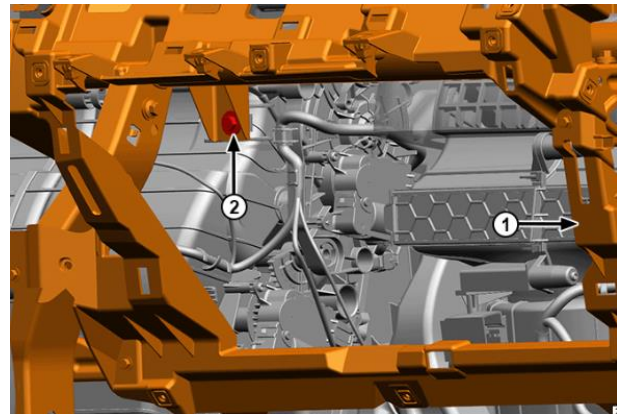
Figure 11 – I/P to HVAC Bolt

25. Remove the instrument panel to HVAC bolt (2) from the glove box opening (Figure 11).

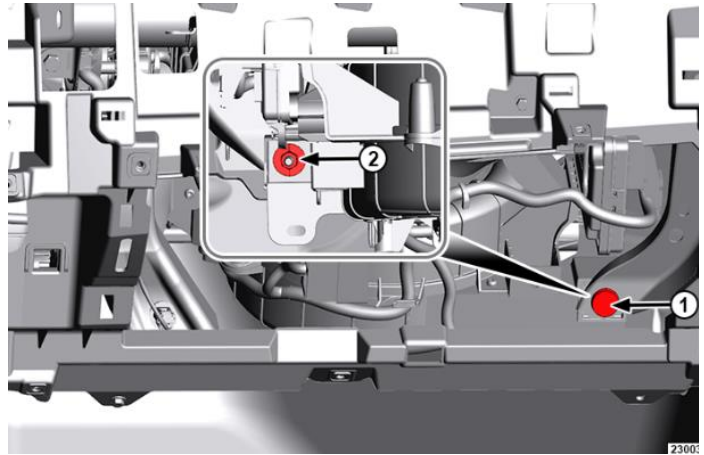
Figure 12 – HVAC to I/P Stud and Nut

- 27. Working in the glove box opening, remove the nut (2) from the stud (1) (Figure 12).
- 28. Remove the defroster grille. Refer to the detailed service procedures available in DealerCONNECT/ Service Library under: Service Info> 23 - Body/Instrument Panel/GRILLE, Defroster/Removal and Installation.

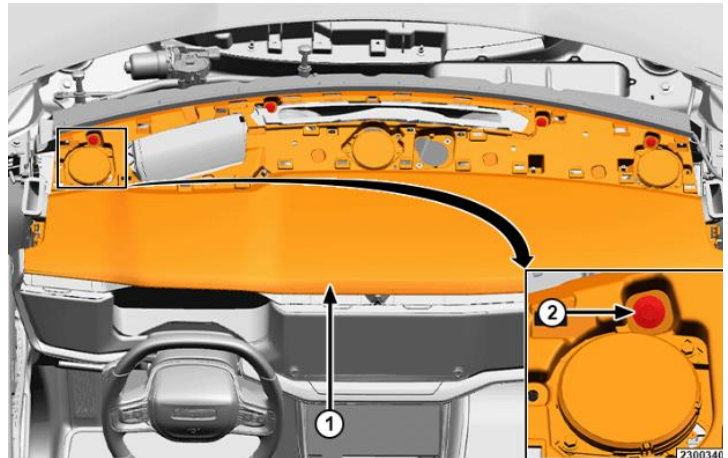
Figure 13 – Plenum to Dashboard Bolts

- 29. Remove the bolts along the top of the instrument panel (Figure 13).

13. Install the bolts along the top of the instrument panel and tighten to 25 N·m (18 ft. lbs.) (Figure 13).
14. Install the defroster grille. Refer to the detailed service procedures available in DealerCONNECT/ Service Library under: Service Info> 23 - Body/Instrument Panel/GRILLE, Defroster/Removal and Installation.

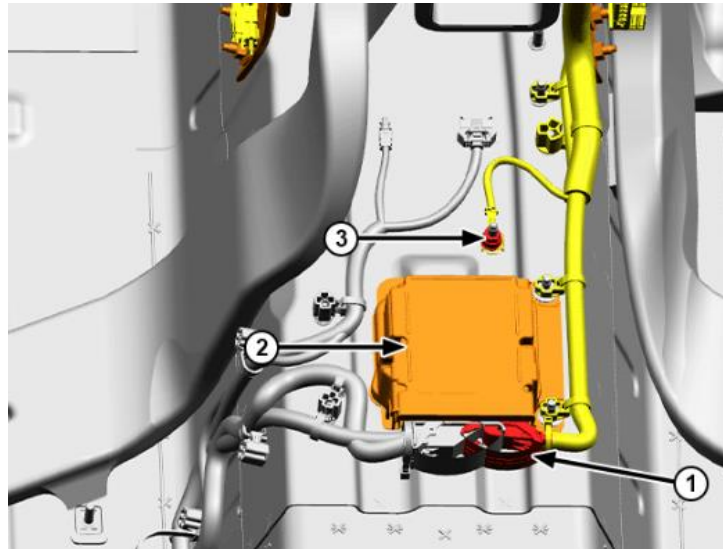
Figure 14 – ORC, Harness and Ground Nut

30. Remove the Occupant Restraint Control (ORC) ground nut (3) (Figure 14).
31. Disconnect the ORC wire harness connector (1) and disengage the connector from the vehicle (Figure 14).

11. Connect the Occupant Restraint Control (ORC) wire harness connector (1) and engage the connector to the vehicle (Figure 14).
12. Install the ORC ground nut (3) and tighten to 12 N·m (9 ft. lbs.) (Figure 14).

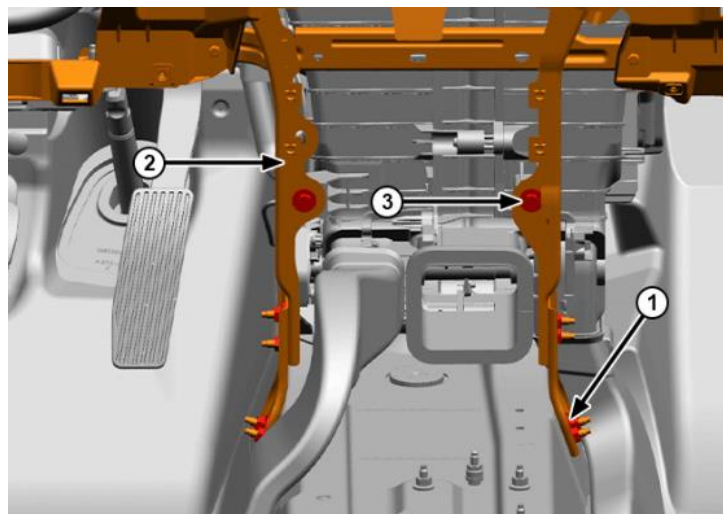
Figure 15 – CCB to Tunnel Bracket Nuts

32. Position the carpet aside and remove the tunnel bracket nuts (1) (Figure 15).
33. Remove the center instrument panel to HVAC bolts (3) (Figure 15).

9. Position the carpet aside and install the tunnel bracket nuts (1) and tighten to 9 N·m (80 in. lbs.) (Figure 15).
10. Install the center instrument panel to HVAC bolts (3) and tighten to 8 N·m (71 in. lbs.) (Figure 15).

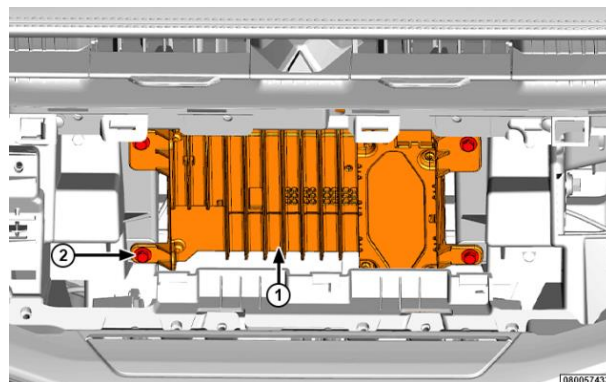
Figure 16 – Radio Fasteners

- 34. Remove the fasteners (2) from the radio (1) (Figure 16).
- 35. Disconnect the wire harness connectors from the radio and remove it from the vehicle.

6. Working in the radio opening, connect the air outlet wire harness connectors (Figure 17).
7. Connect the wire harness connectors to the radio.
8. Install and securely tighten the fasteners to the radio.

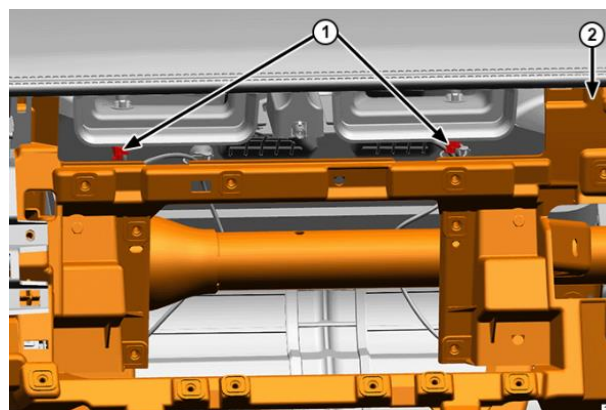
Figure 17 – Air Outlet Wire Harness Connectors

- 36. Working in the radio opening, disconnect the air outlet wire harness connectors (Figure 17).

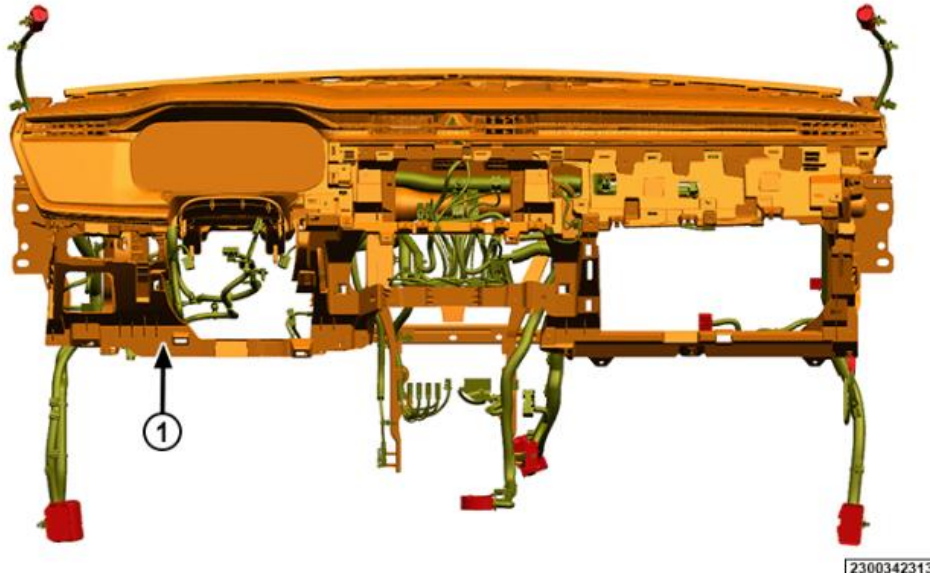
Figure 18 – Instrument Panel

37. With the help of an assistant, lift the instrument panel carrier away from the cowl panel. Verify all of the wire harness retainers are disconnected from the HVAC housing and remove the instrument panel carrier from the vehicle (Figure 18).

5. With the help of an assistant, position the instrument panel in the vehicle and install the left and right side guide pins to the sides of the cowl panel. Verify the routing of the wire harness to ensure that it does not get pinched (Figure 18).

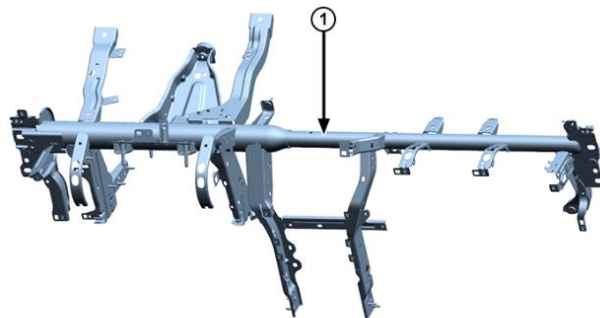
Figure 19 – Instrument Panel Carrier

39. Disengage the wire harness retainers and remove the wire harness from the instrument panel carrier (Figure 19).
40. Discard the old instrument panel carrier (cross car beam) (Figure 19).

1. Compare the new and old beams, and transfer clips as needed. Transfer the foam gasket for the single CCB to instrument panel bolt.
2. Transfer the wiring harness to the new instrument panel carrier, carefully checking harness attachment points and routing (Figure 19).
3. Transfer all modules and tighten fasteners to specifications. Refer to the detailed service procedures available in DealerCONNECT/ Service Library under: Service Info> 23 - Body / Instrument Panel / PANEL, Instrument / Removal and Installation.
