# SAFETY RECALL

## Front Door Upper Day Light Opening Trim

Reference: 77C / NHTSA 25V-593

2022-2025 model year (WS) Jeep Wagoneer and Grand Wagoneer

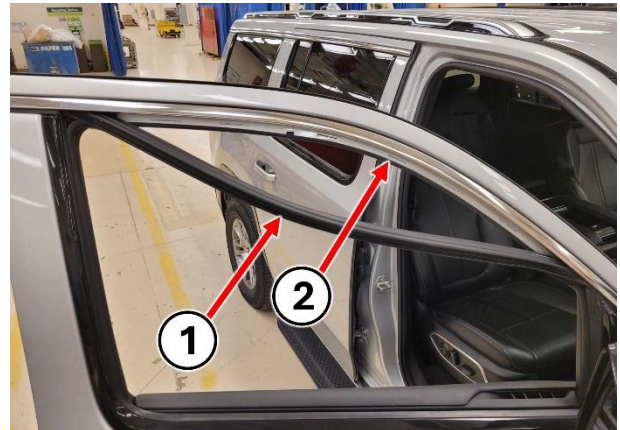
**Figure 1 – Window Run Channel**

1. Roll down the front door windows.
2. Pull the upper portion of the rubber window run channel down for visual inspection inside the door frame run channel (Figure 1).
3. Using a flashlight for better visibility inside the door frame run channel, look at the back side of where DLO trim is attached to the door. Carefully inspect each of the DLO trim six clips for full engagement through the door frame (Figures 2 and 3).

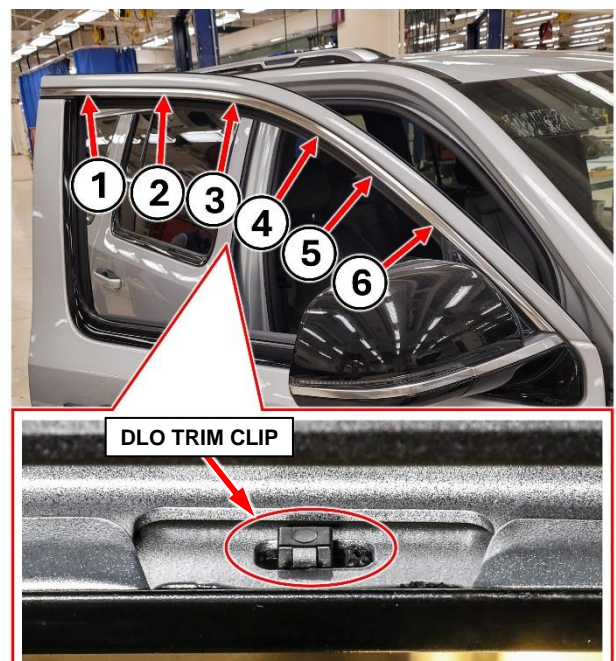
**Figure 2 – DLO Trim Clip Locations**

4. Are all six clips fully engaged to the door frame?
  - **Yes:** All six clips are fully engaged to the door window frame. Reinstall the rubber window run channel, roll up the windows, then return the vehicle to customer or inventory.
  - **No:** One or more of the six clips are not fully engaged to the door window frame. Do not reinstall the rubber window run channel. Proceed to the Repair Procedure.

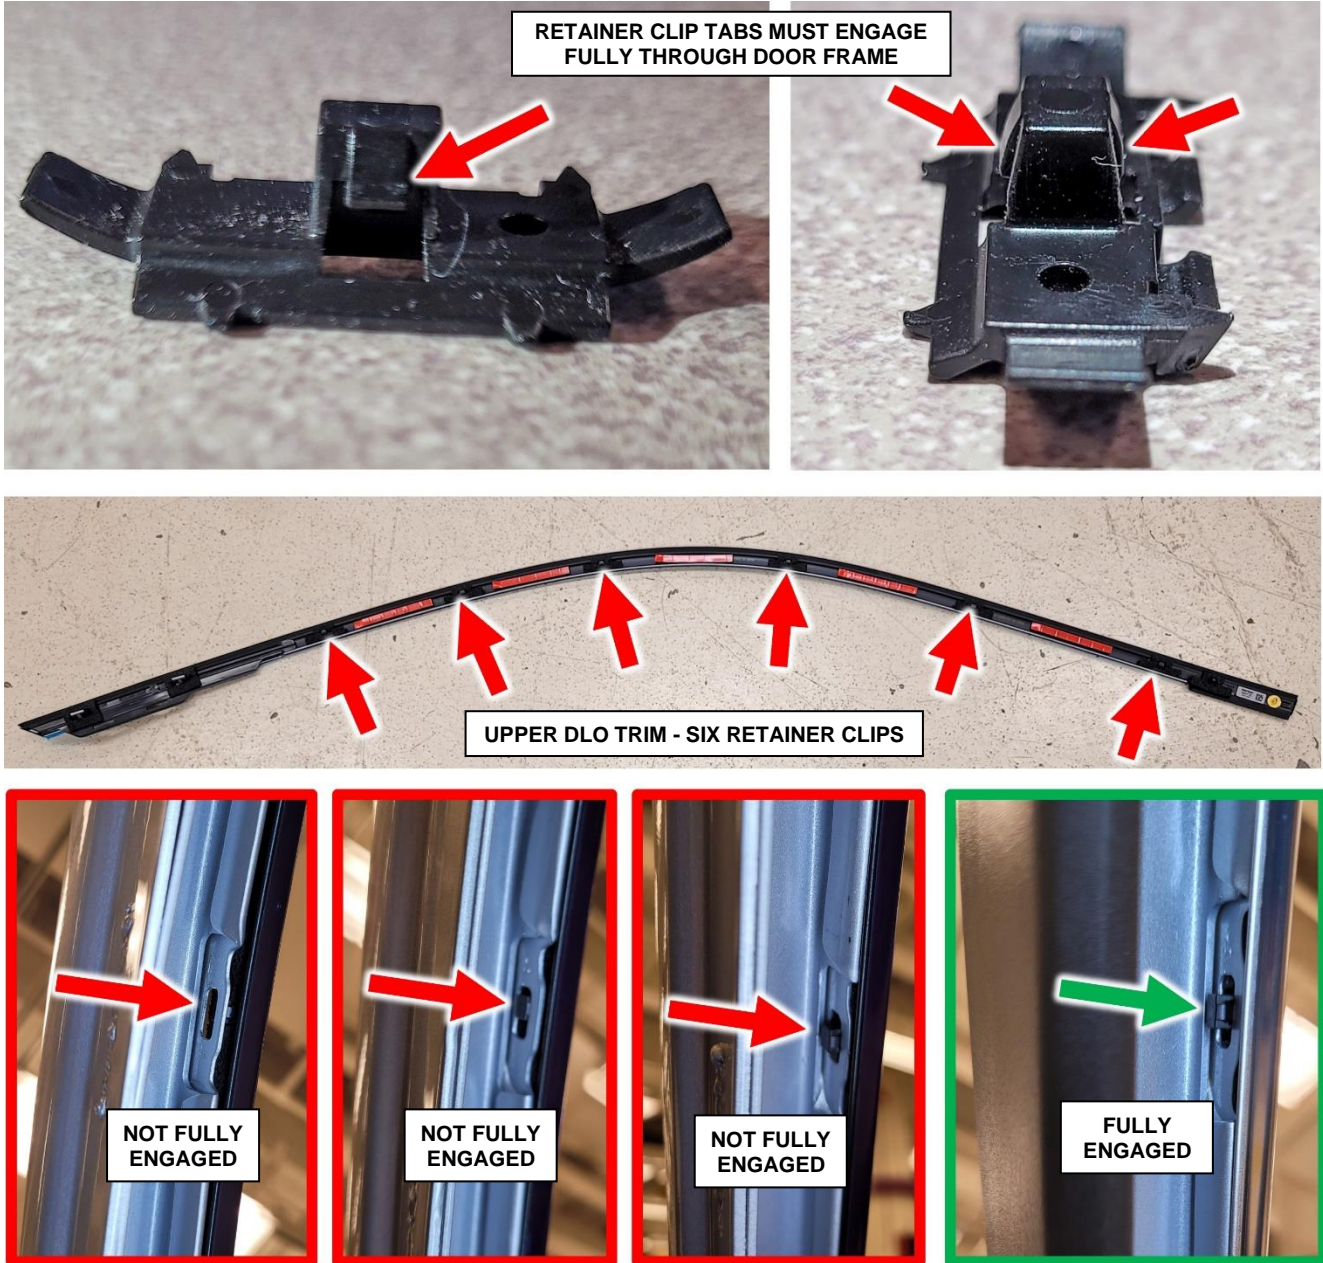
Figure 3 – Upper DLO Trim Retaining Clip Engagement Inspection

**CAUTION:** Do NOT attempt to engage the clips. If any trim clips are not fully engaged, trim MUST be replaced (Figure 3).

23. Use a flashlight for better visibility inside the door frame run channel to ensure all the clips are fully seated into the door. Refer to (Figure 3) of the inspection procedure for example of proper clip engagement.
