# HUSQVARNA TECHNICAL BULLETIN HTB2603 – USA

APRIL 2, 2026

## **\*RECALL - REMEDY NOTICE\***

### **E-THROTTLE ASSEMBLY REPLACEMENT**

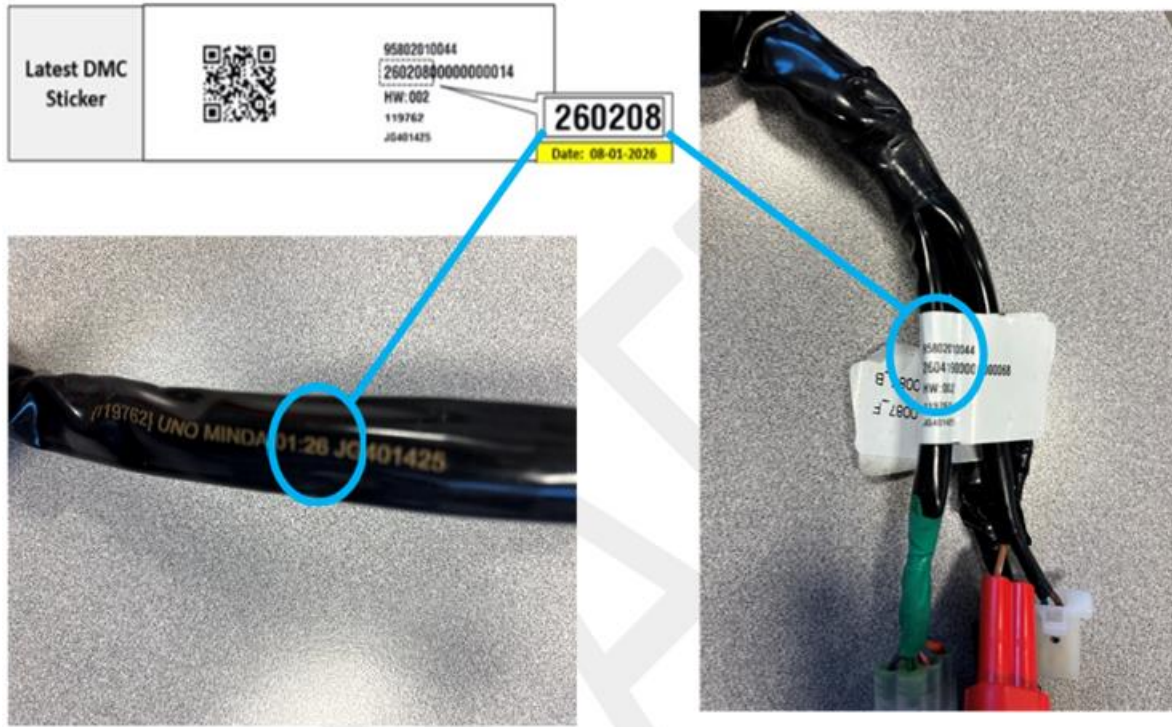
Figure 1 – DMC label on e-throttle wiring

Destroy the old part by cutting off the connector, attach a photo of the destroyed part to the warranty claim. Improved parts can be recognized at the label attached or printed to the wiring of the part (see fig.1). Use only parts with production date starting with 26 (see example in fig.1).
