Technical Service Bulletin

GROUP	NUMBER
RECALL	25-01-067G
DATE	MODEL(S)
SEPTEMBER 2025	GV60 (JW1 EV)

SUBJECT: LOOSE WINDSHIELD GLASS UPPER MOLDING REPLACEMENT (RECALL 028G)

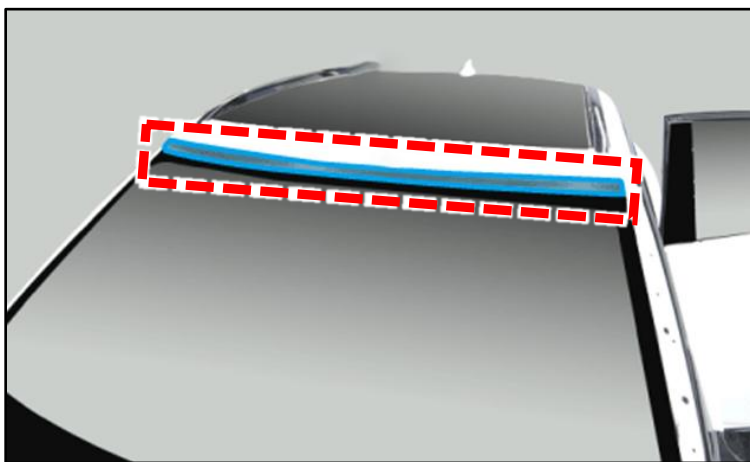
Description: For certain 2023-2025MY GV60 (JW1 EV) vehicles, the stainless-steel upper molding at the top of the windshield assembly may have been produced with insufficient adhesion, increasing the risk of detachment in certain driving scenarios. Detachment of the molding while driving can create road hazards for other drivers and increase the risk of a crash. This bulletin provides the service procedure to replace the upper windshield molding.
