Bentley Bulletin

25-092

Subject: USA RECALL CAMPAIGN – Bentley Continental GT, Continental GTC and Flying Spur V8 – RD69 Loose Screws On High-Pressure Fuel Pumps (RE25/41)

Topic	Loose Screws On High-Pressure Fuel Pumps Continental GT/GTC/Flying Spur V8 PHEV (RE25/41)
Market area	Bentley: worldwide (2WBE),China 796 VW Import Comp. Ltd (Vico), Beijing (6796)
Brand	Bentley
Transaction No.	2079445/1
Campaign number	RD69
Note	
Type	
US code

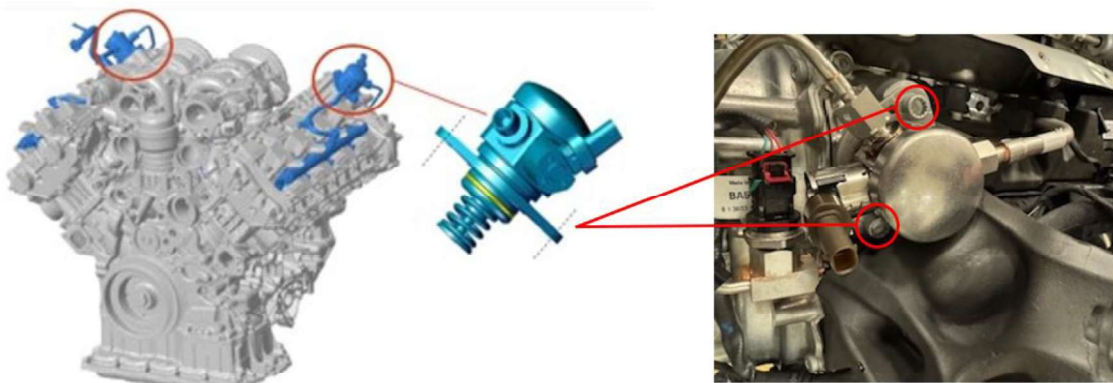
Figure 1 – High pressure fuel pump location

A torque check is required on the high-pressure fuel pump fixings for both Bank 1 and Bank 2. The fixings must meet a minimum torque value. If the torque is below this value further action is required.

To verify the torque of the high-pressure fuel pump fixings, access is required to both banks of the engine. This involves removing the plenum cover, support brace, engine partition components, and heat shielding.

Once exposed, a calibrated torque wrench is used to check each fixing.

- If the measured torque is greater than or equal to (\geq) 18 Nm, and the pen mark position remains unchanged, the fixing connection is OK.
- If the pen mark has moved position, this means the torque of 18Nm has not been achieved and the fixing connection is Not OK.

If a fixing connection is Not OK, replacement of the pump and fuel lines on the associated bank, and fixing screws is required. Full procedural steps are detailed in the Work section.

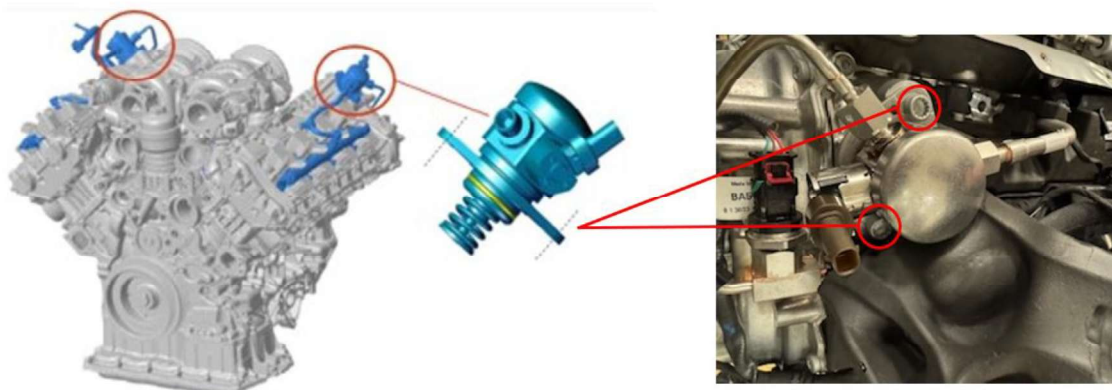
Figure 1 – High pressure fuel pump location

A torque check is required on the high-pressure fuel pump fixings for both Bank 1 and Bank 2. The fixings must meet a minimum torque value. If the torque is below this value further action is required.

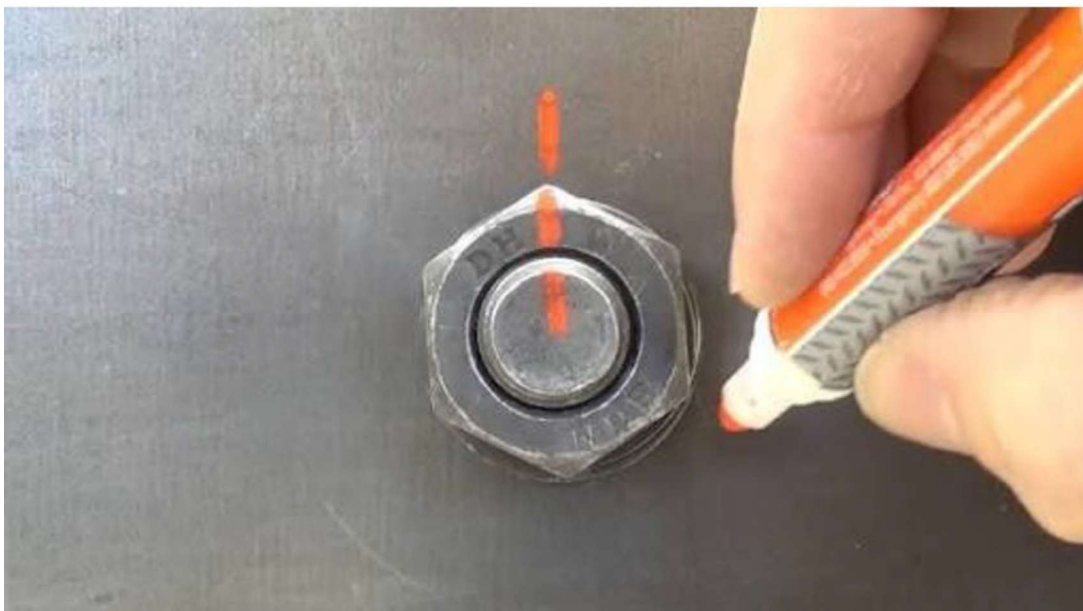
IMPORTANT: Before performing any torque measurement checks, with a paint pen mark the fixing heads and adjacent contact surfaces. This will allow you to visibly notice any movement in the fixings after performing the below torque check.

Using a torque wrench set to 18Nm, measure the existing (continuous) torque on both fixings in each high pressure pump (4x checks required). Please ensure you record your results in the table below.

- If the measured torque is greater than or equal to (\geq) 18 Nm, and the pen mark position remains unchanged, the fixing connection is OK.
- If the pen mark has moved position, this means the torque of 18Nm has not been achieved and the fixing connection is Not OK.
