TECHNICAL INSTRUCTIONS

SAFETY RECALL 25TA10

REARVIEW IMAGE MAY NOT DISPLAY

22-25MY TUNDRA/TUNDRA HYBRID

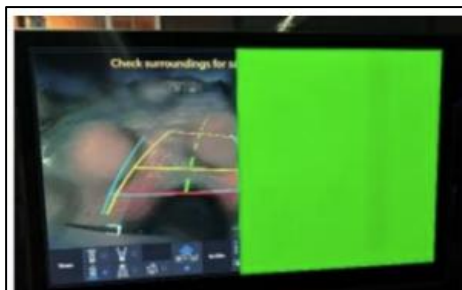
The software in the 14-inch multimedia (center) display in these vehicles could cause the display to show a half green, full green, or full black screen. If this occurs while the vehicle is being reversed, the vehicle may not meet a federal safety standard and there can be an increased risk of a crash with a person behind the vehicle.

Figure 1. Head unit display with half green screen condition

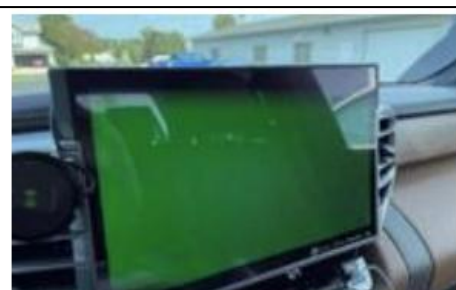
Figure 2. Head unit display with full green screen condition

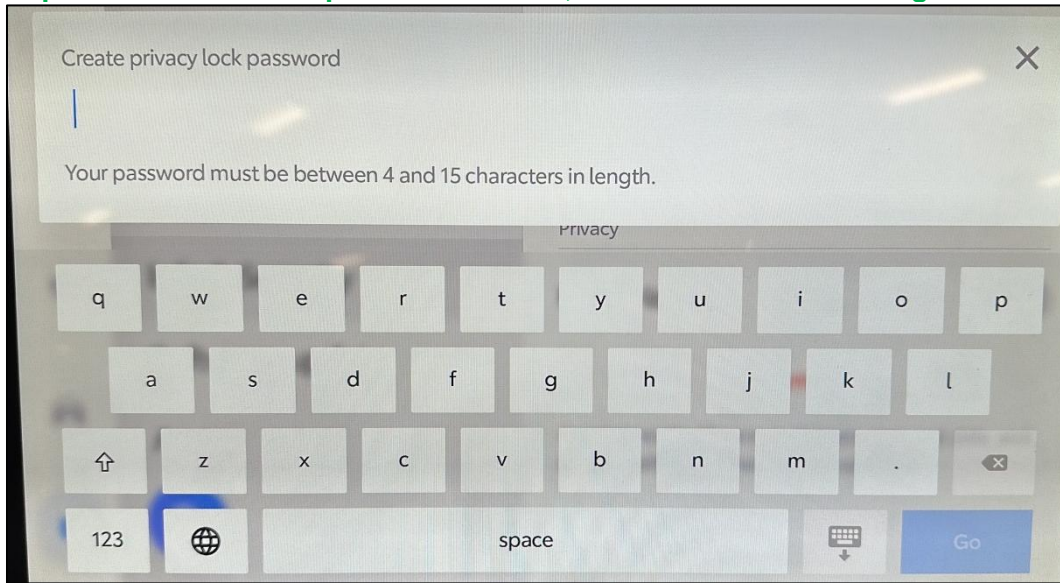
HINT: If privacy lock screen appears, with a keyboard on the screen as in the image below, it must be disabled to complete this software update. To disable, follow instructions using GTS+.

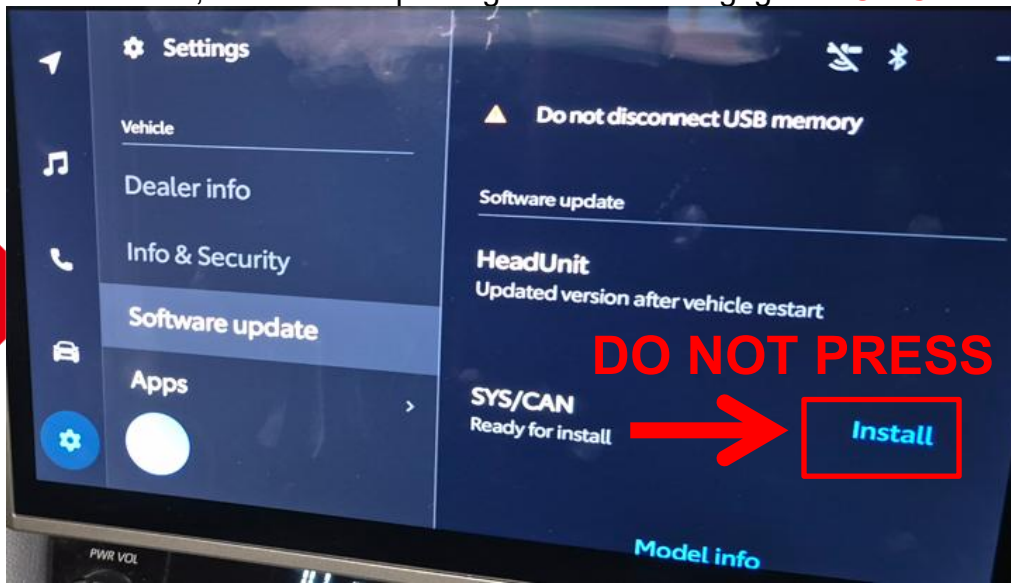
NOTE: If the parking brake is not on, the update will not automatically move to the SYS/CAN update as it should. If this is the case, **DO NOT hit the manual "install" button**. Instead, apply the parking brake and then cycle the IG. This will allow the SYS/CAN to start automatically.

If you see the screen below, it means the parking brake is not engaged. **DO NOT PRESS Install.**
