SAFETY RECALL 25TA10

REARVIEW IMAGE MAY NOT DISPLAY

CERTAIN
22-25MY TUNDRA/TUNDRA HYBRID
23-25MY SEQUOIA HYBRID

DATE	TOPIC
10/22/2025	Add details to aid in reducing software update failures

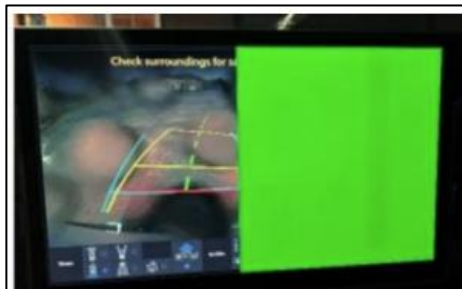
The software in the 14-inch multimedia (center) display in these vehicles could cause the display to show a half green, full green, or full black screen. If this occurs while the vehicle is being reversed, the vehicle may not meet a federal safety standard and there can be an increased risk of a crash with a person behind the vehicle..

Figure 1. Head unit display with half green screen condition

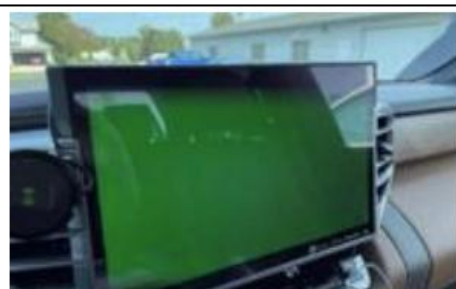
Figure 2. Head unit display with full green screen condition
