HYUNDAI
Technical Service Bulletin

GROUP RECALL	NUMBER 25-01-073H
DATE OCTOBER 2025	MODEL(S) SANTA FE (MX5A)

SUBJECT: STARTER BATTERY TERMINAL BOOT INSPECTION/ADJUSTMENT
 (RECALL 285)

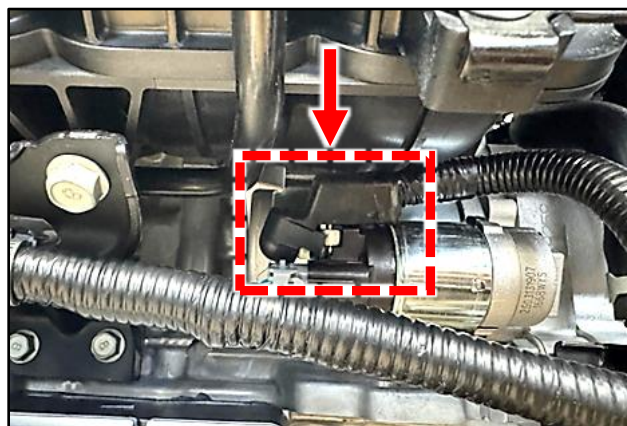
Description: Certain Santa Fe (MX5A) vehicles may have a condition where the starter harness boot (cover) may not be fully seated over the starter motor’s “B+” terminal. In certain crash scenarios involving varying degrees of engine compartment deformation, the exposed terminal could come into contact with the cooling fan assembly, potentially causing an electrical short, which can increase the risk of an electrical fire. Follow the service procedure outlined in this bulletin to position the starter harness “B+” boot as designed.

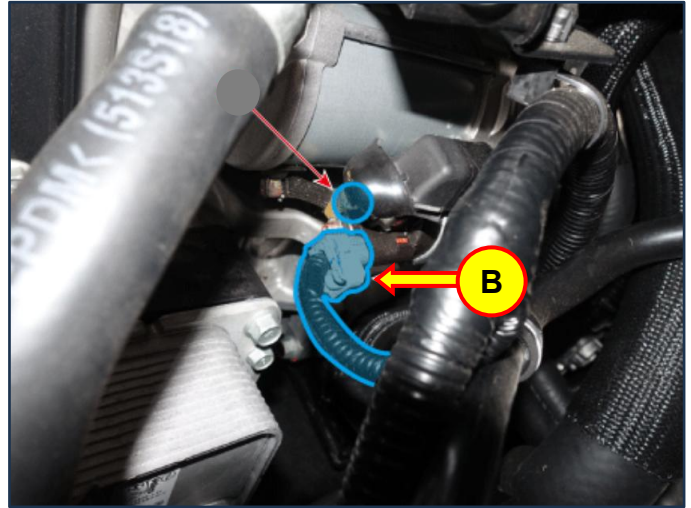
3. Disconnect the starter signal wire connector (B).

The red arrow and circle point to the boot to be inspected.

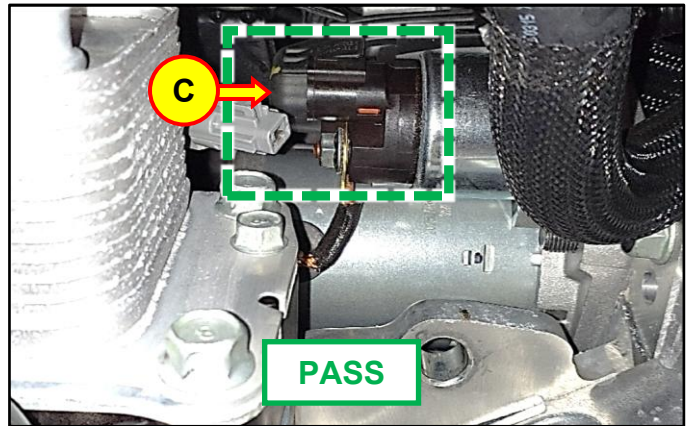
4. Inspect the starter battery terminal boot (C) for proper placement on the battery terminal.

- **PASS:** Boot is covering terminal.

Proceed to the next step.

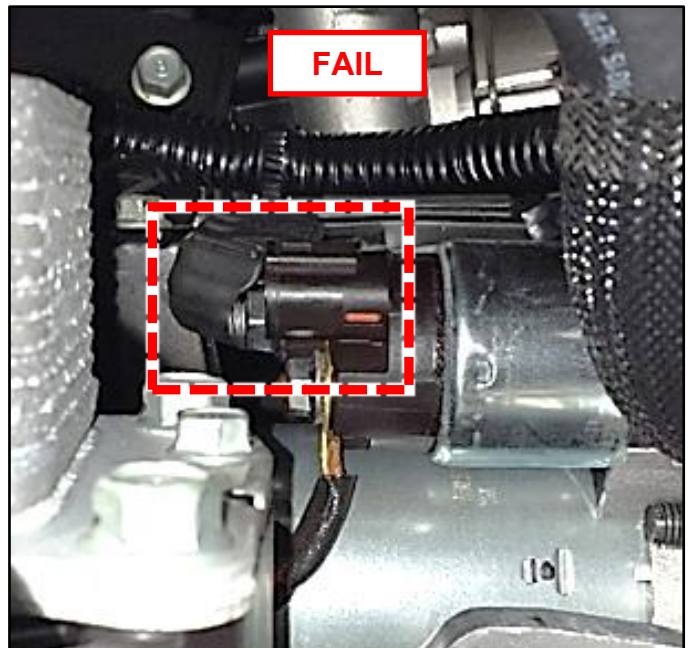
- **FAIL:** Boot is **NOT** covering terminal.

Reposition the boot onto the starter terminal to ensure proper placement. Confirm that the terminal is covered.
