RECALL 25V662 REMEDY INSTRUCTIONS

Make(s): ENTOURAGE
Model(s): E1C320LVC & E1C320LVI
Model Year(s): 2025 - 2026

Concern:
The bolt head for the leaf spring rebound clip may contact the upfitted truss support.
Repetitive jounce impact may cause the bolt to fail.

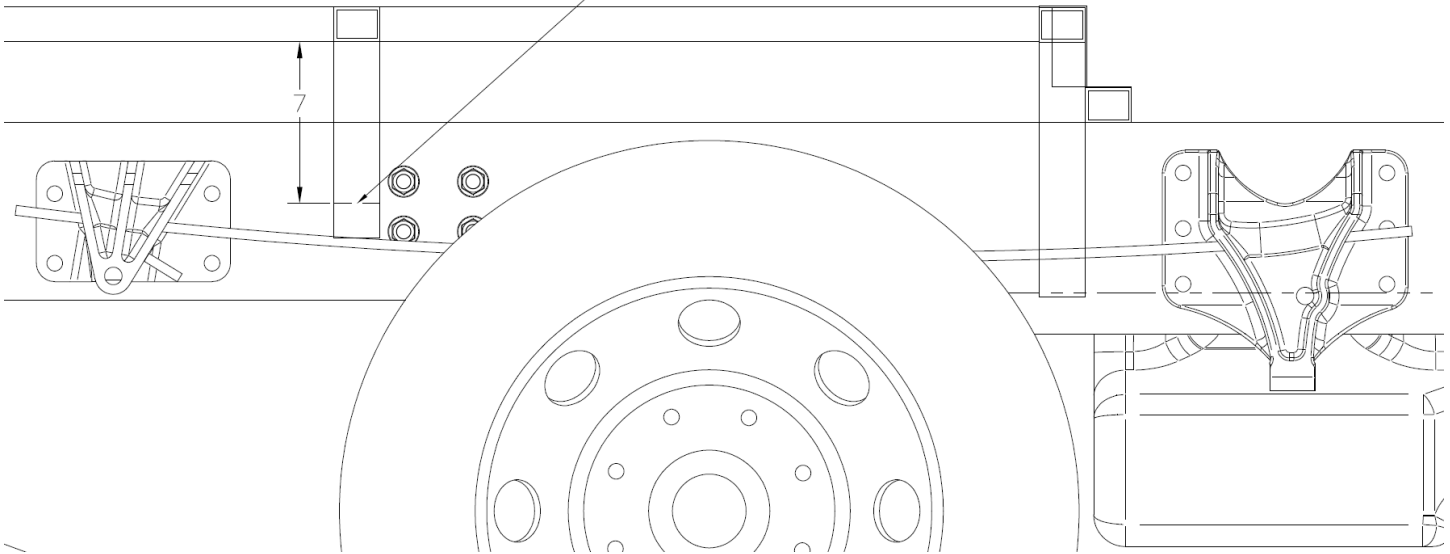
FIGURE 1

CUT TRUSS SUPPORT AT 7"
FROM THE TOP TUBE

STEP 4: MEASURE 7" (7 INCHES) DOWN FROM THE BOTTOM OF THE TRUSS SYSTEM SHOWN IN FIGURE 1;

- MARK THIS SPOT ON THE TUBE AS SHOWN IN FIGURE 1;

STEP 5: CUT THE TRUSS TUBE STARTING AT THE 7" (7 INCH) MARK DOWNWARD;

- DO NOT CUT/DAMAGE THE MAIN CHASSIS RAIL(S)
 - DAMAGED MAIN CHASSIS RAIL(S) WILL NOT BE COVERED UNDER THIS REPAIR/RECALL;
- REMOVE THE EXCESS TUBING;
- GRIND SURFACE FLAT;
- PAINT WITH HIGH QUALITY BLACK SPRAY PAINT;
