## RECALL 25V682 / 2025-545 REMEDY INSTRUCTIONS

| | Concern:<br>The charge line may not have over-current protection. | Photo(s) Required: NO<br>Prior Authorization Required: YES<br>Part(s) Kit Number: N/A<br>Part(s) Return: N/A |

CERTAIN – 2016 - 2026 – SALEM TRAVEL TRAILERS  
CERTAIN – 2016 - 2026 – WILDWOOD TRAVEL TRAILERS

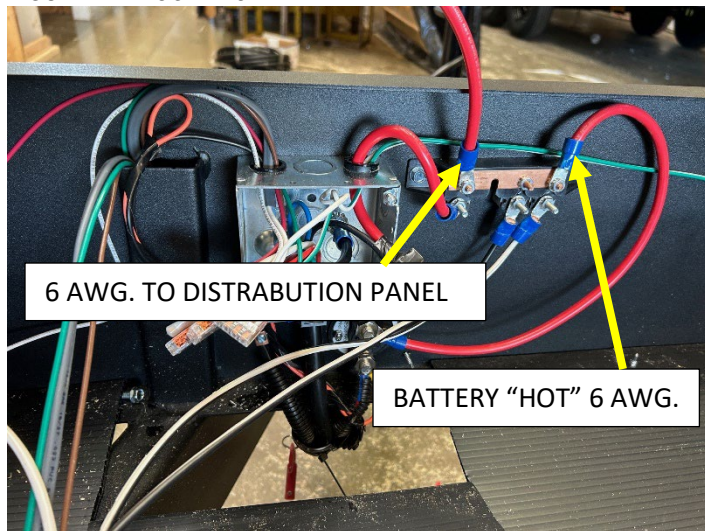
STEP 2: IF THE 6 AWG. WIRES ARE CONNECTED AS SHOWN IN FIGURE 1, FIGURE 2 OR FIGURE 3, MOVE ON TO THE REMEDY;

FIGURE 1 – INCORRECT

STEP 1: LOCATE THE 6 AWG. WIRE ON THE REAR POST OF THE MINI-BREAKER. LOOSEN THE NUT AND REMOVE THE WIRE/EYELET;

STEP 2: INSTALL THE NUT BACK ONTO THE POST YOU REMOVED IT FROM AND TIGHTEN DOWN, ASSURING IT IS SECURE;

STEP 3: REMOVE THE NUT FROM THE LOWER POST ON THE REAR MINI-BREAKER;

- REMOVE THE SMALLER WIRE/EYELET FROM THE POST;
- INSTALL THE 6 AWG. WIRE/EYELET ONTO THE POST;
- RE-INSTALL THE SMALLER WIRE/EYELET ONTO THE POST. ROTATE THE SMALLER WIRE WHERE THE EYELET CRIMPS DO NOT OVERLAP. IF THEY OVERLAP, THEY MAY BECOME LOOSE.
- INSTALL THE NUT AND TIGHTEN, CLAMPING THE TWO WIRE/EYELETS TOGETHER, ENSURING PROPER SECUREMENT;
- THE REMEDY SHOULD NOW MATCH FIGURE 2;

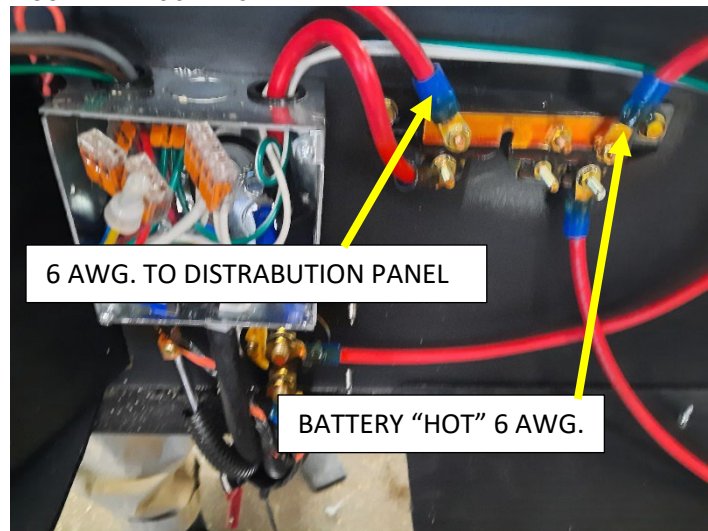
FIGURE 2 – INCORRECT

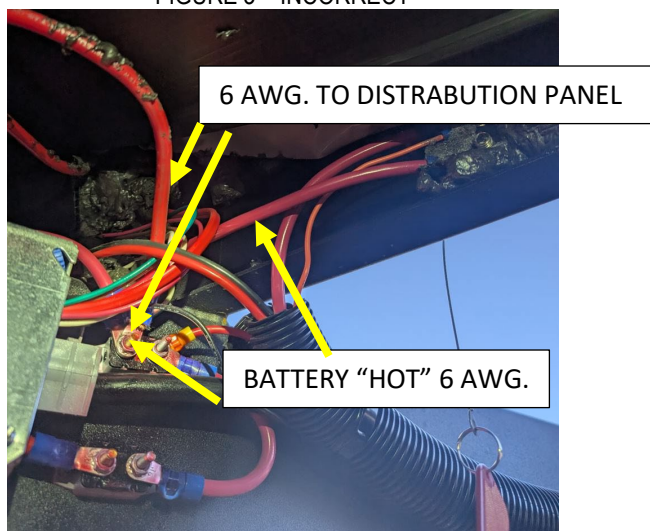
FIGURE 3 – INCORRECT

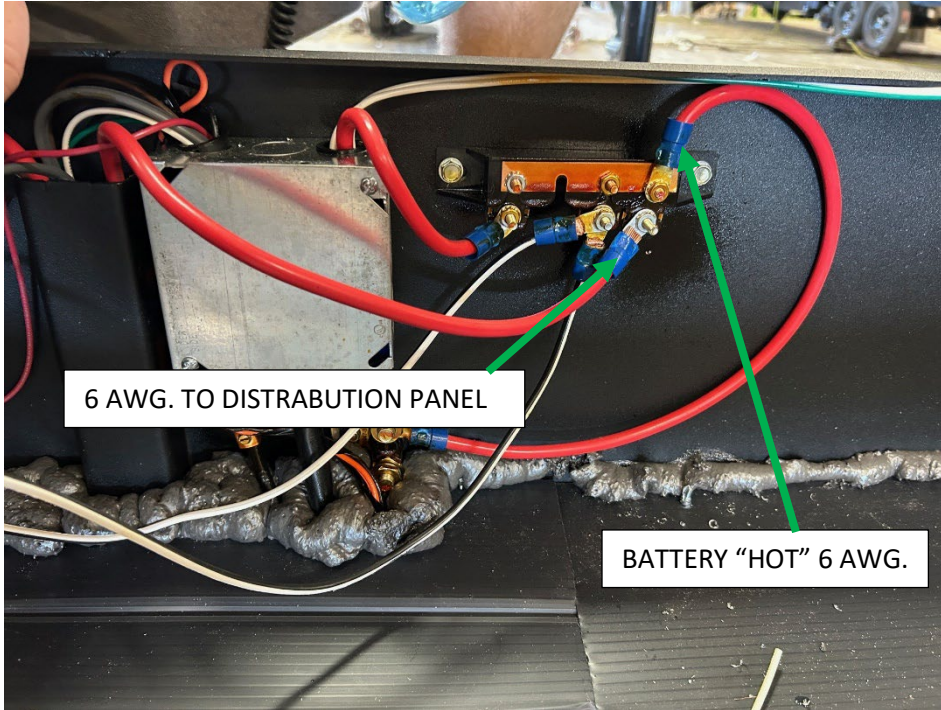
- IF THE 6 AWG. WIRES ARE CONNECTED AS SHOWN IN FIGURE 4 OR FIGURE 5 CLAIM THE INSPECTION, WORK COMPLETED.

FIGURE 4 – CORRECT

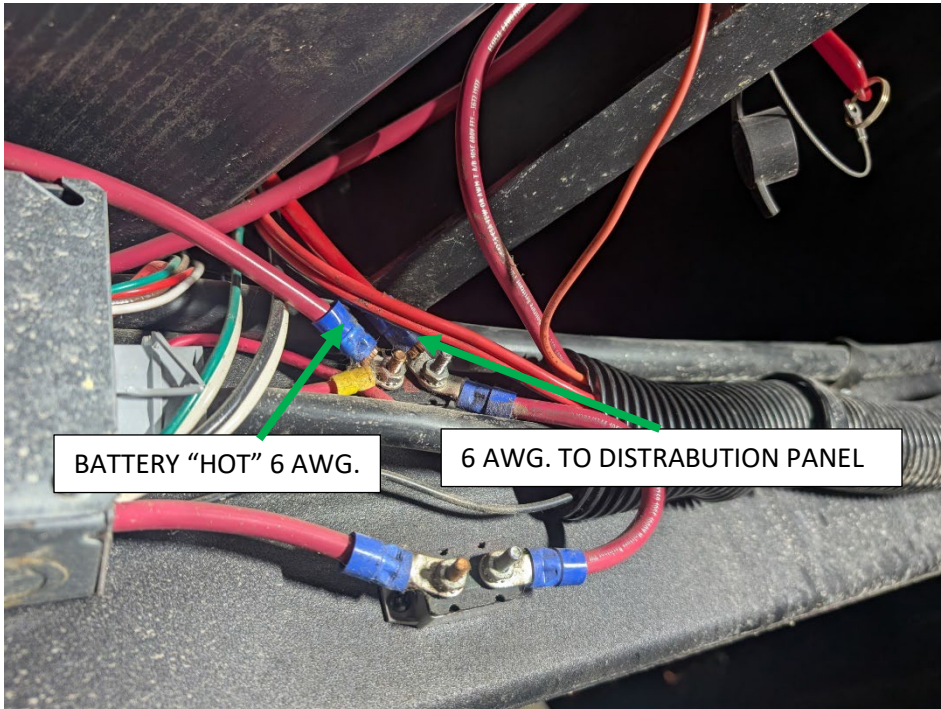
FIGURE 5 – CORRECT
