To: Mercedes-Benz Dealer Principals, General Managers, Sales Managers, Service Managers, Parts Managers	From: Anthony Washington, Senior Manager, Regulations and Certifications
<b>Re: Launch Recall Campaign Notification</b> <b>Model: Sprinter</b> <b>Model Years: 2025</b> <b>Replace DISTRONIC Radar Sensor</b>	Date: November 2025

<b>Campaign No.:</b>	<b>Campaign Desc.:</b>	<b>NHTSA ID:</b>	<b>Replace DISTRONIC Radar Sensor</b>
<b>2025110001</b>	<b>VS3RADARS</b>	<b>25V712</b>	
<p>This is to notify you of a <b>Recall Campaign</b> to replace the DISTRONIC radar sensor on approximately <b>16</b> MY 2025 Sprinter Vans. The recall campaign will be visible on the <a href="http://www.NHTSA.gov">www.NHTSA.gov</a> website and may generate questions from customers. All affected VINs will be flagged as "<b>OPEN</b>" in VMI and cannot be sold until remedied.</p>			
<b>Background</b>			
<b>Issue</b>	<p>Mercedes-Benz AG, the manufacturer of Mercedes-Benz vehicles, has determined that on certain Model Year ("MY") Sprinter (907 platform) vehicles, the front short-range radar sensor printed circuit board might not meet specifications. As a consequence, object detection might not be sufficiently robus

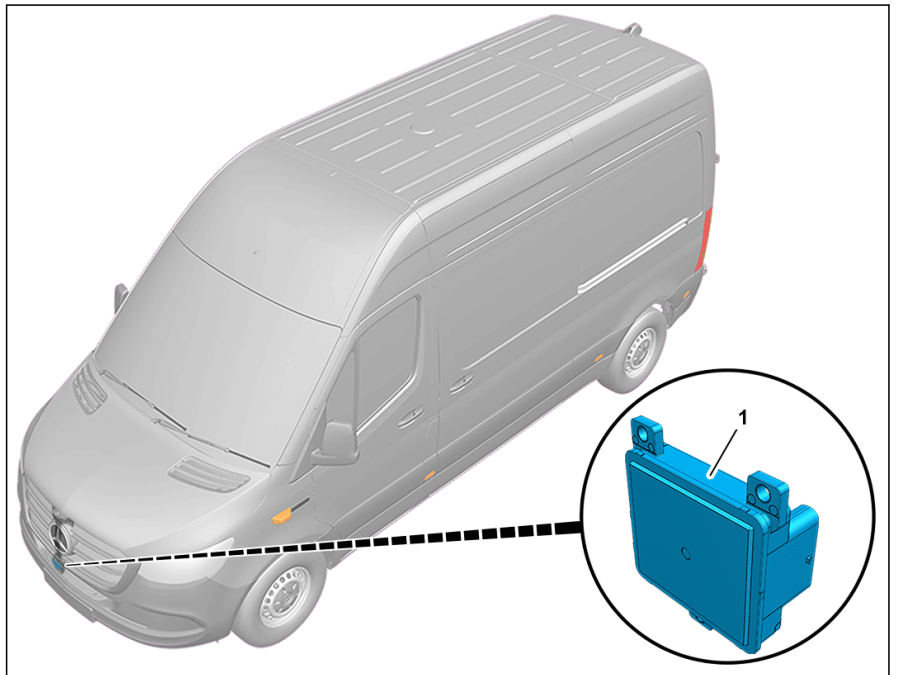
D30.30-A009-76

**Shown on model 907.6 with code BA3 (Active Brake Assist)**

1 Radar sensor

<b>Check</b>		
1	Check if vehicle is affected by measure.		
	<b>Replace</b>		
2	Replace front radar sensor.		AR30.30-D-1210TS

5	Commission radar sensor (1) with diagnostic system.		
6 AD	Disconnect diagnostic system.		AD00.00-D-2000-06TS
7 AR	Remove charger from vehicle.		AR54.10-D-1127TS
