SIB 72 08 25

RECALL 25V-717: REPLACE DRIVER REAR SAFETY BELT

2026-01-08

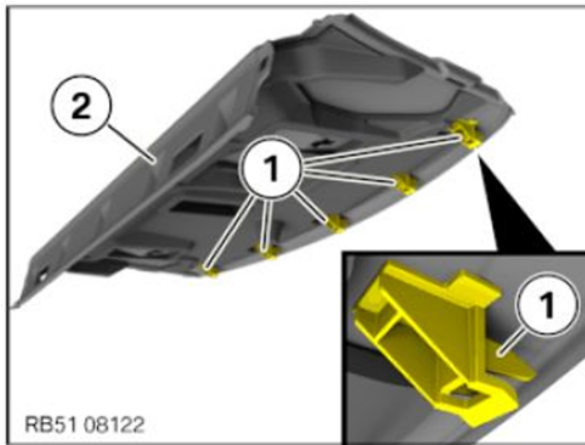
When installing the rear trim panel (F74 model) check to see if any of the snap-in lugs (1) are damaged.

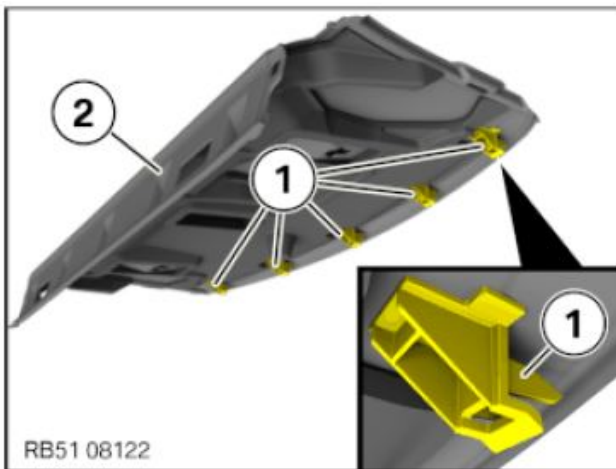
When installing the rear trim panel (F74 model) check to see if any of the snap-in lugs (1) are damaged.

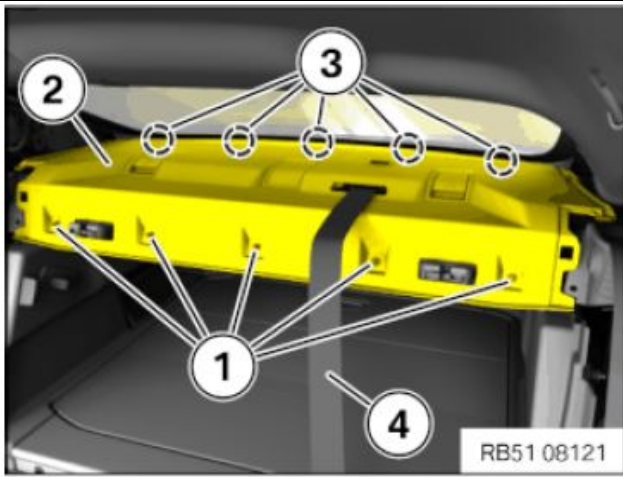
When installing the rear trim panel (F74 model) check to see if any of the snap-in lugs (1) are damaged.

The note in the Repair instruction for the rear trim panel (2) indicates to replace the trim panel **ONLY IF THE SNAP-IN LUG(S) ARE BROKEN**.

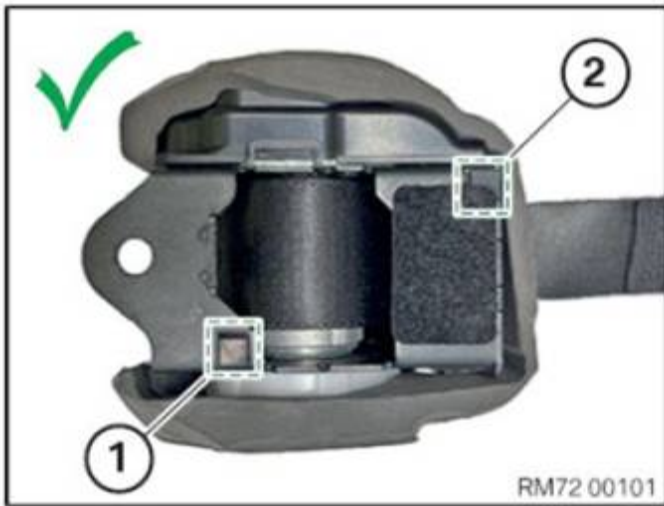
NOTE: Replacement safety belt reels no longer use these adhesive pads (1 and 2). The adhesive pads have been eliminated in production vehicles since May 2025.

Ignore the steps in the repair instructions referencing these adhesive pads.

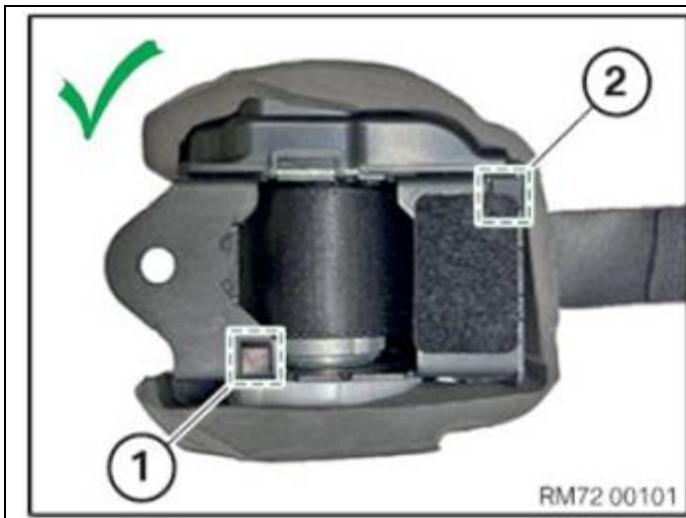
NOTE: Replacement safety belt reels no longer use these adhesive pads (1 and 2). The adhesive pads have been eliminated in production vehicles since May 2025.

Ignore the steps in the repair instructions referencing these adhesive pads.

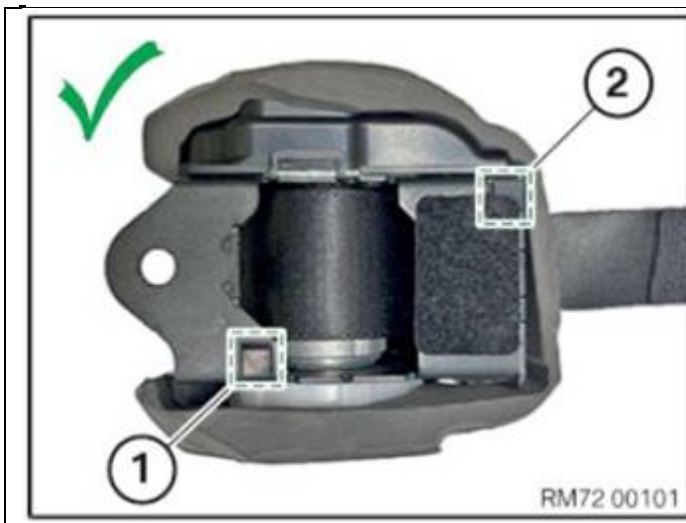
NOTE: Replacement safety belt reels no longer use these adhesive pads (1 and 2). The adhesive pads have been eliminated in production vehicles since May 2025.

Ignore the steps in the repair instructions referencing these adhesive pads.
