**PRODUCT CAMPAIGN BULLETIN**

**APPLICABILITY:** 2023-25MY Solterra **NUMBER:** WRE-25R

**SUBJECT:** Safety Recall: Solterra Parking Assist **DATE:** 11/12/25  
 ECU Reprogramming **REVISED:** 04/24/26

**NHTSA ID:** 25V744

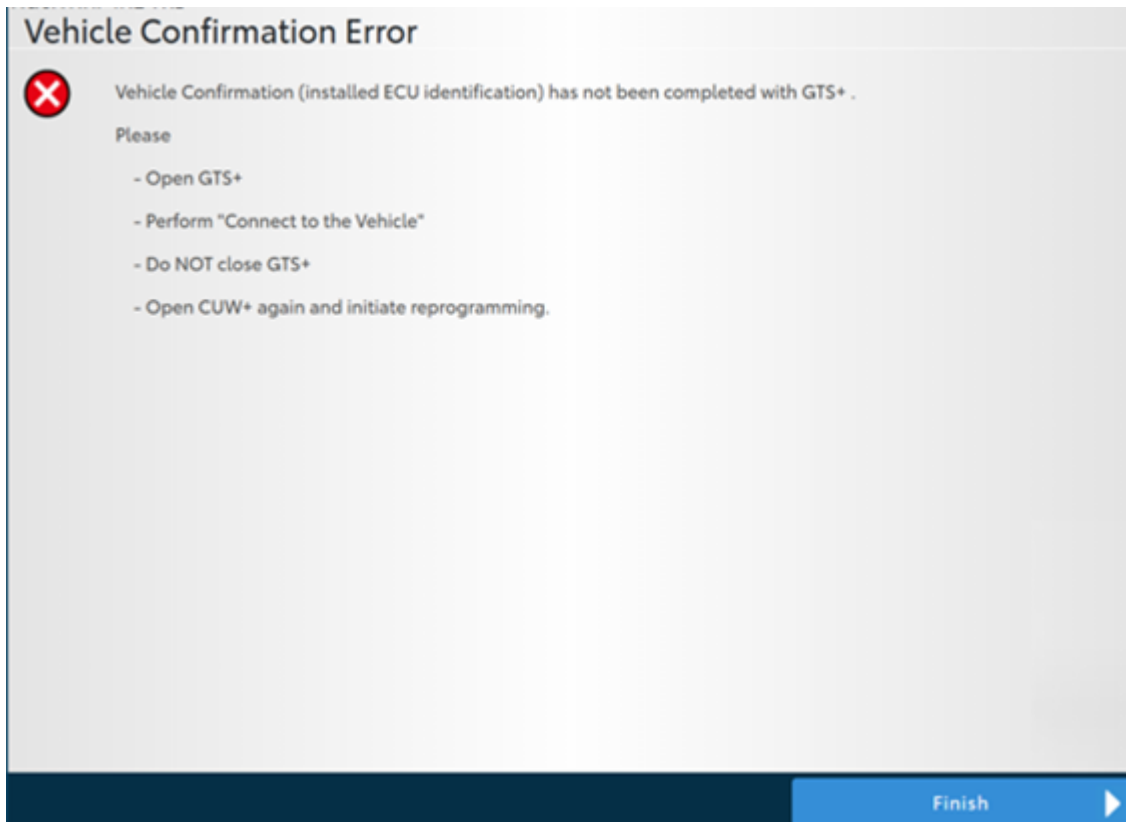
**EXAMPLE** Image of CUW error message:

**NOTE:** If GTS+ is not connected to the vehicle, an error message will be displayed. If there is no message displayed, GTS+ is connected and you can continue the procedure.

**DO NOT** change the vehicle interface. The original interface (DST-i/DST-010) used to attempt the original reprogramming **MUST** be used.

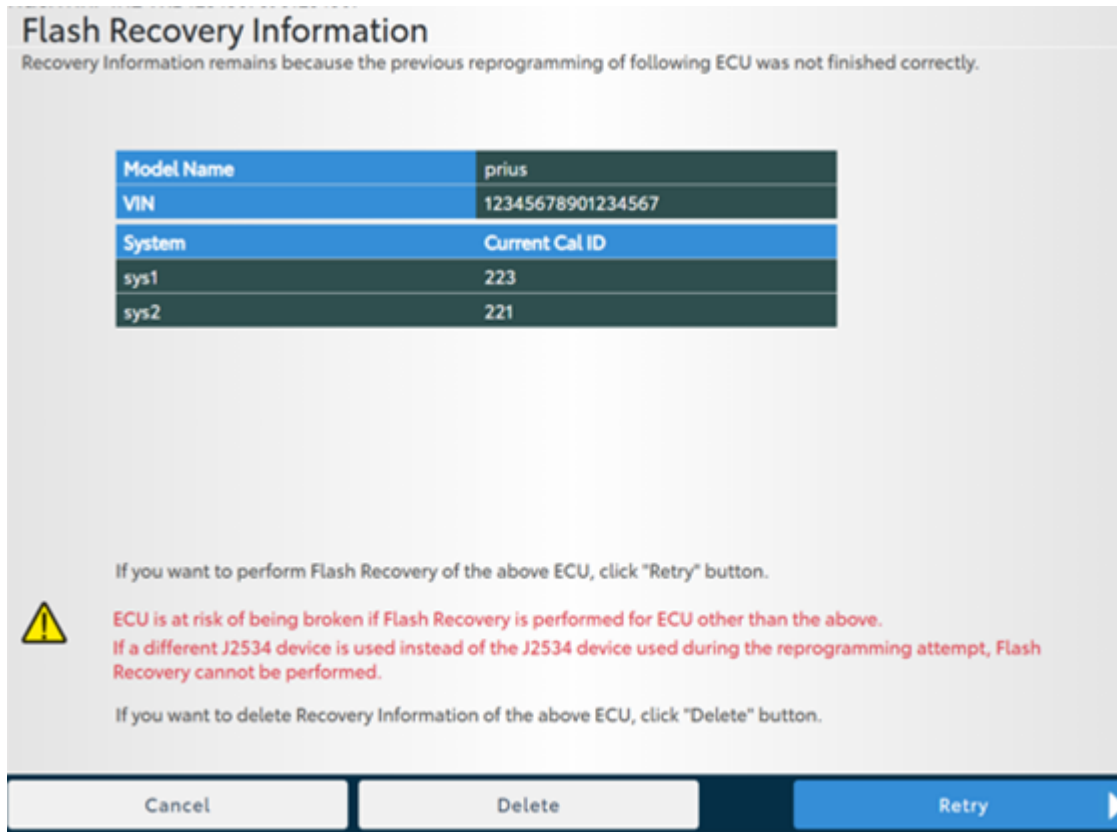
**EXAMPLE** image of the recovery screen:

**STEP 3:** Verify the target VIN matches the vehicle being reprogrammed.

**STEP 4:** To perform reprogramming, press the “Retry” button to continue.
