Safety Recall

N252530830 Both Roof Rail Airbag Inflators May Rupture

Release Date: November 2025

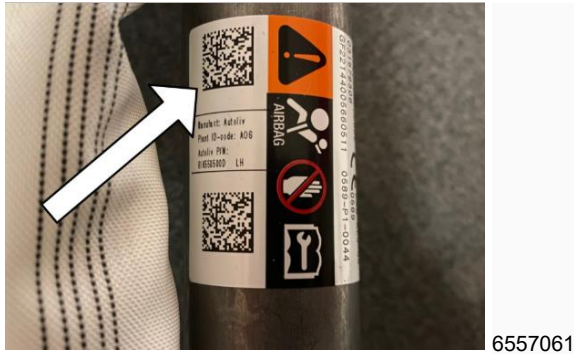
Record and submit BOTH the replacement Roof Side Rail Airbags serial number for RPT as shown above. Refer to TSB 25-NA-195 for more information on how to submit an RPT.

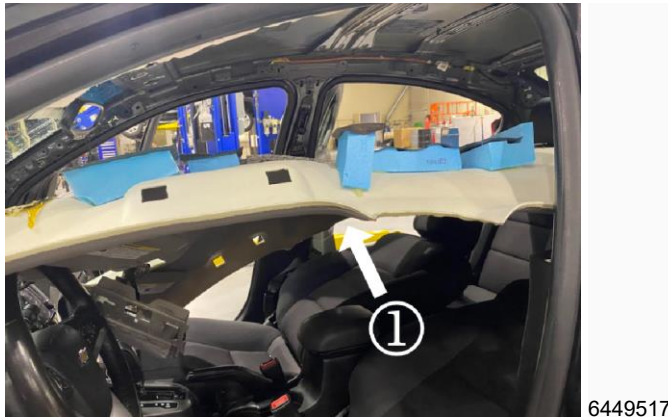
Note: The Headlining Trim Panel only needs to be lowered NOT removed. DO NOT remove the seats as the SI document states. Seat removal is ONLY for headliner removal NOT headliner lowering.

4. Lower the Headlining Trim Panel onto the headrests of the seats (1) as shown above. Refer to *Headlining Trim Panel Replacement* in SI.
5. Remove and replace BOTH the left hand and right hand Roof Side Rail Airbags. Refer to *Roof Side Rail Airbag Replacement* in SI.
6. Reinstall the Headlining Trim Panel. Refer to *Headlining Trim Panel Replacement* in SI.
7. Enable the SIR system. Refer to *SIR Disabling and Enabling* in SI.
8. Return the Front Seats to their original location.
9. Write N252530830 directly on BOTH USED Roof Side Rail Airbag inflators using a permanent marker or paint pen. This is to help ensure the airbag is disposed of correctly, according to the instructions below.
