Thor Motor Coach Recall Repair Instructions

Recall #	25V-791 2025-634		
Description/Title:	Solar Panel		
Affected Product Line(s):	Certain MY 2022-24 Sequence and Tellaro, 2023 Sanctuary and Tranquility, 2023-24 Twist and Dazzle, 2024 Freedom Elite Van		
Service Campaign # :	RC000336		
Repair Code:	Inspect Only: TMCRC80505Y Inspect with Repair: TMCRC80505V	Document Date:	1/8/2026
Time Allowed:	Inspect Only: 0.2 Inspect with Repair: 0.5	Document Revision:	A

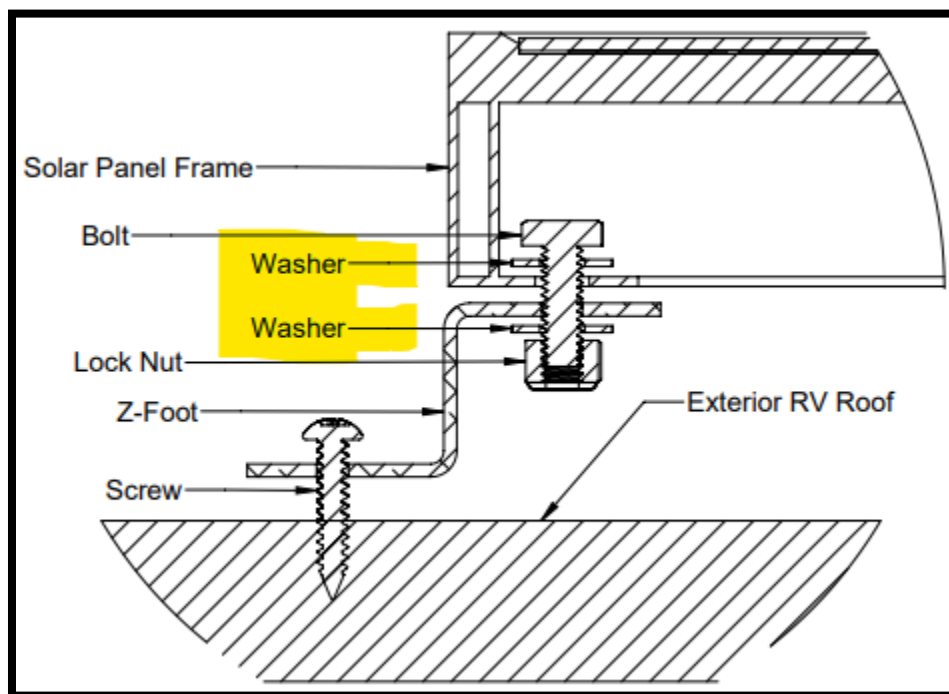
It has been discovered that the hardware used to mount the solar panels to the roof brackets may be missing the washer on the bolts at each of the four brackets.

1. Two ¼" stainless steel washers from local shop supplies are to be installed at each of the four brackets as shown in diagram:
