HYUNDAI
Technical Service Bulletin

GROUP RECALL	NUMBER 26-01-004H
DATE JANUARY 2026	MODEL(S) SANTA FE (MX5A) SANTA FE HYBRID (MX5A HEV)

SUBJECT: INOPERATIVE REAR-VIEW CAMERA – HARNESS REPLACEMENT (RECALL 288)

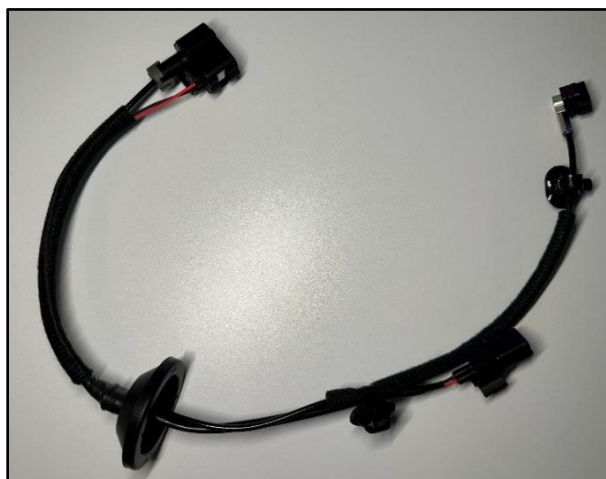
Description: Certain Santa Fe (MX5A) and Santa Fe Hybrid (MX5A HEV) vehicles may have a rearview camera that was improperly installed during assembly, potentially resulting in a damaged wire harness. In this condition, the rearview camera could malfunction or become inoperative. This bulletin provides instructions to replace the rear-view camera harness.
