VOLUNTARY RECALL CAMPAIGN

Classification: AN25-006B	Reference: NTB25-061B	Date: February 17, 2026
------------------------------	--------------------------	----------------------------

VOLUNTARY SAFETY RECALL CAMPAIGN 2025-2026 ARMADA; IVI REPROGRAM

CAMPAIGN ID #: R25D5
APPLIED VEHICLES: 2025-2026 Armada (Y63)

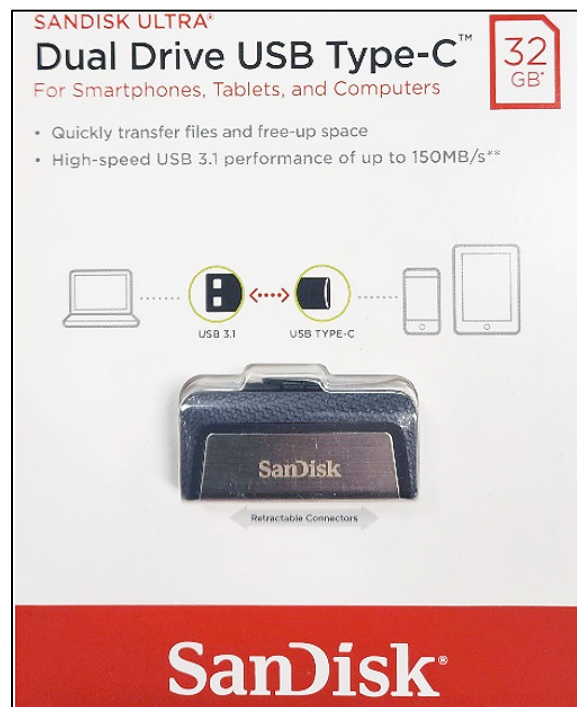
Figure 1

- This reprogram requires the use of two (2) 32GB Dual Type-A/Type-C USB drives. The in-vehicle infotainment system will not recognize a 64GB USB drive.
- Per dealer announcement, obtain a SanDisk Ultra Dual USB flash drive - 32GB, SKU SDDDC2-032G-A46 (Figure 1) through a local source, or special tool USB drive NI-52727-32DD from Tech•Mate: techmatetools.com or 1-833- 397-3493.

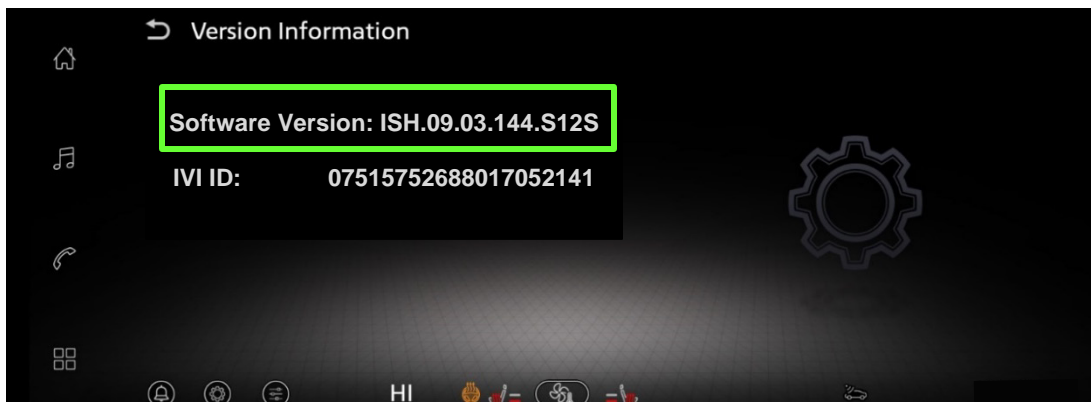
6. Does the **Software Version** shown in Figure 7 start with **ISH.25.28.05** ?

NO: Continue to step 7 on page 5 to reprogram the IVI Control Unit.

YES: No further action is needed. Proceed to **CLAIMS INFORMATION** on the last page.
