**SAFETY RECALL**  
 NORTH AMERICA  
**Curtain Airbag Inflator**

Reference: C2C / NHTSA 25V-824

FCA US LLC

- 2019 (DS) Ram 1500 Pickup
- 2019 (DJ) Ram 2500 Pickup
- 2019 (D2) Ram 3500 Pickup

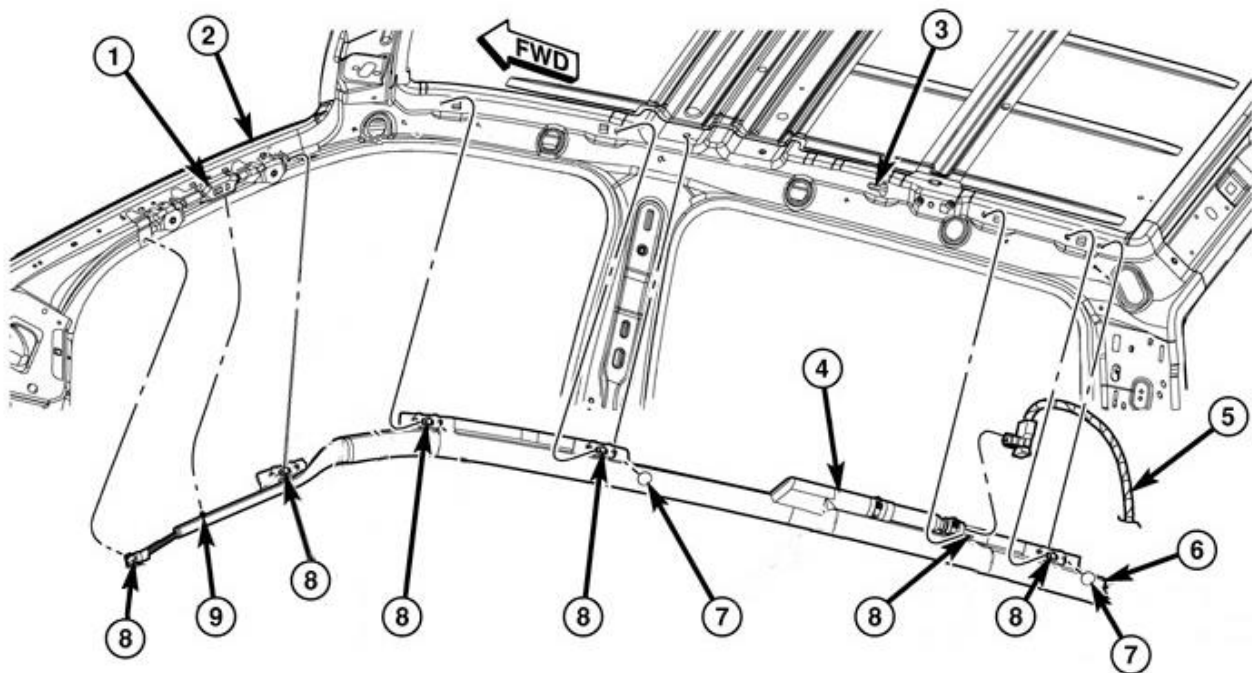
**Figure 17 – Side Curtain Airbag**

The Curtain Airbag (CAB) inflator on about 225 of the above vehicles may rupture result in compressed gas rapidly escaping from the inflator and material potentially being propelled into the vehicle. Material being propelled into an occupied vehicle may cause injury.

28. Remove the six bolts (8) that secure the side curtain airbag (6) to the inner roof rail and A-pillar (Figure 17).
29. Disengage the push-in retainer (9) that secures the side curtain airbag tether to the inner A-pillar (1) and the two push-in retainers (7) that secure the side curtain airbag to the inner roof rail (Figure 17).

31. Remove the CAB (6) from the vehicle as a unit and **DISCARD** following local ordinances and recommended procedures for handling and disposal of Non-Deployed Supplemental Restraints (Figure 17). Provided packaging is not authorized for the transport of the recalled CAB Module. Parts will need to be either deployed on-site or transported in alternative approved containers.

32. Check to be certain that the spring nuts are properly installed in the inner roof rail and that they are in good condition.
33. Position the **NEW** CAB (6) into the vehicle as a unit (Figure 17).

35. Engage the two push-in retainers (7) that secure the side curtain airbag to the inner roof rail and ensure the tether is not twisted then engage the plastic push-in retainer (9) that secures the side curtain airbag front tether to the assist handle bracket on the inner A-pillar (1) (Figure 17).
36. Working from rear to front, install and tighten the six bolts (8) that secure the side curtain airbag (6) to the inner roof rail and A-pillar and ensure the tether is not twisted. Tighten the bolts to 7 N·m (62 in. lbs.) (Figure 17).
37. Connect the body wire harness connector (5) for the side curtain airbag to the connector receptacle of the inflator (4). Be certain that each connector is fully engaged in its receptacle by listening carefully for a distinct, audible click as the connector latches snap into place (Figure 17).
