Technical Service Bulletin

GROUP	NUMBER
RECALL	26-01-005G
DATE	MODEL(S)
JANUARY 2026	G90 (RS4)

SUBJECT: FALSE DETECTION OF VEHICLE WITH HIGHWAY DRIVE ASSIST ENABLED (RECALL 030G)

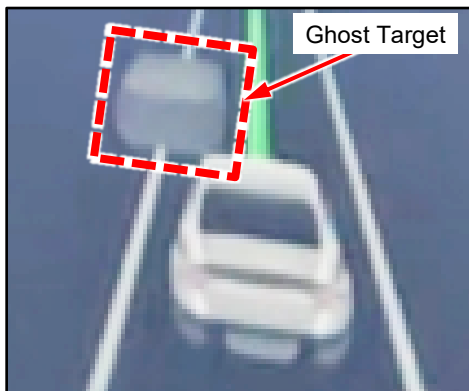
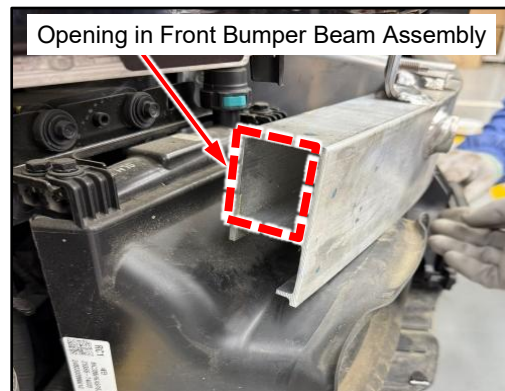
Description: Certain G90 (RS4) vehicles painted in Seville Silver (SSS) and equipped with Highway Drive Assist (HDA)—an advanced driver assistance system that enables semi-autonomous driving on limited-access highways under continuous driver supervision—may, under specific conditions, falsely detect another vehicle entering the lane of travel and apply the brakes without warning. This may occur when HDA is enabled at speeds below approximately 12 mph or when HDA is enabled in conjunction with the Lane Change Assist (LCA) feature, which is activated by the driver signaling a lane change. Sudden, unintended braking can increase the risk of a crash. This bulletin provides instructions to replace the front bumper beam assembly with a revised part to address this condition.
