# Technical Service Bulletin

<b>GROUP</b>	<b>NUMBER</b>
<b>RECALL</b>	<b>26-01-005G</b>
<b>DATE</b>	<b>MODEL(S)</b>
<b>JANUARY 2026</b>	<b>G90 (RS4)</b>

**SUBJECT:** FALSE DETECTION OF VEHICLE IN HDA MODE – FRONT BUMPER BEAM REPLACEMENT (RECALL 030G)

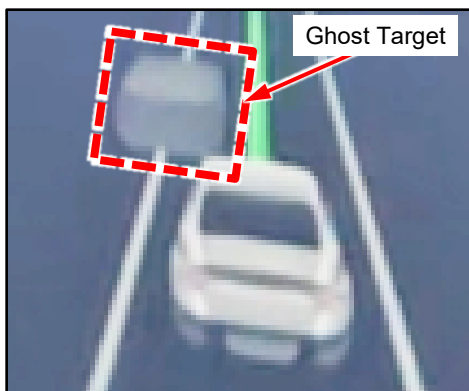
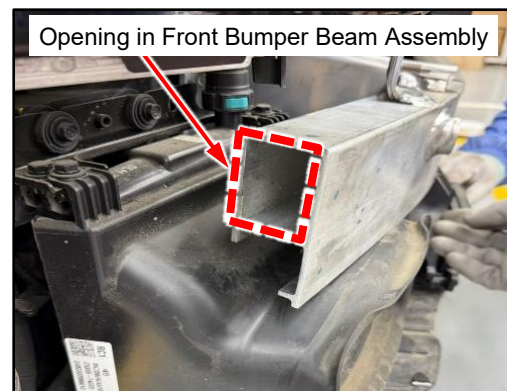
**Description:** Certain G90 (RS4) vehicles painted in Savile Silver (SSS) and equipped with Highway Driving Assist (HDA)—an advanced driver assistance system that enables semi-autonomous driving on limited-access highways under continuous driver supervision—may, under specific conditions, falsely detect another vehicle entering the lane of travel. The falsely detected vehicle may appear if the front corner radar signals reflect off silver bumper cover paint and pass through the front bumper beam causing these signals to register as an object in the opposing lane. This false vehicle detection could cause the brakes to apply without warning when HDA is enabled at speeds below approximately 12 mph or when HDA is enabled in conjunction with the Lane Change Assist (LCA) feature, which is activated by the driver signaling a lane change. Sudden, unintended braking can increase the risk of a crash. This bulletin provides instructions to replace the front bumper beam assembly with a revised part to address this condition.
