SAFETY RECALL

Collapsed Brake Pedal

Reference: D0C / NHTSA 25V-846

FCA US LLC

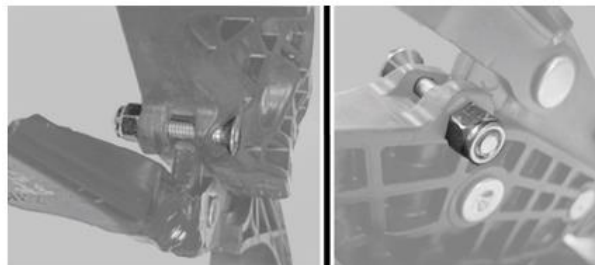
Figure 4 – A Properly Seated Fastener

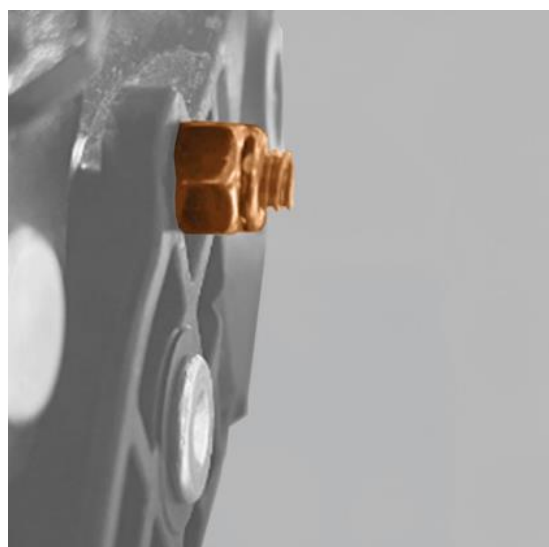
Figure 5 – An Over Torqued Fastener

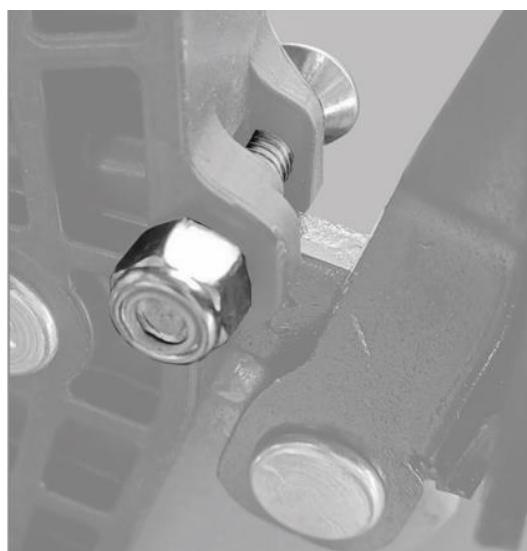
Figure 6 – An Under Torqued Fastener
