Safety Recall

Code: 74HE

Subject Heater Element Wiring Harness

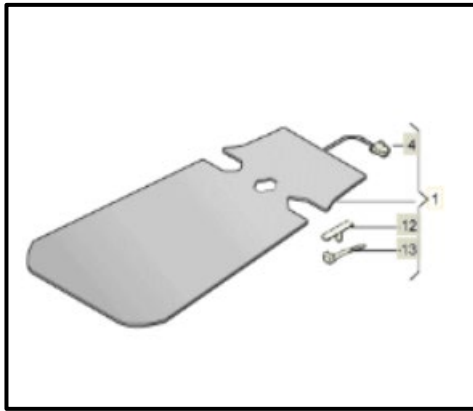
Repair Overview

The passenger occupant detection system (PODS) may experience a fault due to a crimp that could be missing at a connection point, potentially deactivating the front passenger airbag when the seat is occupied. If the fault occurs, the front passenger airbag would not deploy in the event of a crash, increasing the risk of injury to a front passenger seat occupant.

- Repair PODS harness shield wire splice.
