SIB 65 32 25

RECALL 25V-871: REPLACE LEFT AND RIGHT HEAD AIR BAGS

2026-01-05

SIB 65 31 25

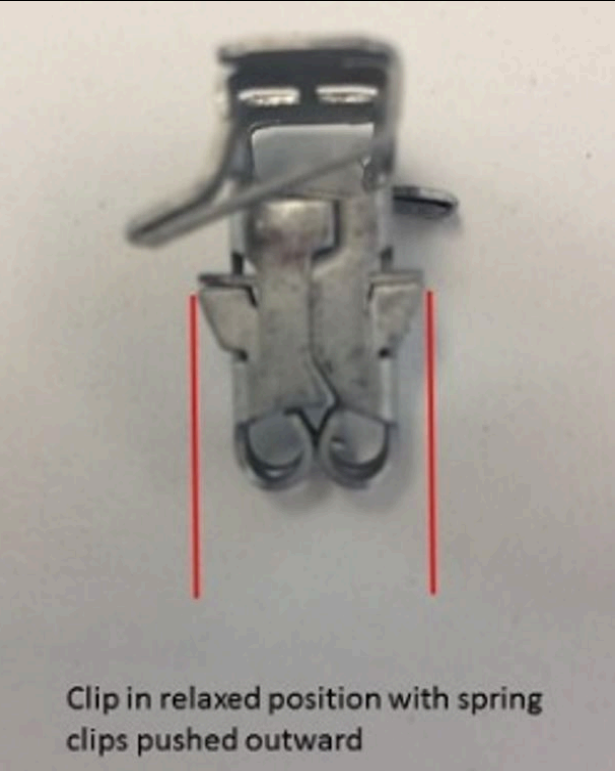
Here is a spring clip that holds the air bag assembly into the body in its installed state.

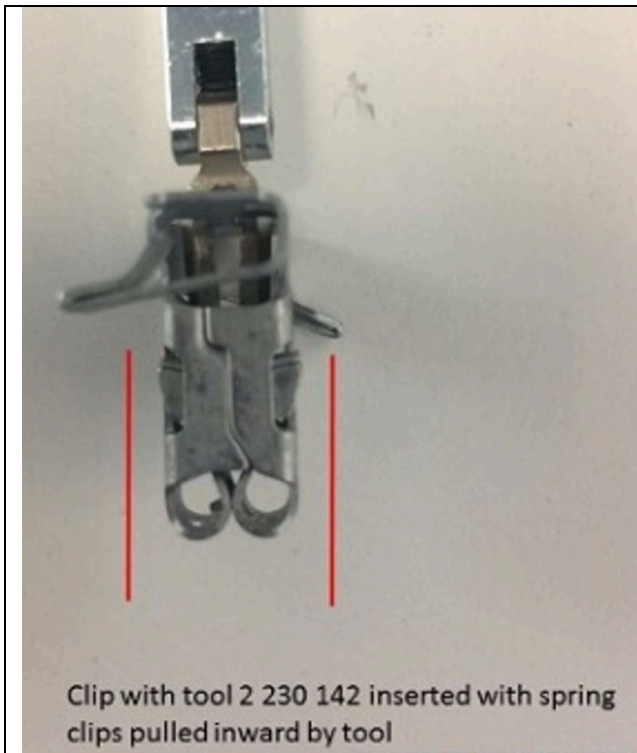
Clip with tool 2 230 142 inserted with spring clips pulled inward by tool

When the tool is inserted into the spring clip, it will retract the spring-loaded locking clips. This allows the clip to be removed from the blind hole in the vehicle body.

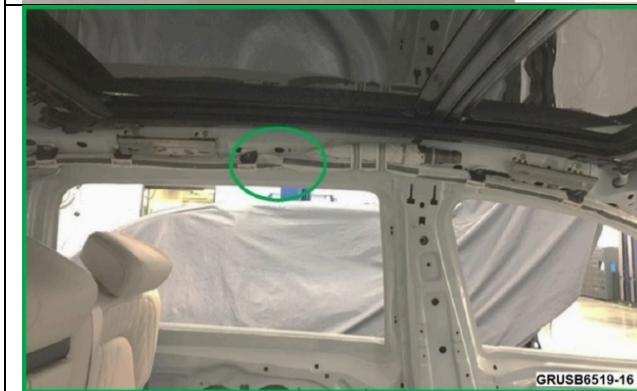
GRUSB6519-16

To ensure correct function for deployment, the head air bag must be positioned so that the printed, colored line points towards the vehicle interior across the entire component length

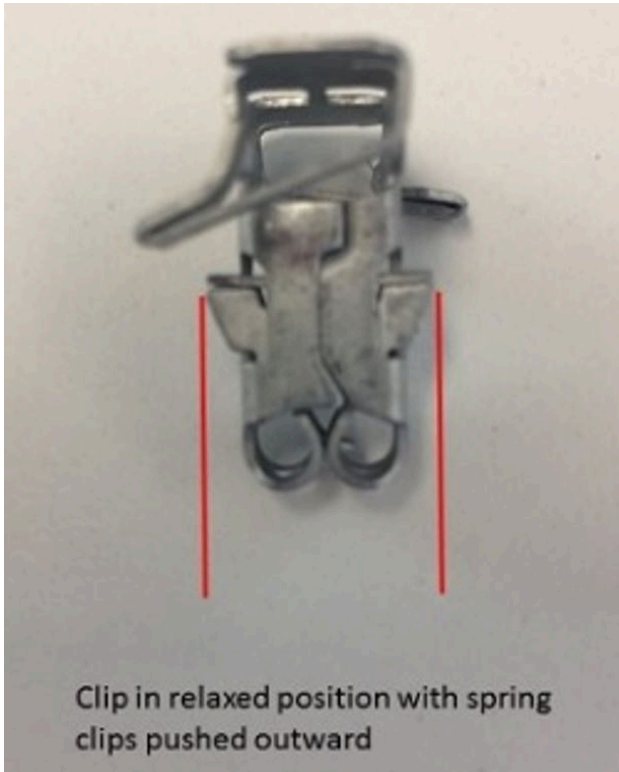
Clip in relaxed position with spring clips pushed outward

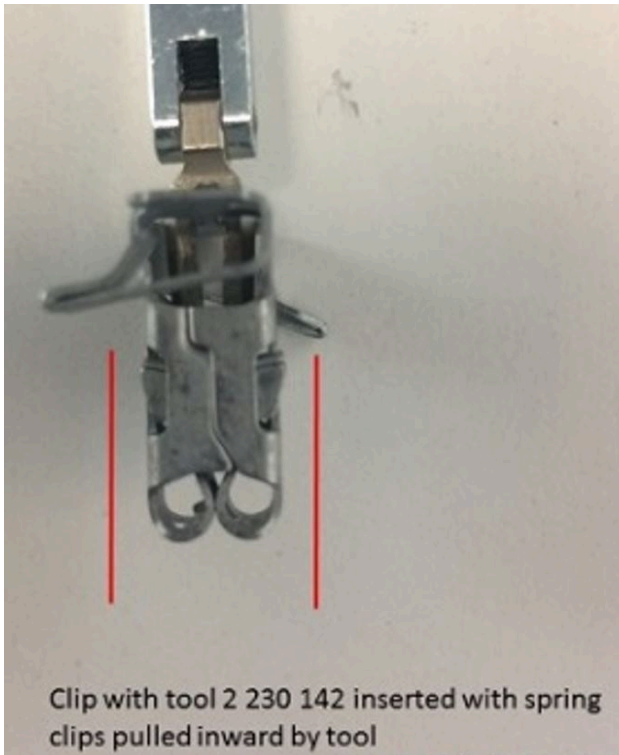
Clip with tool 2 230 142 inserted with spring clips pulled inward by tool

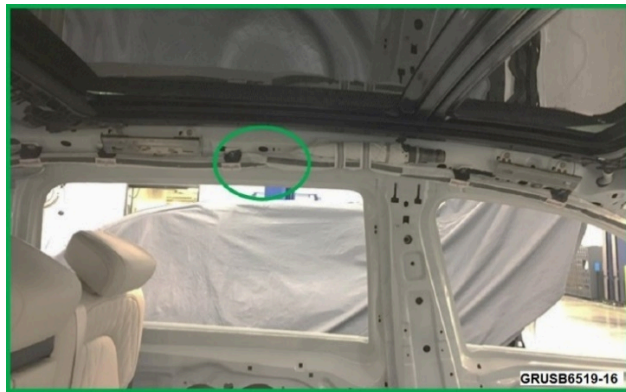
To ensure correct function for deployment, the head air bag must be positioned so that the printed, colored line points towards the vehicle interior across the entire component length.
