GROUP	MODEL
Noncompliance Safety Recall Campaign	2023-2025MY Sportage (NQ5a), Sportage PHEV (NQ5 PHEV) X-Line Trims Only
NUMBER	DATE
SC359 (Rev 1, 02/11/2026)	December 2025

NONCOMPLIANCE SAFETY RECALL CAMPAIGN

TRAILER HITCH HARNESS INSPECTION AND MODULE REPLACEMENT (SC359)

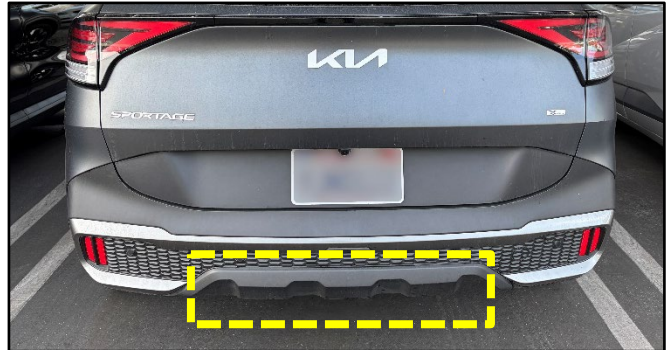
- Vehicle is **not equipped** with a 'Genuine Kia' 4-pin tow hitch harness accessory. No further action is required.

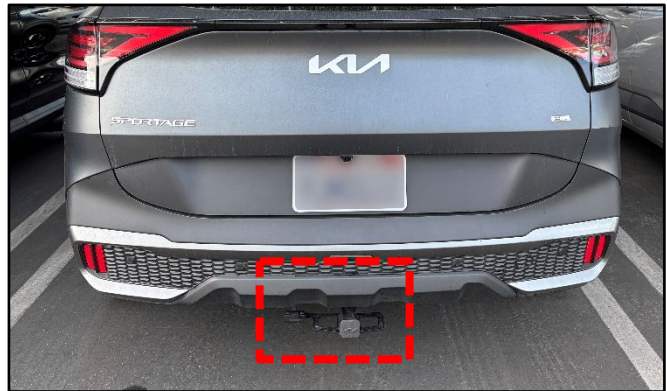
- Vehicle is equipped with a 'Genuine Kia' 4-Pin tow hitch harness accessory.

2. **If equipped**, refer to the table above for the applicable VIN for either SC359A or SC359B to replace the trailer control module by referring to the 'Replacement Procedure' outlined on pages 3-4.
