PRODUCT CAMPAIGN BULLETIN

APPLICABILITY:	2026MY Forester	NUMBER:	WRG-25R
		DATE:	01/30/26
SUBJECT:	Safety Recall and Stop Sale: Rear Gate Stay Bracket	REVISED:	03/03/26
		NHTSA ID:	25V-889

Subaru of America, Inc. (Subaru) has initiated a safety recall for certain 2026 model year Forester Vehicles to replace the rear gate stay and bracket.

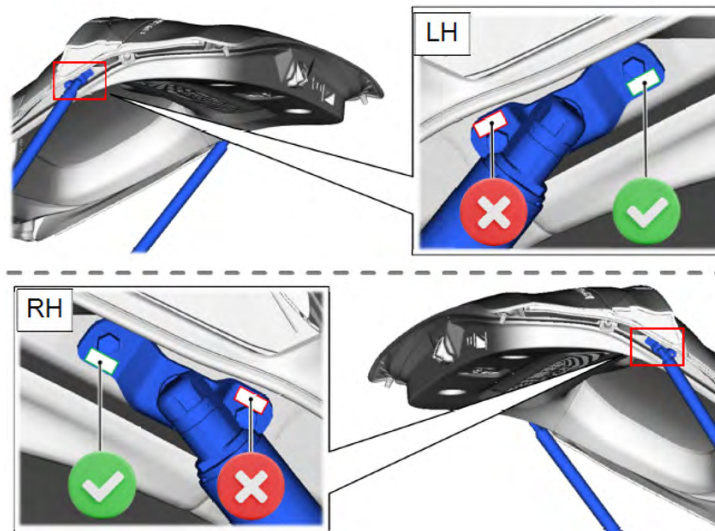
Step 1) Open rear gate, inspect the location of the bracket identification mark.

Is the mark at the top of the bracket with the gate open?

No – Go to replacement procedure for the applicable rear gate model.

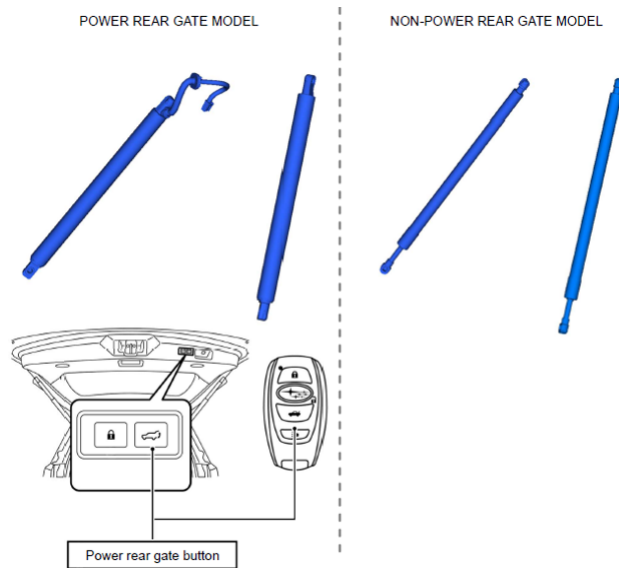
Step 2) Inspect the rear gate stays.

Are they the correct stays for the rear gate model?

No - Go to replacement procedure for the applicable rear gate model.

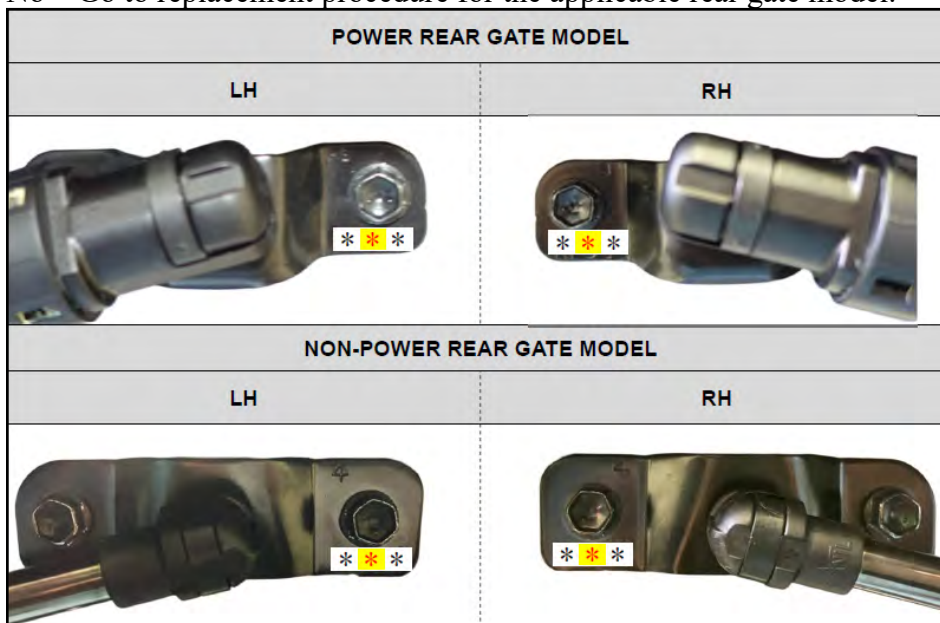
Step 3) Inspect rear gate stay bracket identification mark to ensure it is correct for rear gate model.

Check the middle digit of the identification mark:

The middle digit will be either P or N. P brackets are for power rear gates, and N brackets are for non-power rear gates.

Is the middle digit correct on both rear gate stay brackets?

No – Go to replacement procedure for the applicable rear gate model.
