PRODUCT CAMPAIGN BULLETIN

APPLICABILITY: 2026MY Forester **NUMBER:** WRG-25R

SUBJECT: Safety Recall and Stop Sale: Rear Gate Stay Bracket **DATE:** 01/30/26

Subaru of America, Inc. (Subaru) has initiated a safety recall for certain 2026 model year Forester Vehicles to replace the rear gate stay and bracket.

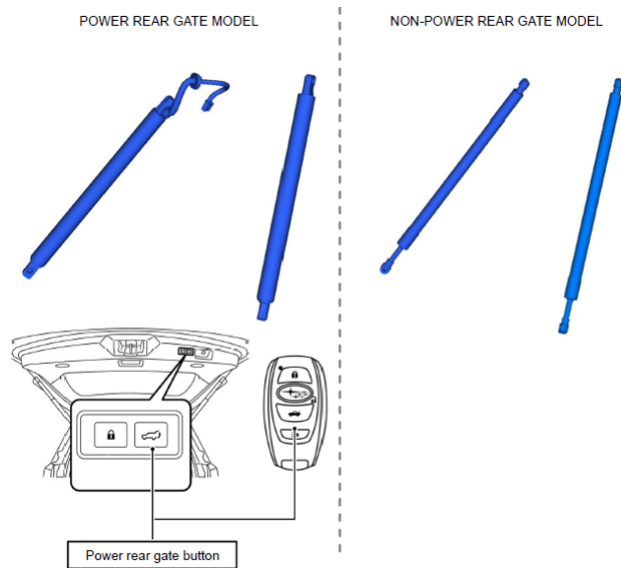
Step 2) Inspect the rear gate stays.

Are they the correct stays for the rear gate model?

Yes – Go to step 3.

No - Go to replacement procedure for the applicable rear gate model.

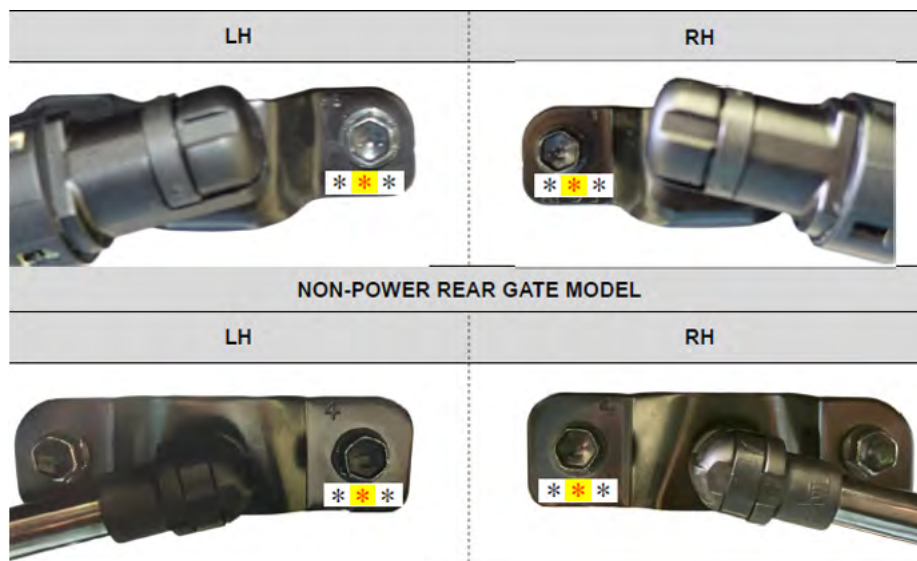
Step 3) Inspect rear gate stay bracket identification mark to ensure it is correct for rear gate model.

Check the middle digit of the identification mark:

The middle digit will be either P or N. P brackets are for power rear gates, and N brackets are for non-power rear gates.

Is the middle digit correct on both rear gate stay brackets?

Yes – Inspection is complete no repair is necessary.

No – Go to replacement procedure for the applicable rear gate model.
