**Recall Service Bulletin
RSB26-900-001**

DATE: 1/23/2026

APPLIES TO: This service bulletin applies to certain model year 2021-2023, 2025 Legend, 2007, 2015-2026 Star Series, and 2019-2020 UST Body model emergency response vehicles built between March 29, 2016 and November 11, 2025.

CONDITION: The ladder lock handle assembly attached to the ladder bracket assembly may have been installed incorrectly. This may result in the handle becoming detached from the thread rod.

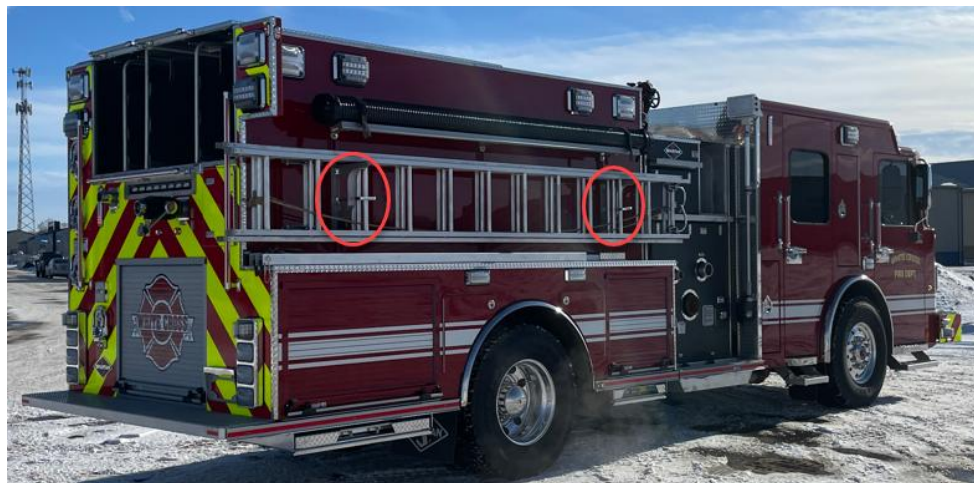
- 1) Locate the Ladder Lock bracket and handle assembly. It will either be on the side of the apparatus body or mounted to the ladder rack.

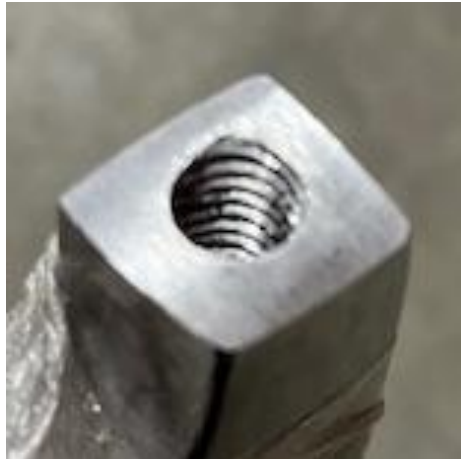
Example of threads in good condition:

- 5) Observe the first few threads inside the cast aluminum handle. Are they chipped or cracked?
