SAFETY RECALL

CERTAIN 2022-2024 XSR900, 2021-2025 MT-09, 2021-2025 MT-09 SP, 2021-2022 TRACER 9 GT, 2024 TRACER 9 GT+, 2022-2025 MT-10, AND 2022-2025 MT-10 SP MOTORCYCLES

FACTORY MODIFICATION CAMPAIGN – ECU Programming Error

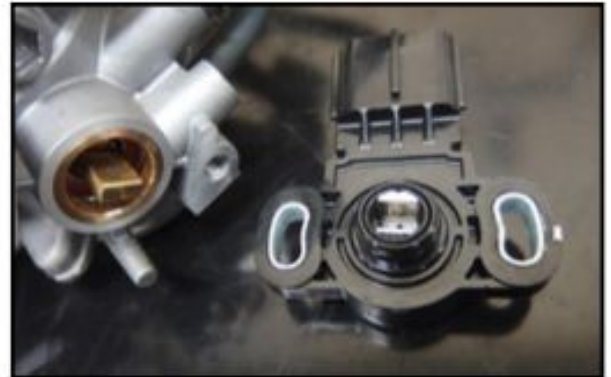
In affected motorcycles, brushes inside the Throttle Position Sensor (TPS) will slide excessively due to improper ECU programming. While the motorcycle is driven, this excessive sliding generates abrasion particles that can accumulate on the contact points in the TPS. This illuminates the malfunction indicator light (engine trouble warning light) while displaying a P2135 fault code on YDT. This can also cause unstable idling and engine stalling, potentially resulting in loss of control and a crash with severe injury or death.

To correct this issue, Yamaha is initiating a Factory Modification Campaign. Affected motorcycles that are new and unsold must have the ECU reprogrammed ("reflashed") with the latest updated version. Motorcycles that have been sold or used as demo vehicles must have both the ECU reprogrammed and the TPS replaced with a new one. Yamaha is notifying all registered owners of affected motorcycles by mail. A copy of this letter is included in this bulletin. The customer should take this letter along with the affected vehicle to an authorized Yamaha dealer for modification.
