# Safety Recall

## N252494000 L87 Engine Loss of Propulsion

Release Date: May 2025

Revision: 02

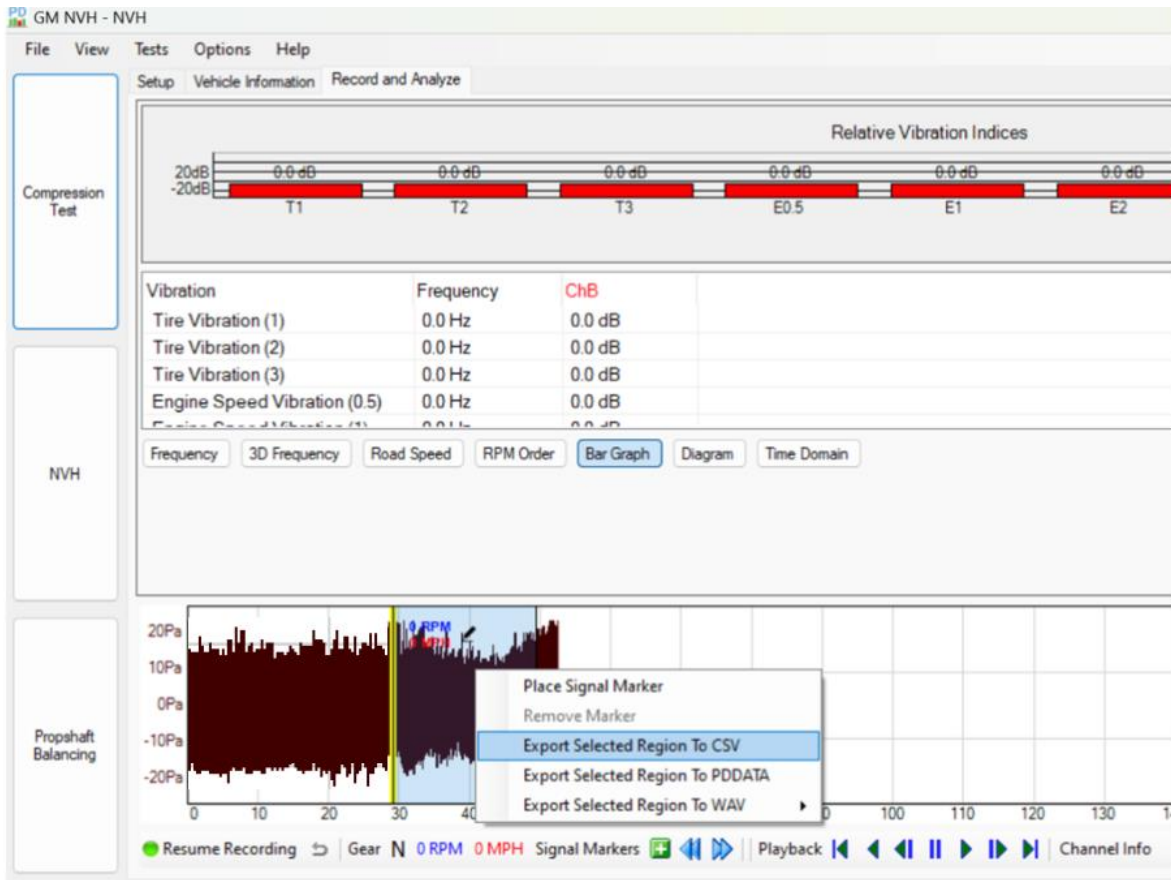
6937631

27. Switch back to the GM NVH software and **select a roughly 20-second-long clip** of the data displayed at the bottom, as shown above. You may select data by clicking and dragging the vertical bars. Then, right click it and hit “export selected region as CSV” as shown above. Note where the file is saved to, or save it to an easy to find location such as ‘my documents’ or your desktop. It may be helpful to name the file with the last 8 of the VIN if you will be running a lot of these tests.
28. Return to TLC and hit “Select Pico CSV” then navigate to the folder where you exported the CSV file in the previous step and open it.
29. Select “Process CSV.” An automated diagnostic will run, which will give you a result at the end determining whether the engine has passed or failed the test. The example shown above is a fail.
