SUBJECT:			R25-3-02RB
<p style="text-align: center;"><b>SAFETY BULLETIN</b></p> <p style="text-align: center;"><b>Ball Joint Inspection / Replacement</b></p> <p style="text-align: center;">NHTSA Campaign Number: 25V-380</p>			Date: 6/23/2025
			Model: All (see VIN list)
CIRCULATE TO:	<input checked="" type="checkbox"/> GENERAL MANAGER	<input type="checkbox"/> PARTS MANAGER	<input checked="" type="checkbox"/> TECHNICIAN
<input checked="" type="checkbox"/> SERVICE ADVISOR	<input checked="" type="checkbox"/> SERVICE MANAGER	<input checked="" type="checkbox"/> WARRANTY ADMIN	<input checked="" type="checkbox"/> SALES MANAGER

Product Line:  Taylor-Dunn  GEM  Tiger

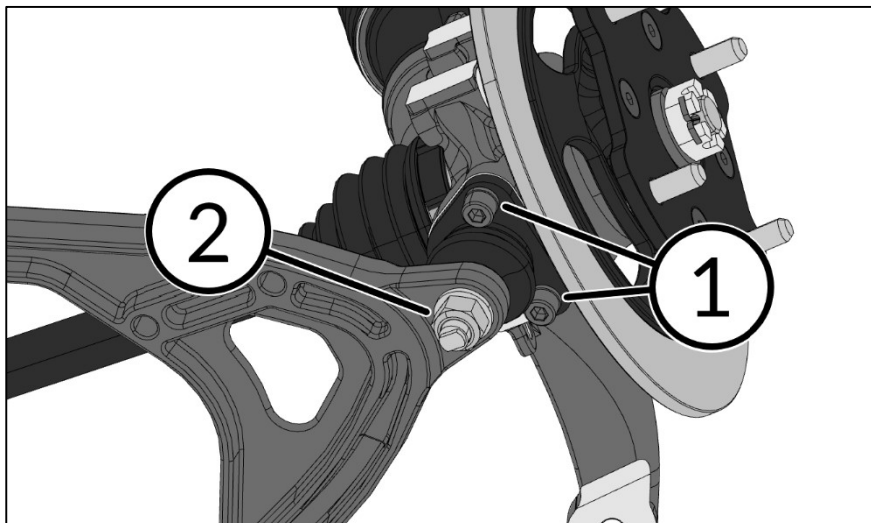
On some vehicles the ball joint retainer fasteners ① or the ball joint nut ② may not have been torqued to the correct specification. Also, the ball joint washers may not be present or in the correct order. Incorrectly torqued fasteners or nut, or incorrectly installed or missing washers, could lead to front suspension failure. Front suspension failure can cause a loss of steering control, increasing the risk of crash. A visual inspection and torque verification is required.

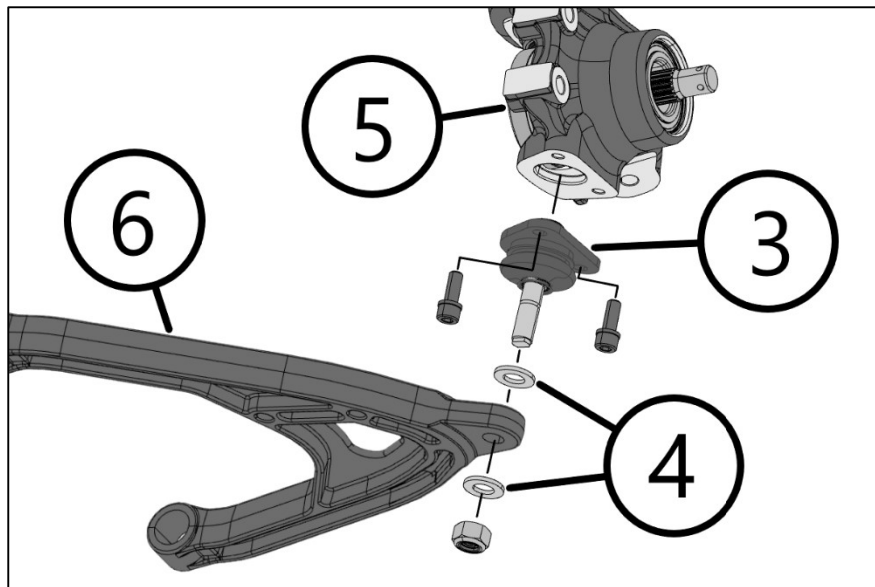
- 1) Set parking brake and ensure vehicle cannot move.
- 2) Turn steering as needed to gain access to ball joint.
- 3) Visually inspect to determine if the washers (4) are present and installed correctly as shown. If they are not, **STOP** and proceed to **Ball Joint Replacement**.

- 4) Set the torque wrench to 36 in-lbs (4 Nm). Ensure the 19mm crows foot is set at 90° on the torque wrench. Using the 7mm wrench to hold the ball joint stud, verify the ball joint nut ② is torqued to a minimum of 36 in-lbs (4 Nm). If the nut is not torqued to this minimum specification, **STOP** and proceed to **Ball Joint Replacement**. If the nut is tighter than 36 in-lbs (4 Nm), proceed to step 5.

- 6) Set the torque wrench to 18-ft-lbs (24 Nm). Using the 6mm allen socket, torque the ball joint retainers ① to 18-ft-lbs (24 Nm). Note: If looseness is found, inspect the strut housing ⑤ for signs of damage. If damage is found, please contact Waev Technical Support at [Techservice@Waevinc.com](mailto:Techservice@Waevinc.com) and DO NOT return the vehicle to service.

- 5) Set the torque wrench to 40 ft-lbs (55 Nm). Ensure that the 19mm crows foot is set at 90° on the torque wrench. Using the 7mm wrench to hold the ball joint stud, torque the nut to 40 ft-lbs (55 Nm).

- 7) Apply a red paint mark to each ball joint retainer and nut after torquing to the correct specification.
- 8) Repeat steps 2-6 for the remaining side.

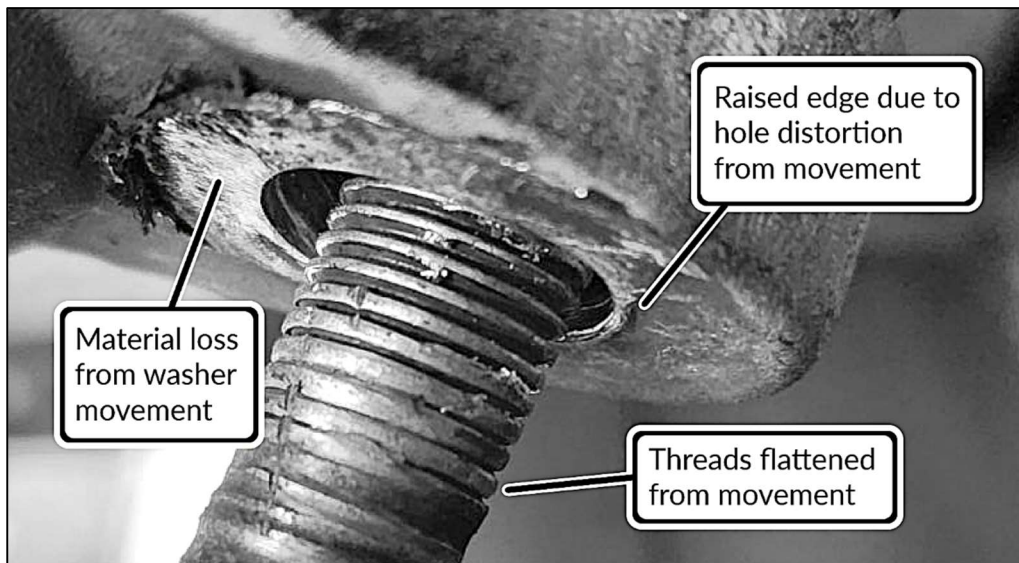
Inspect the control arm ⑥ at the ball joint mount points for ANY signs of damage. If damage is found, proceed with the replacement of the affected control arm in addition to the ball joints. See image below for examples of potential damage.

If it is determined that the ball joint nut ② is not torqued to the minimum spec, OR the washers ④ are incorrectly placed or missing, on either side, you **MUST** proceed with replacement of BOTH ball joints on the front suspension.

The replacement ball joints will include a castle nut and cotter pin for each. Discard the existing ball joint nuts. The cutter pin is installed once the castle nut is torqued to 40 ft-lbs (55 Nm). Once torqued, install the cotter pin. NOTE: if the hole for the cotter does not align with the castle nut, tighten the nut as required to allow installation. Refer to the appropriate service manual for full details on ball joint and control arm replacement procedures.
