# Service Bulletin

CBR650R #1  
December 2025

## SAFETY RECALL

### 2024 - 2025 CBR650R/RA WIRE HARNESS SHORT CIRCUIT

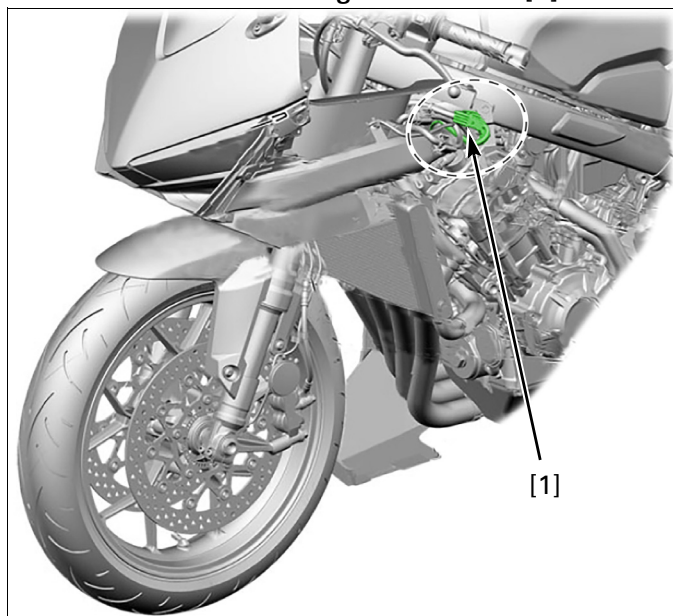
Honda is issuing a **STOP SALE NOTICE** for CERTAIN 2024–2025 CBR650R/RA motorcycles. Due to an assembly error, the turn-signal switch wiring harness was routed too close to the stay for the left middle cowl, and normal vibrations can wear through the insulation, exposing the copper wires and cause a short circuit. A shorted harness can cause a fuse to blow, which can prevent the operator from activating the turn signals, brake lights, hazard lights, license-plate light, horn, and gauge cluster, increasing the risk of a crash or injury.

Locate the 8P Turn Signal Harness [1].

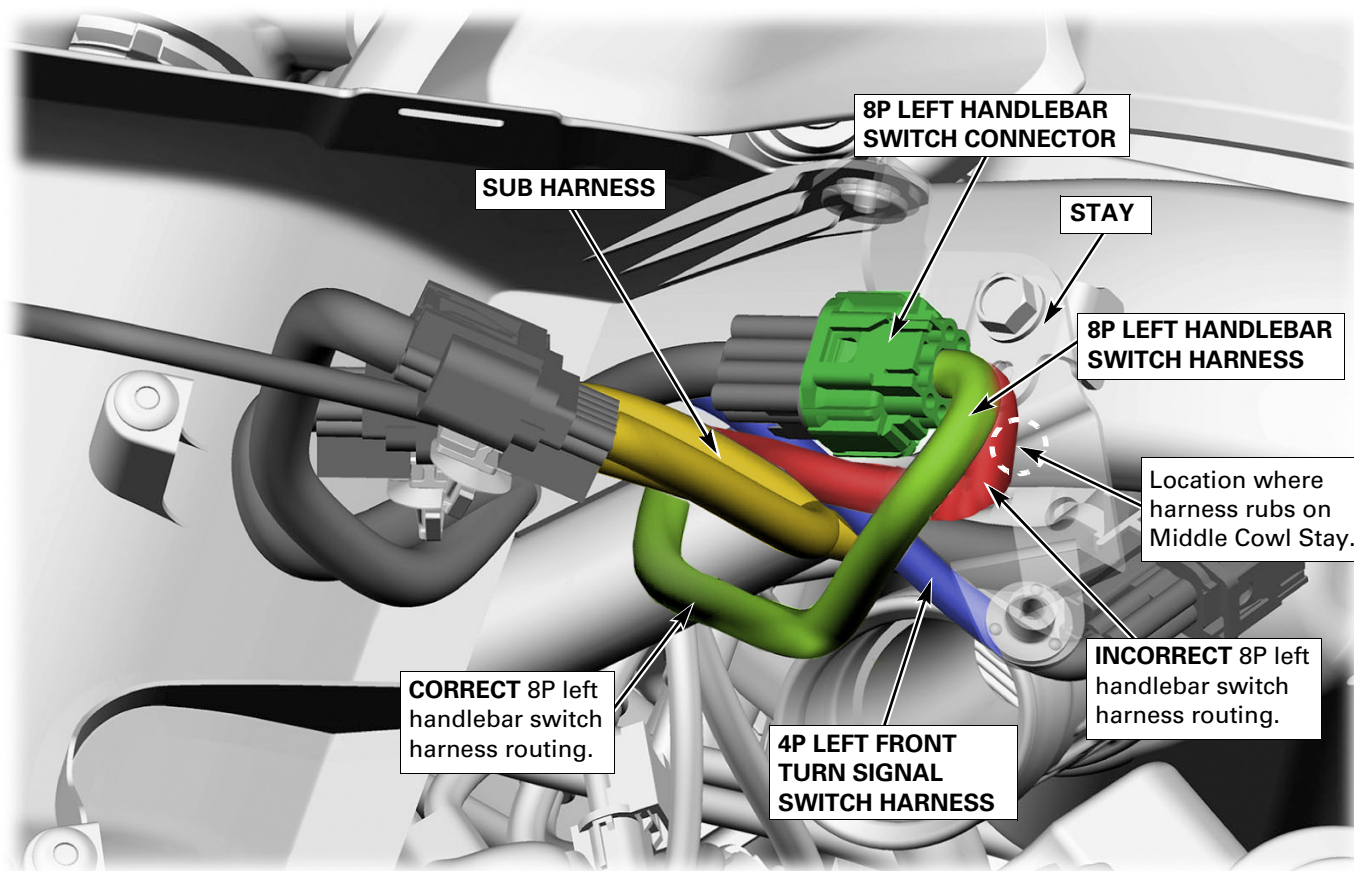
Perform an initial inspection on the 8P Turn Signal Harness (highlighted in green) to ensure there is ZERO damage on the harness near the middle cowl stay. Although unlikely on a new unit, if you notice wear or damage on a NEW unregistered unit, submit a *TechLine Connect*. See TECHLINE CONNECT - PHOTOGRAPH UPLOAD PROCEDURE on [page 5](#) for details.

Reroute the 8P Turn Signal Harness using the steps below. You must ensure it is installed beneath the Sub Harness, and routed to the front side of the 4P Left Turn Signal Switch Harness.

1. Disconnect the 8P Left Handlebar Switch connector.
2. Route the 8P Left Handlebar Switch harness and connector (highlighted in green) underneath the front sub harness (highlighted in yellow).
3. Ensure the 8P Left Handlebar Switch harness and connector are routed in front of the 4P Left Front Turn Signal Switch Harness (highlighted in blue).
4. Slightly untwist and re-situate the Front Sub Harness, as demonstrated in the video link above.
5. Reconnect the 8P Left Handlebar Switch Harness connector.
6. Be sure the 8P Left Handlebar Switch harness does not contact the Left Middle Cowl stay.
