## Hyundai Recall 304 (NHTSA Recall # 26V-400)

### MyHyundai App Messaging for Over-The-Air Update

### Instrument Cluster (CLU) OTA Software Update

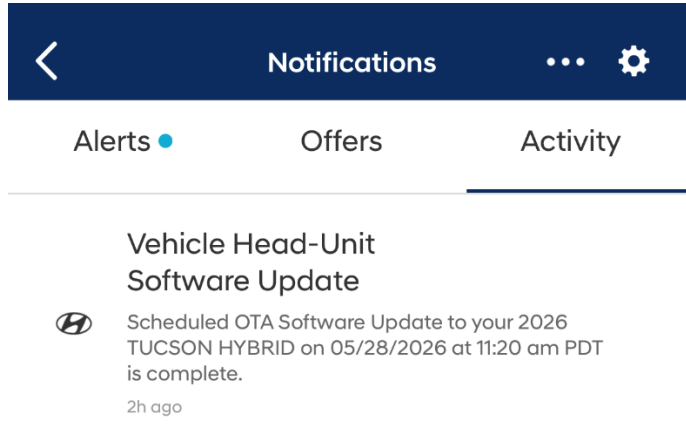
- Push Notification via MyHyundai with Connected Services App After Completion of the OTA Update (See the document, “Infotainment Messaging for OTA ” for reference):
