IMPORTANT SAFETY RECALL

NHTSA Recall No. 26V-006

Terex Utilities	
SAFETY NOTICE	SN735

SUBJECT: Upper Control Valve – Enable Cavity Plugs

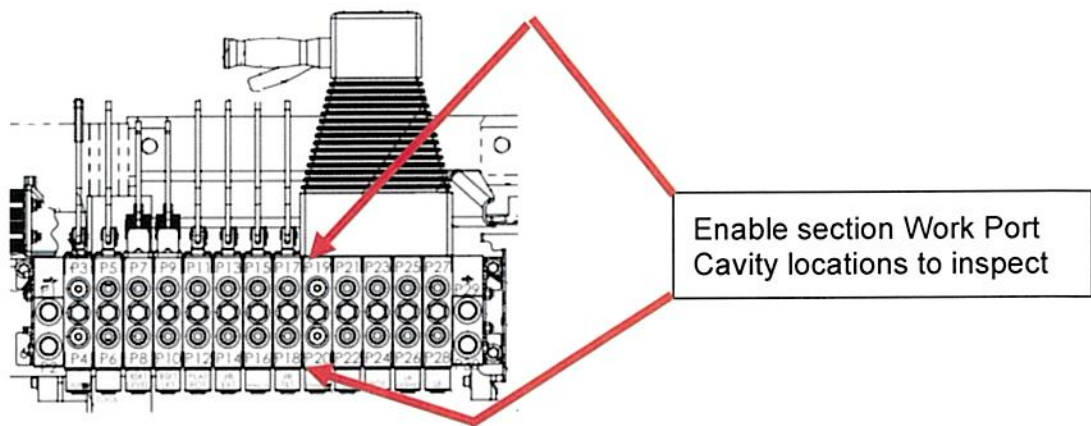
Valve assemblies 462052, 481326, 485616, and 486437 may have been assembled with No Relief (NR) plug in the enable section of the upper control valve for units built from January 1, 2025 to September 9, 2025. The plug in the enable section work port cavity should be a standard SAE O-ring plug to allow oil flow into the return passage when the enable is not engaged. The NR plugs will cause flow across the lower relief valve if upper controls are selected and the enable functions are not operated. It will also hold the engine speed on high throttle if demand throttle is installed. **Continued use will increase the oil temperature and may cause burns.**

- Figure 1 - Typical location to inspect of upper control valve enable section

Figure 2 – Correct Plug in the enable section cavity locations as shown above.

Figure 3 - NR Plug graphics which should not be in the enable section work port cavities.

Perform one or more of the inspections above. Refer to the pictures below for clarification. If the plug are black in color or verified by visual examination the incorrect plug is installed and must be removed and replaced with a standard SAE 10 Hollow Hex Plug, 411585 included in Z1765. Fill in the completion record included with the owner letter and return.
